TP 185E
Issue 2/2012

AVIATION SAFETY LETTER

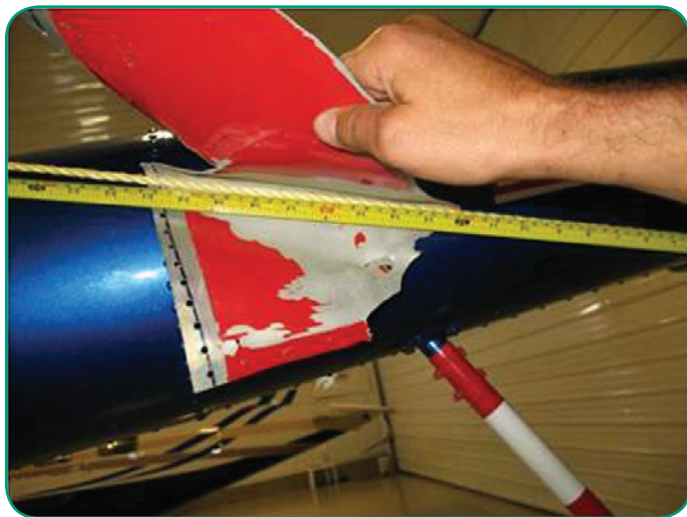
Tailboom rotor blade strike

It is conceivable that the student pilot encountered a bird during his steep-turn practice. During his attempt to avoid it, he may have applied control inputs that led to excessive main rotor flapping and mast bumping. Had he also lowered the collective, pushed the nose forward, or both, he would have been even more greatly exposed to the large aerodynamic forces that cause mast bumping. Such reactive manoeuvring is instinctive and often rapid, and in conjunction with the control inputs and in-flight attitudes often seen in steep-turn manoeuvres, is likely to cause rotor path plane upset and reduced clearance from the tailboom. Such flight conditions make mast bumping almost inevitable. In-flight mast bumping is frequently

irrecoverable and catastrophic, with either the mast being severed or a blade strike to the fuselage. In either case, the result is invariably fatal.

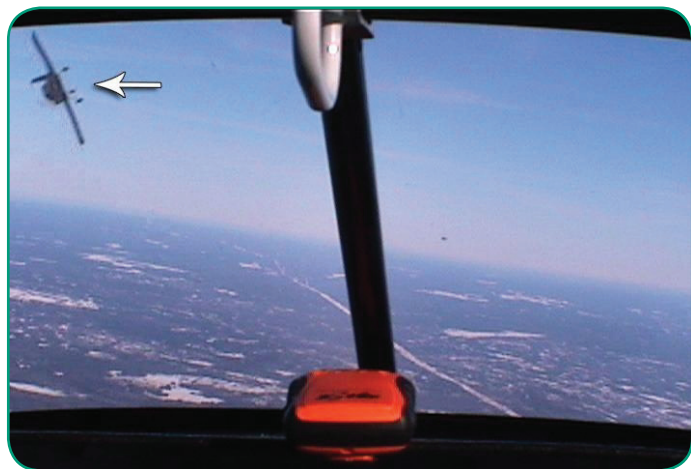
Video still image of the lead aircraft manoeuvring

position with the lead. Near Wolfe Lake, the lead began a series of manoeuvres. The RV-7A chased the lead through the manoeuvres and, at times, the lead could be seen within view of the recording video camera. During this type of manoeuvre, the pursuing aircraft must turn at a higher rate or g in order to maintain the lead within the field of view of the video camera.

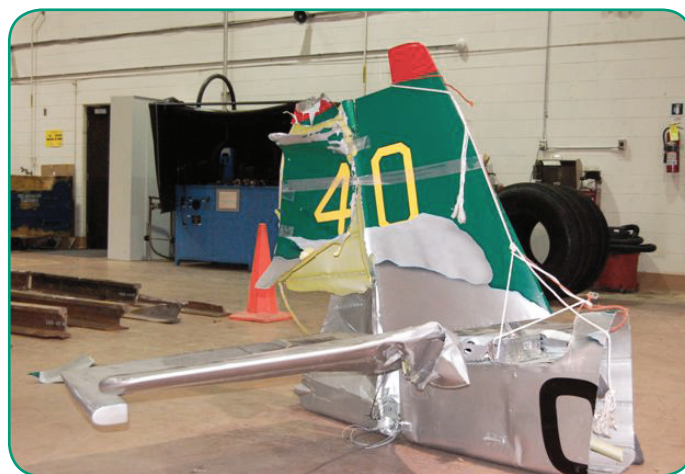
*Picture of re-assembled tail section during the investigation.
Pictures of the failed rudder are included in the
TSB Final Report*

The aircraft struck terrain at approximately 80° nose down, flipped over and came to rest upside down. The aircraft was destroyed from impact forces and there was no post-impact fire. Damage to the aircraft was consistent with severe impact forces. The vertical stabilizer and top half of the rudder were missing from the aircraft and could not be located at the wreckage site. After an extensive ground search, the vertical stabilizer and rudder were found approximately 0.6 NM southeast of the main wreckage site. The vertical stabilizer was intact. A portion of the rudder was attached to the vertical stabilizer. Numerous parts of the rudder, including the right aluminum skin and rudder trailing edge wedge, had separated from the main rudder structure and were located within 100 m of the vertical stabilizer. The rudder counterweight could not be found. The vertical stabilizer had completely separated from the fuselage. The fractures in the vertical spars occurred just above where the spars fastened to the fuselage. The fracture surfaces were consistent with failure by overstress.

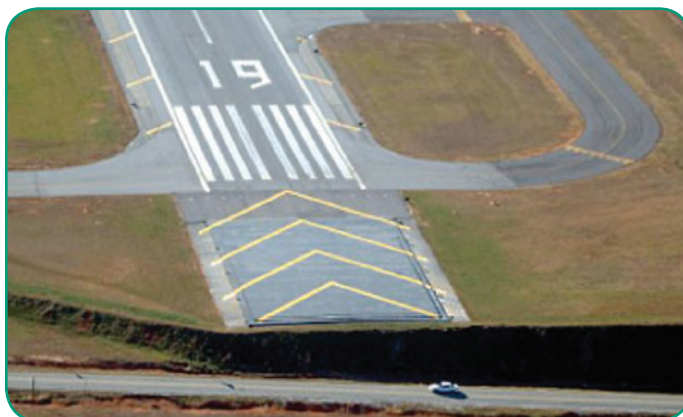
Photograph of an EMAS installation. (The EMAS bed is the grey area under the yellow chevrons) Ref: TC AIM AGA 9.1
