TP 185E  
Issue 2/2013

# AVIATION SAFETY LETTER

## In this issue...

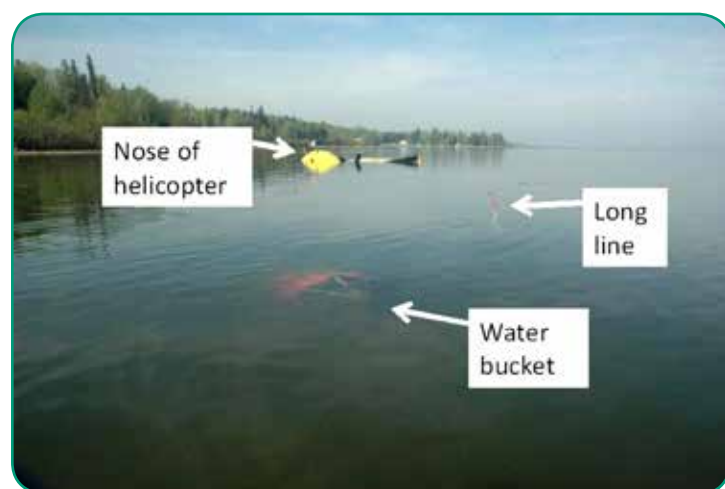
*Helicopter Crash Location*

An examination of the wreckage revealed that the collective was found in the full up position, and all collective connections to the engines were consistent with full power being requested. There was no indication of any system malfunction prior to the occurrence. Damage was consistent with the helicopter landing with a high downward velocity on its right side at impact.

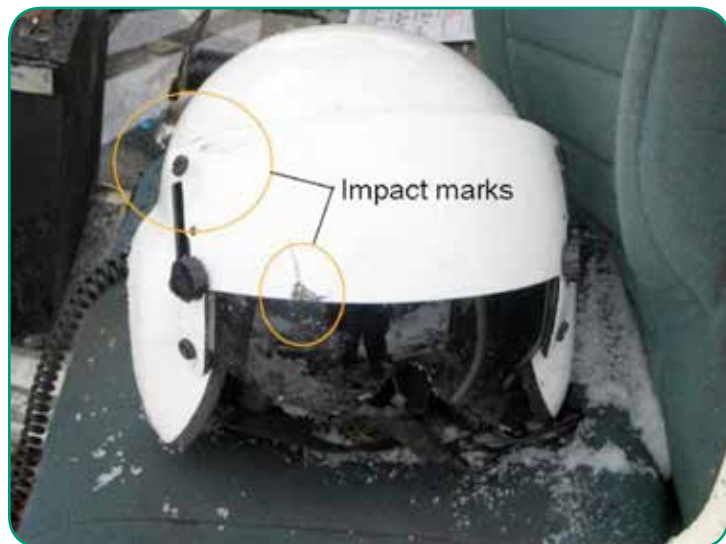
*This helmet was retrieved from an AS350 accident in Atlantic Region (TSB File A07A0007). The other pilot was not wearing his helmet and suffered serious head injuries.*

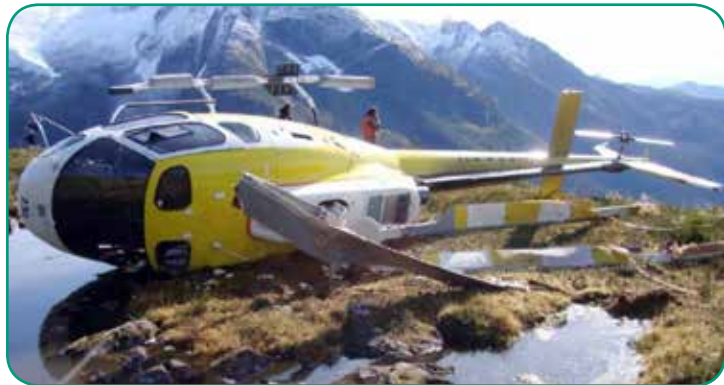
**Discussion:** On September 26, 2011, a Eurocopter AS-350BA sustained substantial damage after winds caused the aircraft to lift up and roll over on a ridgeline near Juneau, Alaska, despite the engine operating at idle rpm (NTSB # [ANC11LA108](#)). The aircraft had landed on the top edge of a steep slope where winds were forecast to be strong and erratic due to an arriving low pressure system over the area. The National Weather Service (NWS) forecasted the surface winds at 35 to 45 kt, however, NWS hourly observations from three different observation locations indicated maximum velocities ranging from 10 to 29 kt.

In an effort to better understand how this accident occurred, Eurocopter simulated the event with a similar aircraft of the same weight and rotor speed, and other environmental features including surrounding terrain (based on pictures supplied from the accident site), landing surface, and winds. The simulation revealed that the aircraft could be lifted off the ground with a wind speed of as little as 37 mph (32 kt) when the impact

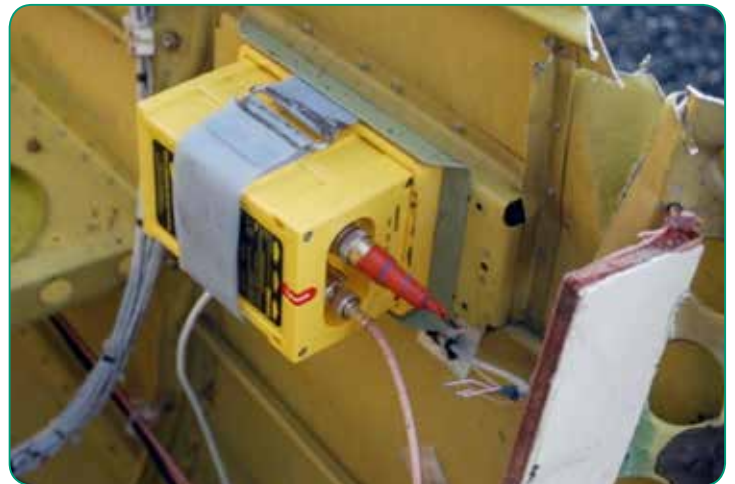
The type of mounting system used on the accident flight consists of a rectangular composite tray affixed to the aircraft. The ELT rests within a raised box structure that goes around the perimeter of the mounting tray and is secured by a fabric strap featuring a Velcro™ hook and loop system. When the strap is tight, the ELT is firmly held in the mounting tray box (see Photo 1).

*Photo 1: Properly mounted ELT with strap tightened*

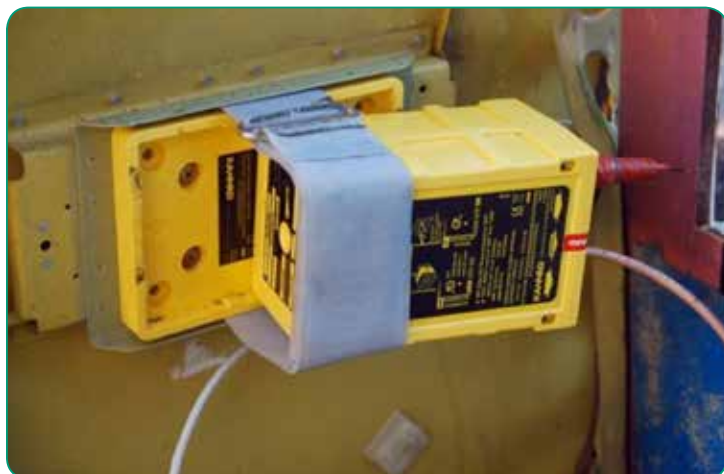
Field examination of the ELT and mounting bracket revealed that the retention strap was loosely fastened, and that it was possible to slide the ELT under the strap and back into its mount (see Photo 2). The unit could be easily removed in the same manner. Shortening the strap by  $\frac{3}{4}$  inch

tightened it around the ELT and secured the ELT to the bracket so that it could not be manually removed without loosening the strap.

*Photo 2: ELT sliding under loose strap*

The manufacturer's instructions direct installers to align the strap buckle with the centre line of the unit and "fasten the self-stripping strap tightly". There is no further definition of the degree of strap tightness required to adequately secure the ELT to the mounting tray. The subjective judgment of the installer is relied upon to make this determination.

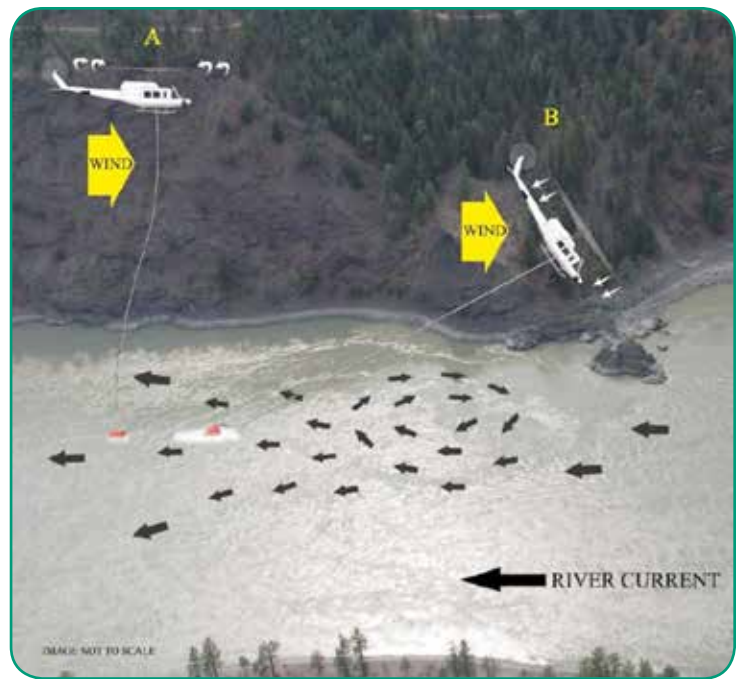
On August 14, 2009, a Bell 212 helicopter was engaged in firefighting operations about 20 NM south of Lillooet, B.C. At approximately 16:02 PDT, the accident helicopter approached the Fraser River to pick up water. Shortly before reaching the pickup location, the helicopter descended unexpectedly and its water bucket, on a 150-ft longline, touched down in a fast flowing section of the river. As the helicopter continued forward, it was dragging the water bucket. Moments later, the helicopter pitched nose-down, yawed to the left, struck the river surface, broke up, and sank. The pilot escaped the wreckage and was swimming in the fast flowing water. Repeated attempts to rescue the pilot by

*Accident sequence (VRS followed by bucket anchoring)*

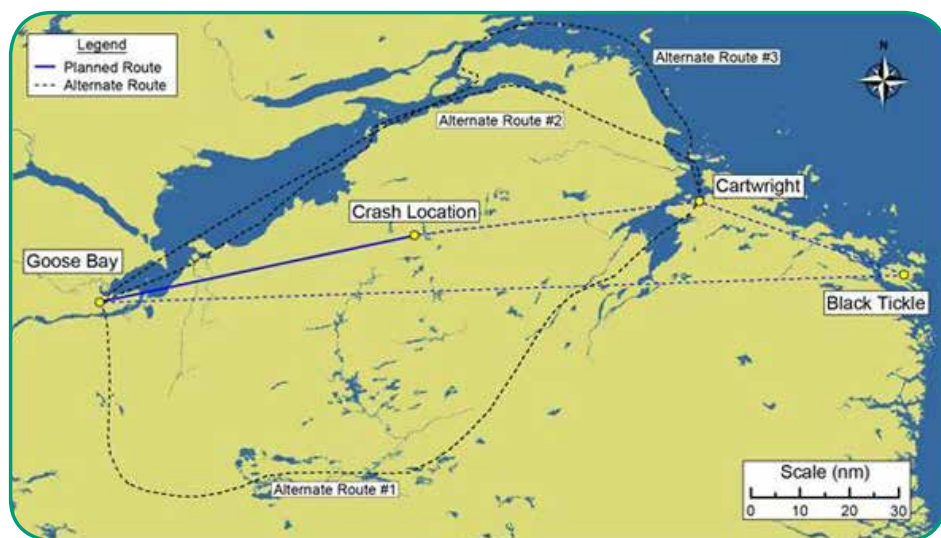
*The pilot was flying VFR direct to Cartwright in weather conditions where he would have encountered lowering ceilings and reduced visibility en route towards the Mealy Mountains.*

The pilot planned and flew the most common route from Goose Bay to Cartwright, which is direct. However, weather conditions may require flying around the Mealy Mountains. Pilots who routinely fly the coast of Labrador choose any one of the following alternate routes:

- Alternate Route 1: Follow the Kenamu River Valley until south of the Mealy Mountains, then proceed eastward and follow the Eagle River.
- Alternate Route 2: Proceed northeast from Goose Bay along the south shore of Lake Melville to Frenchman Point, then

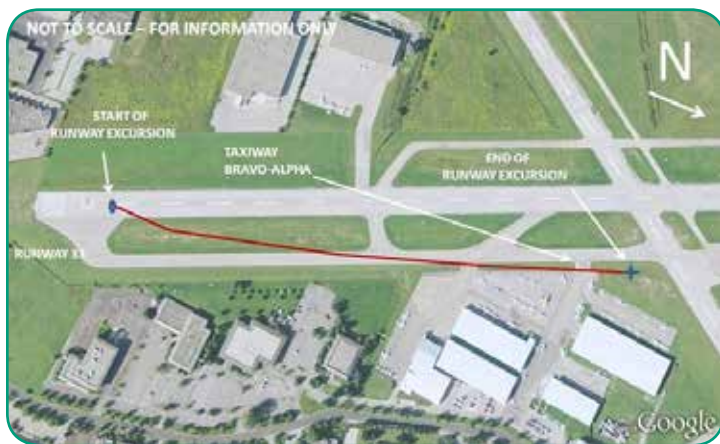
Runway excursion diagram

As the aircraft exited the infield and entered the paved Taxiway Bravo, the brakes regained effectiveness. However, directional control was not fully regained, and the aircraft struck the runway/taxiway identification sign before exiting Taxiway Bravo onto the grass infield.

ATC requested that the flight crew keep the circuit tight. Because of its excessive speed, however, the aircraft overshot the final approach track. The radar display indicated that the aircraft transitioned through the final approach course at approximately 140 kt. Consequently, a left turn was performed exceeding 30° of bank, well above the SOP limit and outside the Flight Safety Foundation (FSF) criteria for a stabilized approach. The distance to the runway threshold continued to reduce quickly, and manoeuvres to regain runway heading became more aggressive and non-standard.

Just prior to touchdown, the FO called for engine power, likely to arrest the high rate of descent. The captain did not increase engine power, and the aircraft touched down hard. Attempts at rudder steering and braking were ineffective in reducing speed and providing directional control, as tire traction would have been greatly reduced on the grass surface.
