Performance of Sprayed Polyurethane Foam on Indoor Foundation Walls

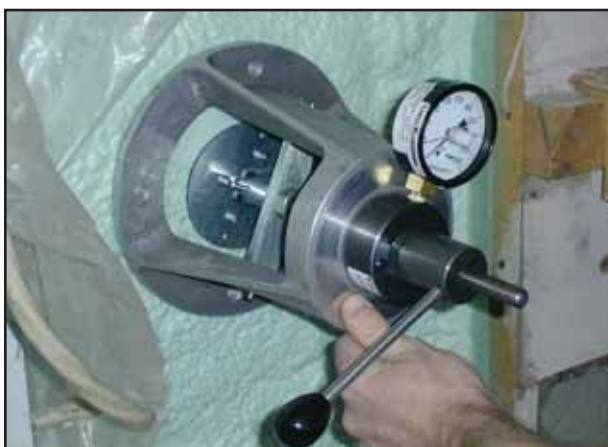
The device used displayed a reading on a dial, expressed in kg, of the tear strength force required to detach the insulation from the foundation wall.

Figure 1 Device used to test tear strength force

Adhesion tests were performed with a specialized instrument to ascertain whether the insulation provided acceptable adhesion to the foundation over time. To do so, two to four tests were performed in each house, at strategic sites:
