Transport
Canada

TP 185E
Issue 1/2015

AVIATION SAFETY LETTER

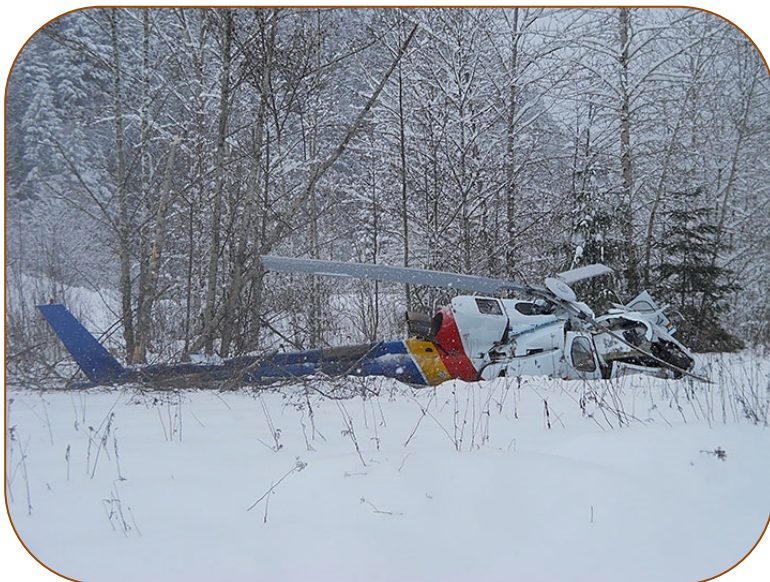
Wreckage

On January 17, 2012, at 13:51 Pacific Standard Time (PST), a Eurocopter AS 350 B3 helicopter with only the pilot on board, took off from an open field near Cultus Lake, B.C., on the outskirts of the city of Chilliwack. The helicopter slowly travelled nearly 260 ft to the north, and then hovered at about 80 ft above ground level (AGL) for approximately 30 s. Suddenly, a distinct noise and a puff of grey/white vapour from the engine area occurred, followed by a rapid loss of rotor revolutions per minute (rpm). The helicopter descended quickly, and within seconds, landed heavily on the snow-covered terrain. Upon impact with the ground, the helicopter fuselage collapsed and the fuel tank ruptured. There was no fire. The helicopter was destroyed, and the pilot was fatally injured. The emergency locator transmitter (ELT) activated and was detected by the search and rescue satellite system. The accident occurred in daylight at an elevation of about 650 ft above sea level (ASL). *The TSB authorized the release of this report on March 12, 2014.*

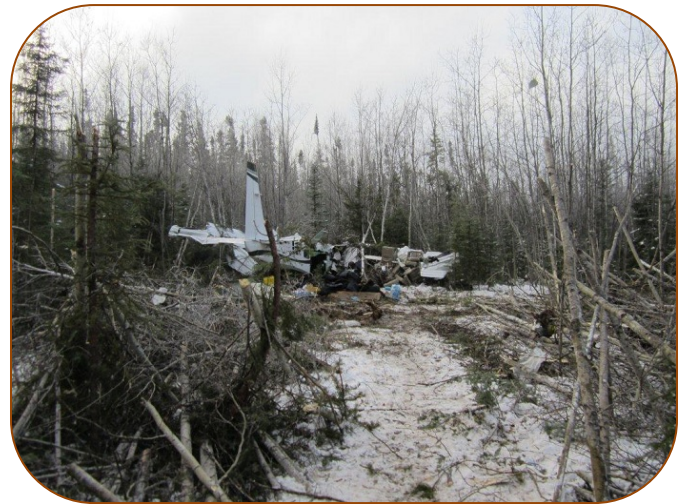
*Cessna 208 and crash trail near
Snow Lake Airport, Manitoba*

On November 18, 2012, a Cessna 208B departed Runway 21 at Snow Lake Airport (CJE4), Man., en route to Winnipeg, Man., with the pilot and 7 passengers on board. At approximately 0956 Central Standard Time, shortly after take-off, the aircraft descended and struck the terrain in a wooded area approximately 0.9 nautical miles beyond the departure end of the runway. The pilot was fatally injured, and the 7 passengers sustained serious injuries. The aircraft was destroyed by impact forces, and a small fire ensued near the engine. The aircraft's emergency locator transmitter activated. First responders attended the scene, and the injured passengers were taken to area hospitals. The aircraft's fuel cells ruptured, and some of the onboard fuel spilled at the site. *The TSB authorized the release of this report on April 16, 2014.*

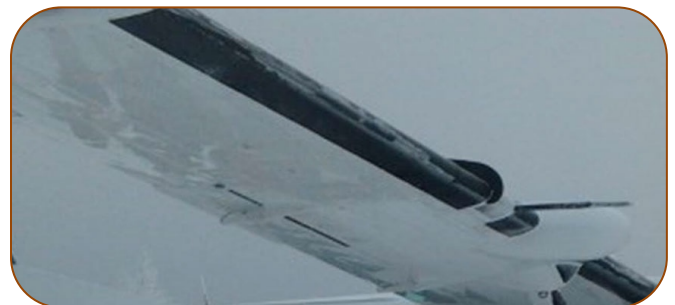
Ice on edge of wing before the accident flight

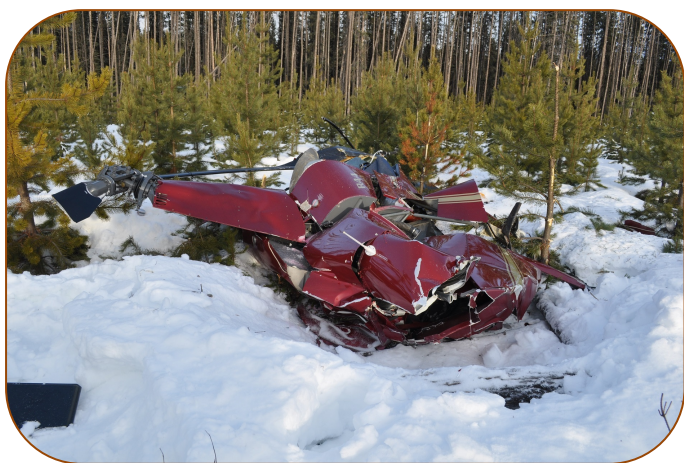
Main wreckage

On January 27, 2013, a Robinson R44 Raven II helicopter was being used to conduct monitoring of well sites southwest of Fox Creek, Alta. At 1311 Mountain Standard Time, the helicopter departed from its base of operations at the Horse Facility gas plant camp for the day's activities. After several flights, including one with a passenger, the helicopter landed at a roadside security gate, dropped off the passenger, and departed at 1735 with only the pilot on board. The helicopter broke up in flight over a wooded area 5 minutes later. The pilot was fatally injured. There was no post-crash fire. Although the emergency locator transmitter activated on impact, no signal was received due to impact damage to the emergency locator transmitter. *The TSB authorized the release of this report on May 21, 2014.*

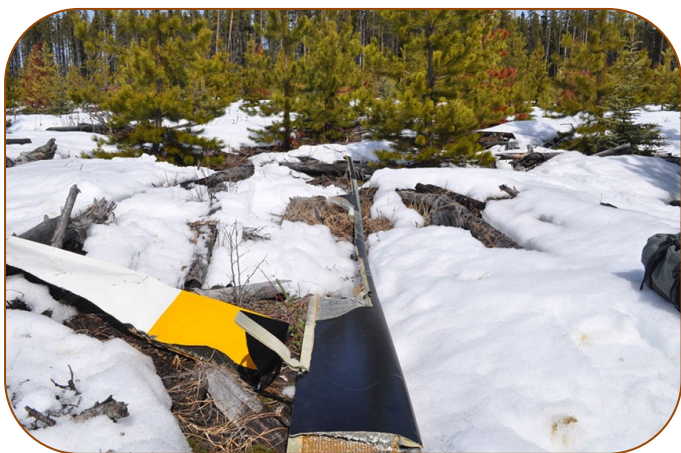
Detached main rotor blade

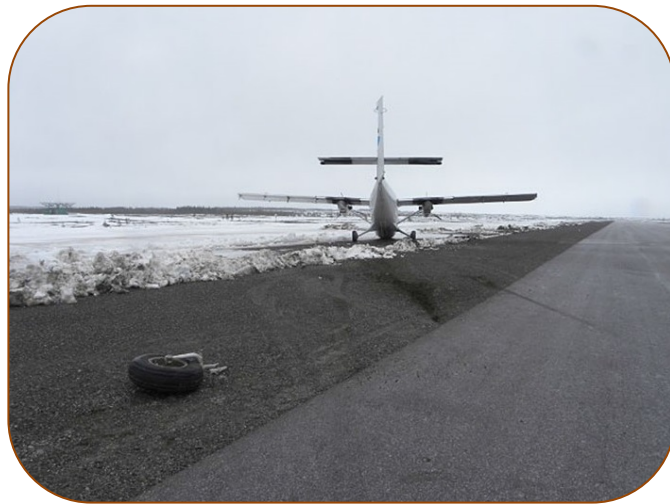
Occurrence aircraft after coming to rest off the side of the runway (Source: RCMP)

On March 27, 2013, a de Havilland DHC-6-300 Twin Otter aircraft was landing at St. Anthony Airport, N.L., with two crew members and eight passengers on board. The aircraft first contacted the runway with the left tire, bounced, and became airborne before touching down hard on the nose wheel. The nose landing gear collapsed, and the aircraft skidded on its nose, coming to rest 96 ft off the north side of Runway 10. There were no injuries. The aircraft was substantially damaged. The 406-MHz emergency locator transmitter (ELT) did not activate. The accident occurred at 12:53 Newfoundland Daylight Time (NDT). *The TSB authorized the release of this report on April 16, 2014.* △
