DIRECTORATE OF FLIGHT SAFETY
R.C.A.F. HEADQUARTERS • OTTAWA, ONT.
SEPTEMBER • OCTOBER • 1956

FLIGHT COMMENT

LIGHT on the SUBJECT

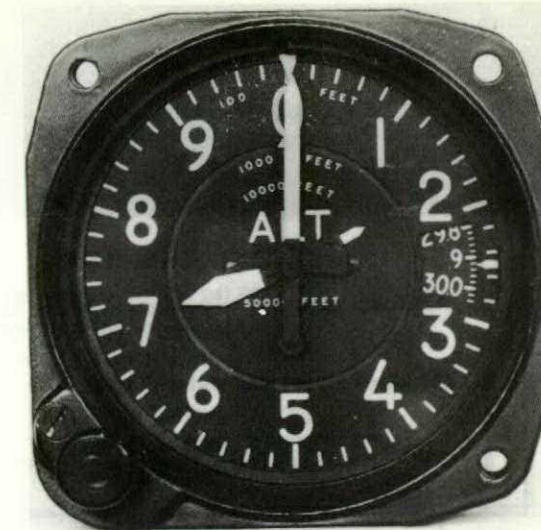
Fig 1. Older model (above) with short pointer, and new model (below) showing long, thin pointer with triangular end.

Changes are simple but effective. The short, 10,000-foot pointer has been extended by adding a long, thin pointer with a triangular end (see fig.1). The two sides of the triangle are curved inward so that it will hide as little as possible of the millibar sub-scale when in that position. This modification provides a positive indication of the 10,000-foot reading and reduces reading time considerably.

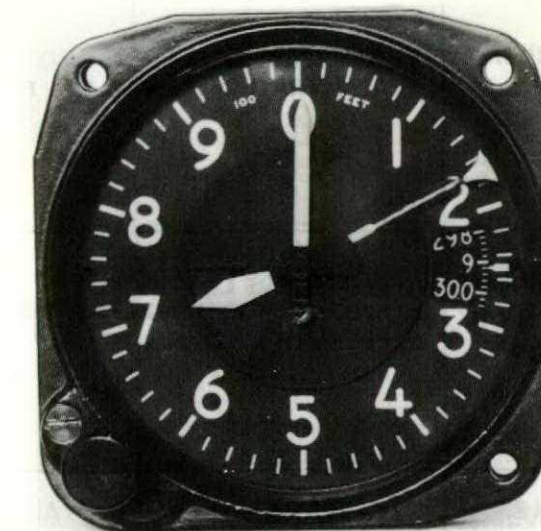
Fig 2. Older model (left) and new model (right) showing flag warning window.

The second modification is the introduction of a flag warning window immediately above the 500-foot position (see fig.2). The flag is painted in yellow and black stripes so as to be clearly visible by day or night. As the aircraft reaches the 10,000-foot level, the flag gradually disappears from the window, until at approximately 15,000 feet the window is clear. During descent the flag starts to move across at roughly 15,000 feet, and by 10,000 the window is completely covered. Thus, at

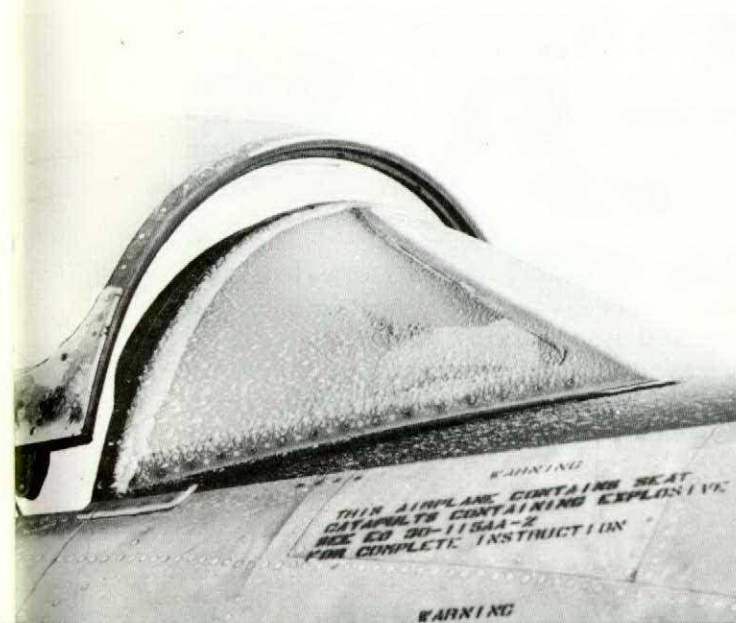
Cause and Effect

As shown in the photographs the two aircraft were damaged; but after stall checks both were landed safely. For flying illegally, the instructors were formally charged with violation of regulations and flying discipline.

A T-33 carrying a student and an instructor was signed out on a clear hood dual training flight (no formation). Shortly after takeoff this aircraft joined up with and formed on another T-33 which was flown by a junior instructor who had been signed out on a local solo clear hood exercise (again no formation). Following a short period of unauthorized formation flying led by the junior instructor, he initiated formation aerobatics—also unauthorized. In the words of number 2, "We did a loop and I lost position on the recovery and pulled into the lead aircraft."

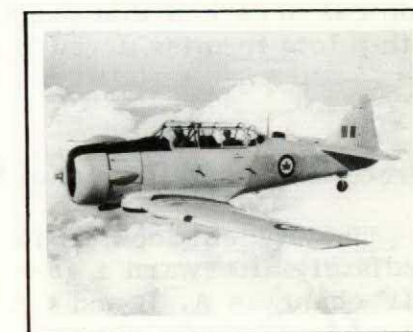
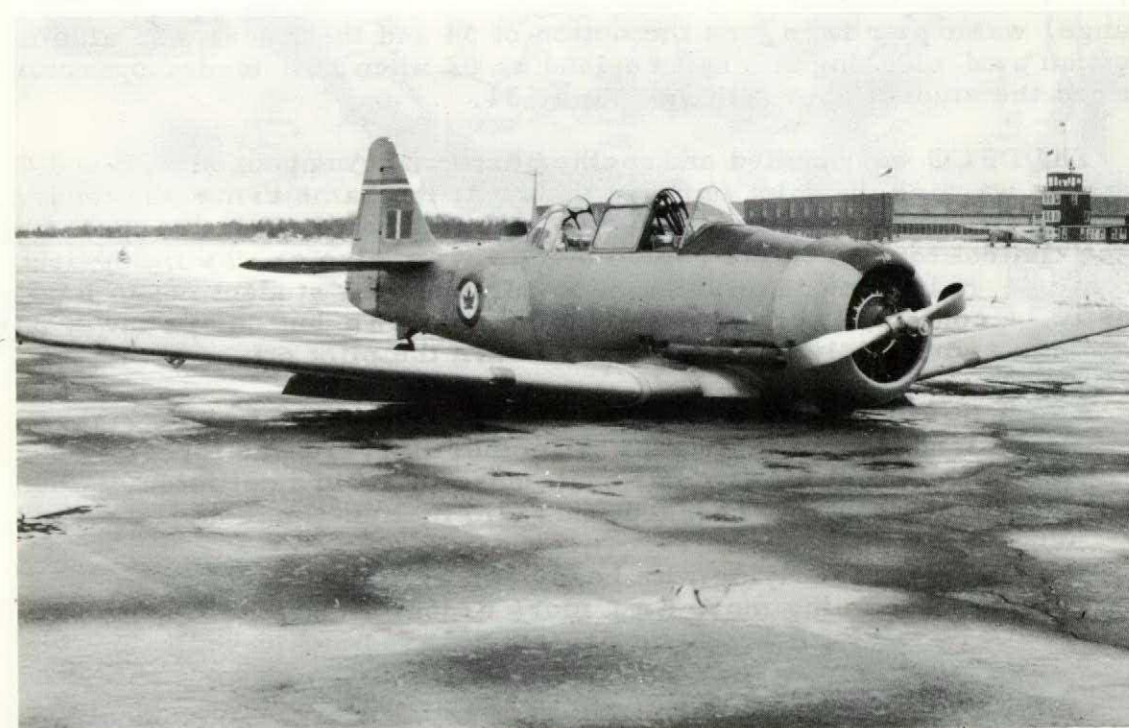
Don't Depend on the Horn

confusion involved in checking the radio set for the required frequency, they skipped their pre-landing checks—and the Harvard bellied in.

Both pilots stated that the warning horn did not sound until after the propeller first hit the runway. While the system checked serviceable immediately after the accident it was agreed that ice from slush picked up on previous circuits could have caused a temporary malfunction of the warning system. But why depend only on the horn? These pilots had the combined experience of some 9000 hours' flying behind them. Are we expecting too much of them when we say they should have learned prior to takeoff the frequency of the facility they were to use? Furthermore, should we not also expect them to know that permission—either visual or aural—must be gained before joining a circuit? Had these two procedures been correctly attended to at the proper time, undoubtedly the vital pre-landing check would not have been missed. It is somewhat ironical to record that preoccupation with the radio problem also caused both pilots to miss a red warning light from the tower.

Two experienced pilots were flying a Harvard on a mutual exercise. After some instrument work they began practising various types of landings at a radio-controlled satellite field with which they had not made radio contact. While on final for a 180-degree, power-off approach they heard their base controller broadcast the frequency of the satellite tower. In the
