# FLIGHT COMMENT

ROYAL CANADIAN AIR FORCE

## FLYING WITH THE R3350

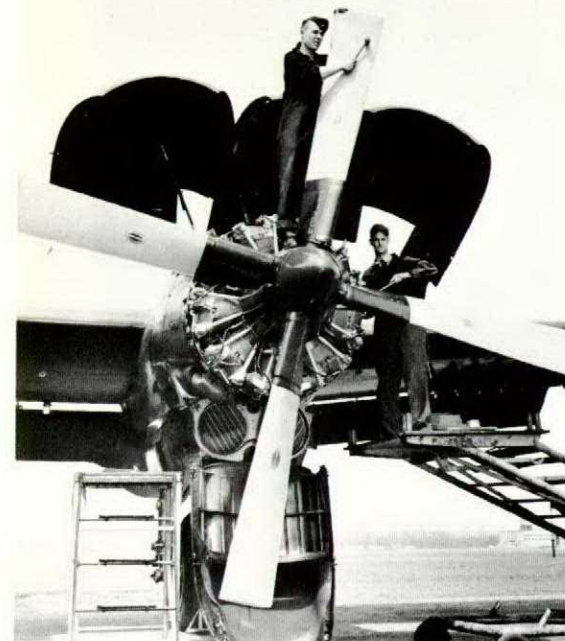
Make all engine checks with aircraft facing into the wind

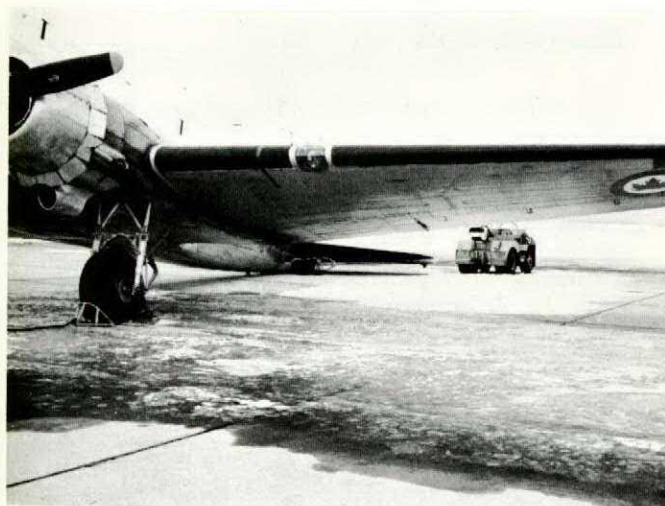
A D8 and a crosswind played at tug-of-war for a C47

Investigation revealed that when the aircraft reached the icy patch of tarmac the driver of the D8 slowed down, allowing the aircraft to jack-knife in the high wind. Had he maintained a steady pull on the aircraft over the icy section, in all probability this accident would not have happened.
