FLIGHT **COMMENT**

ROYAL CANADIAN AIR FORCE

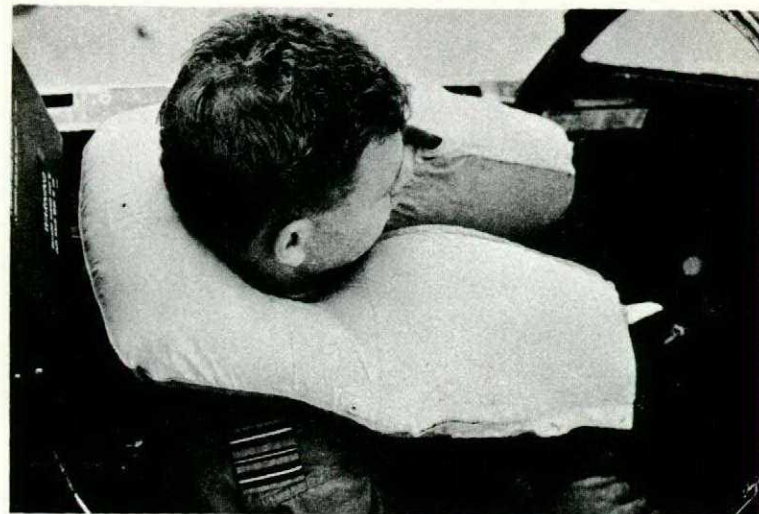
FIG. 7

A similar test was carried out using a Frankenstein vest-type lifejacket as used by the RAF and shown in fig. 7. As this jacket inflates outside the harness, no discomfort was felt but the view of the entire cockpit is cut off. This lifejacket can also be deflated easily by the oral inflation valve.

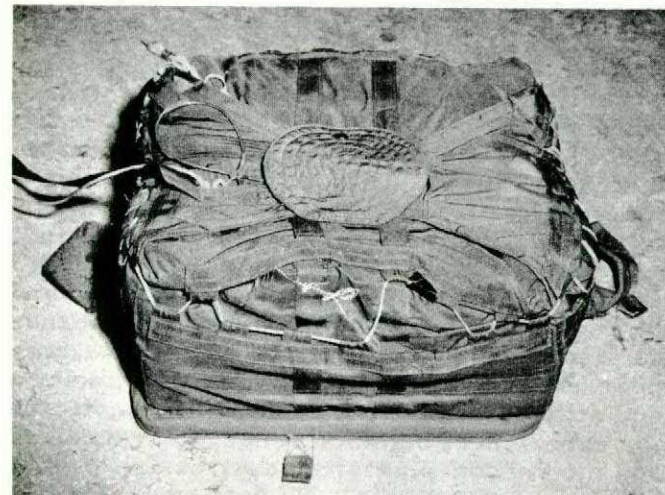
FIG. 3 Damage sustained by seat pack.

The Institute of Aviation Medicine carried out a technical evaluation of aircrew knives. One phase of the evaluation was concerned with the puncturing of an inadvertently inflated liferaft or lifejacket in the cockpit. A survey has shown that there is no recorded instance of a liferaft inflating in the cockpit within the past 8 years, which is as far back as accurate records are available. In order to determine what would happen to a crew member if an inadvertent inflation occurred in a cockpit, four one-man liferafts were inflated in ejection seats in the Laboratory. A mannequin was outfitted to simulate a crew member and strapped into a CF100 seat complete with a 15D/273 Survival Kit containing a RFD 15F/201 Liferaft. The CO₂ bottle was fired by means of a wire attached to the operating head. On firing, the survival pack expanded raising the mannequin in the seat causing the seat harness to tighten. A corner of the survival pack opened slightly exposing the dinghy fabric which immediately burst and the liferaft deflated. Only 5 seconds elapsed between firing the bottle and the dinghy bursting. At no time was any part of the liferaft exposed so that it could have been punctured with a knife. Similar tests were conducted in a T33 seat using the 15F/201 Liferaft and the PK2 modified Liferaft. Similar results were noted with the PK2 Liferaft bursting in approximately 3 seconds. A further trial was conducted in the T33 seat with a 15D/229 Survival Pack and PK2 modified Liferaft using a live subject. The subject reported no ill effects other than a momentary tightening of the seat harness which was relieved as soon as the liferaft burst. Fig. 1 shows the survival pack before liferaft inflation and fig. 2 shows the expansion on inflation. Fig. 3 shows the bulged and damaged but still intact survival kit.

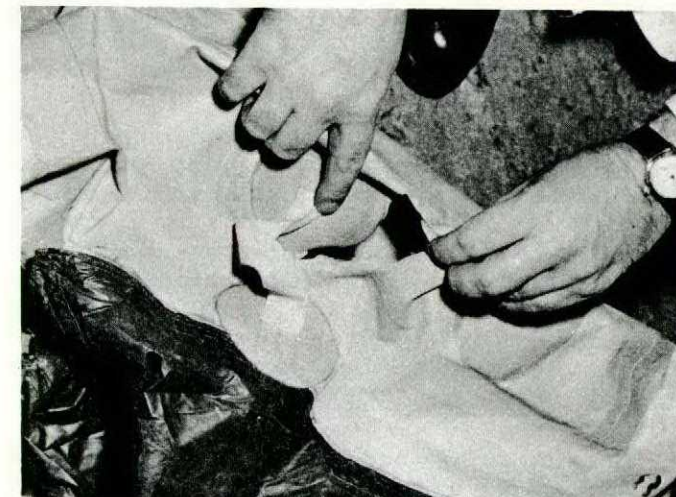
FIG. 4 Ruptured buoyancy chamber of liferaft.

Fig. 4 shows the ruptured buoyancy chamber of the contained liferaft. No inflations of this type were carried out in the cockpit.

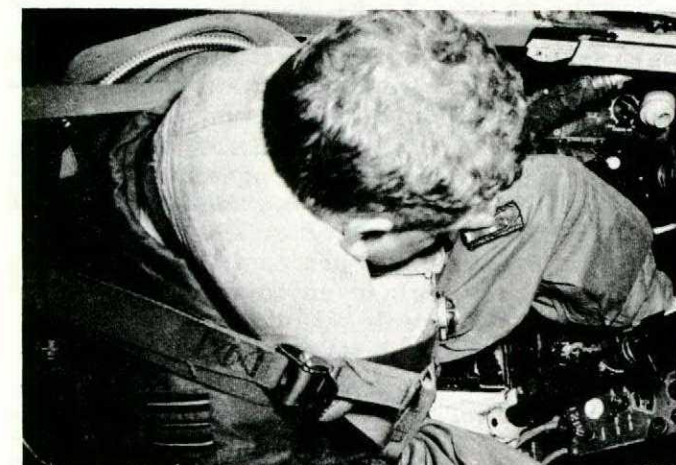
FIG. 6 Lifejacket after inflation.

Further trials in this phase consisted of inflating lifejackets in the cockpit of a T33 aircraft. Fig. 5 shows the standard 15F/187 Lifejacket in an uninflated state and fig. 6 shows it in the inflated state. Inflation of this lifejacket under tightly adjusted harnesses causes some discomfort and forces the head forward slightly. No inflation was undertaken in the air, however, there is no reason to believe that this would cause the pilot any undue difficulty in controlling the aircraft. There is a possibility that it could cause some interference with the helmet and oxygen mask. Stabbing this lifejacket with a sharp knife is considered hazardous. There is no difficulty in releasing the pressure quickly by means of the oral inflation tube valve.
