FLIGHT COMMENT

CANADIAN FORCES HEADQUARTERS

DIRECTORATE OF FLIGHT SAFETY

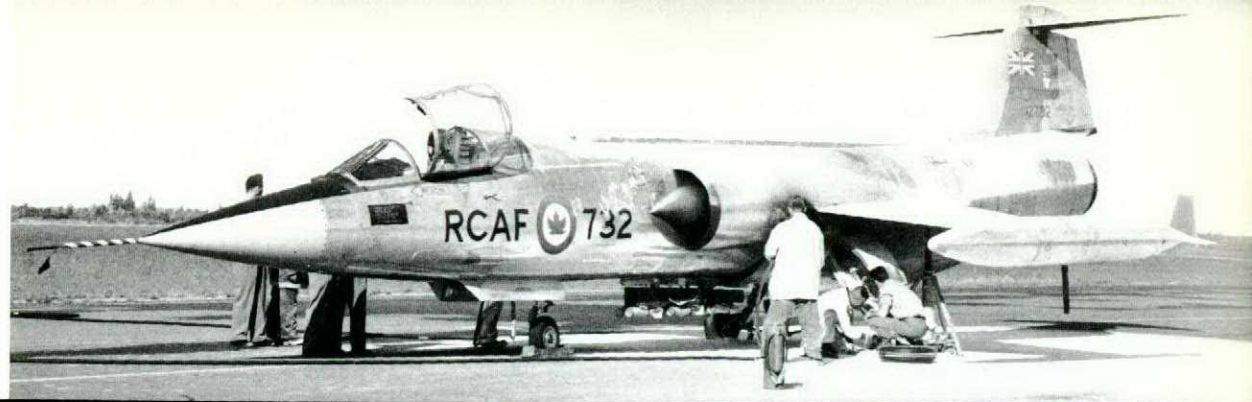
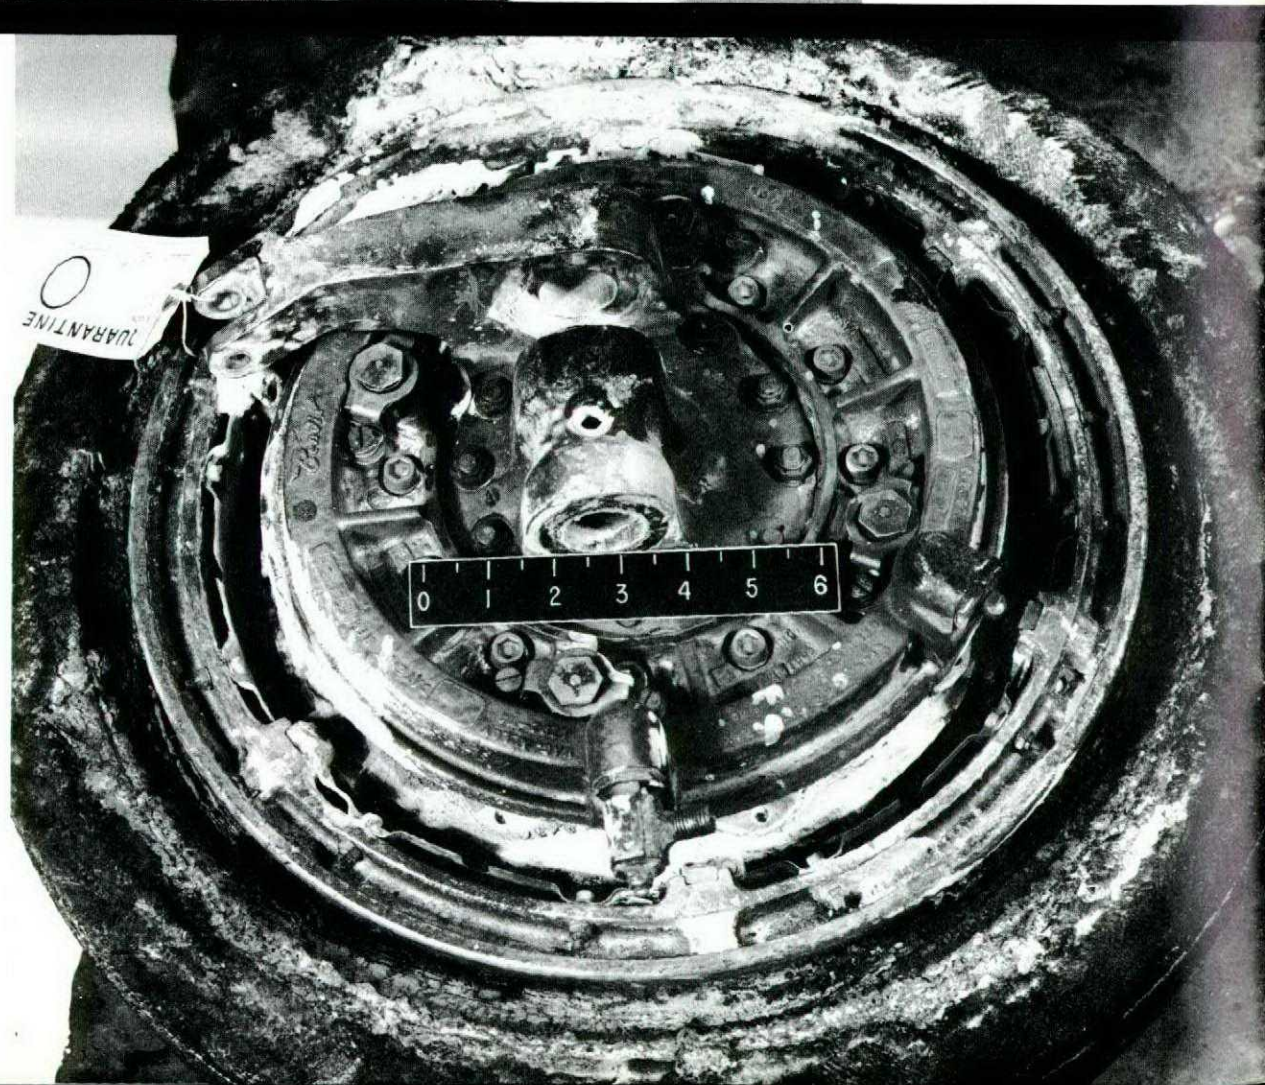
BRAKING: A HEATED DISCUSSION

Recently, a CF104 pilot aborting a takeoff, decided that there was sufficient runway remaining to stop without deploying the dragchute. He probably reasoned: there's 9000 feet of dry runway ahead of me and the AOIs indicate that I can stop in half that distance. Why bother with the dragchute and put the groundcrew to all the extra work of picking it up, repacking it and installing another in the aircraft? The photos on the opposite page give the grim answer.

Did this pilot consider all the factors in making such a decision? Obviously not—the aircraft suffered "D" category damage.

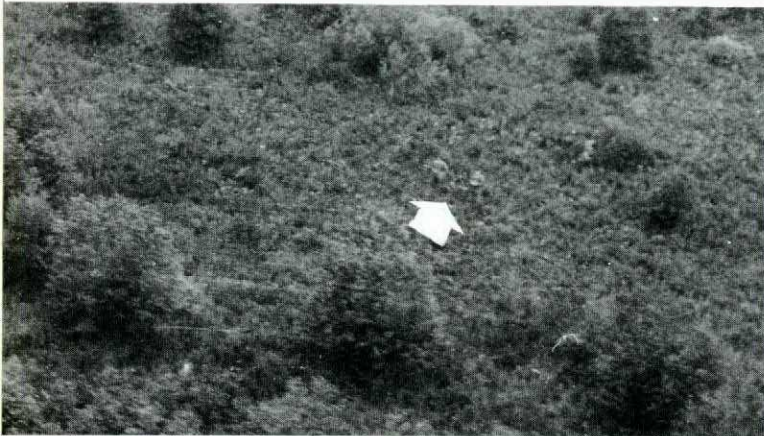
From 200 feet up

For several years some aircrew have recommended the adoption of the orange-coloured flying suit and a bright single or multi-coloured parachute; the conspicuity of these items, they point out, is an aid in the sighting of downed aircrew. This reason is valid against some back-ground conditions if the altitude of the search aircraft is not too great and visual conditions are favourable.

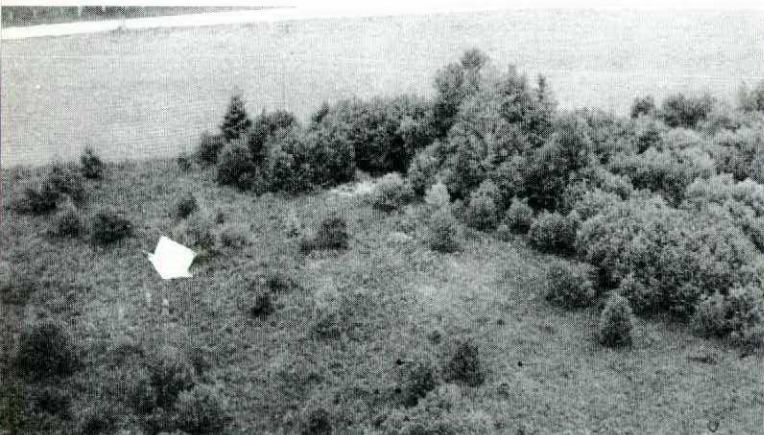
From 350 feet up

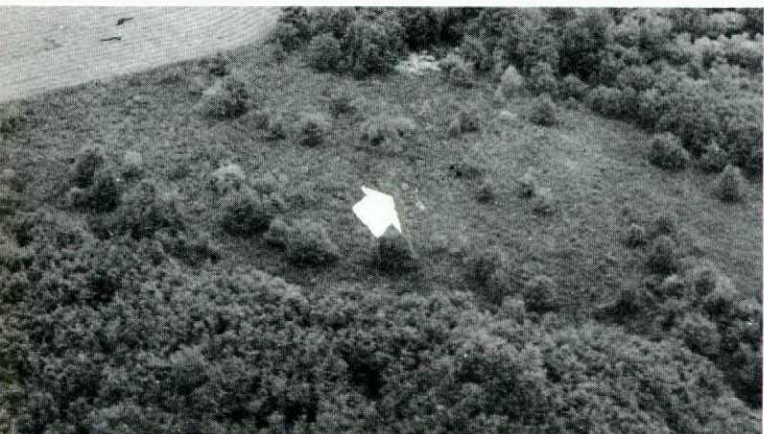
From 1000 feet up

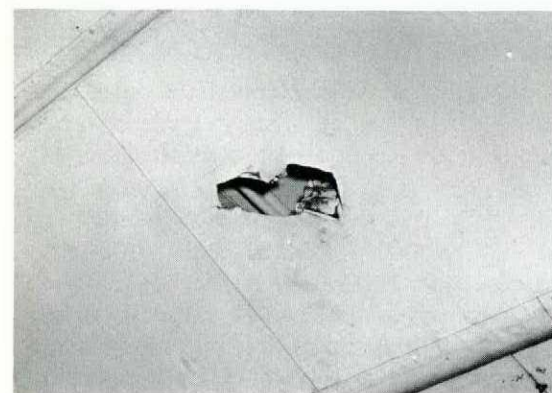
"I wasn't aware of the height of the hydraulic tilt boom on the forklift and I attempted to drive under the port wing."

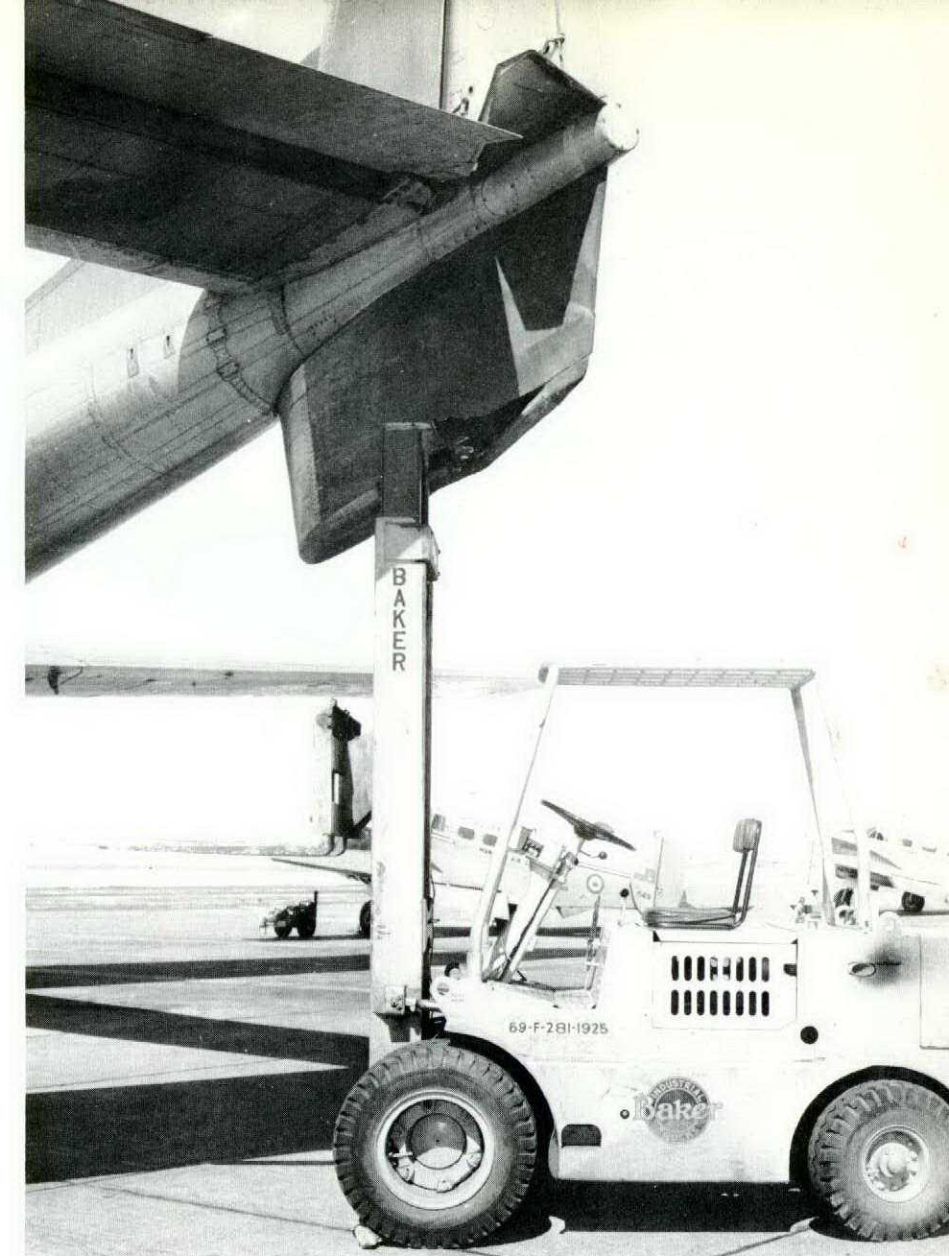
" . . . and I misjudged the height of the boom of the forklift, which struck the tail of the aircraft causing considerable damage."
