FLIGHT COMMENT

MAY • JUNE • 1966

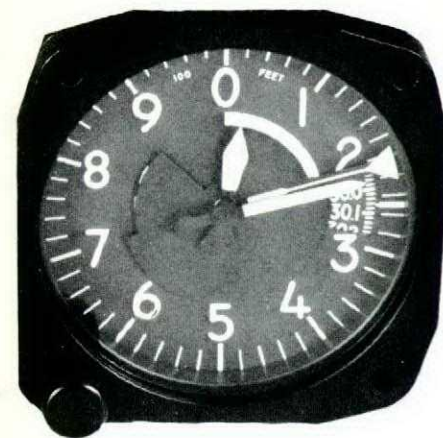
Some proposed altitude presentations
