# FLIGHT SAFETY SCIENCE

# SOAP

## Spectrometric Oil Analysis Program in Air Div

# Was it a Birdstrike?

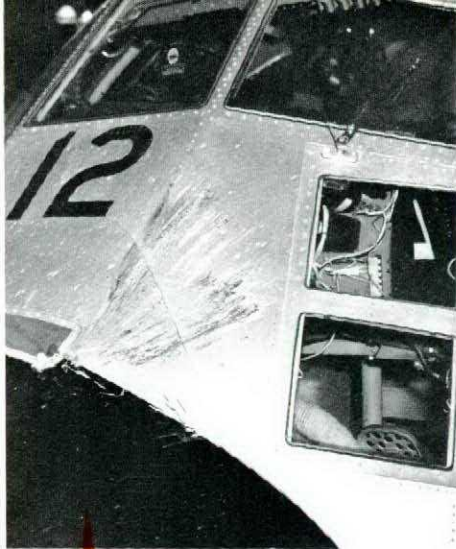
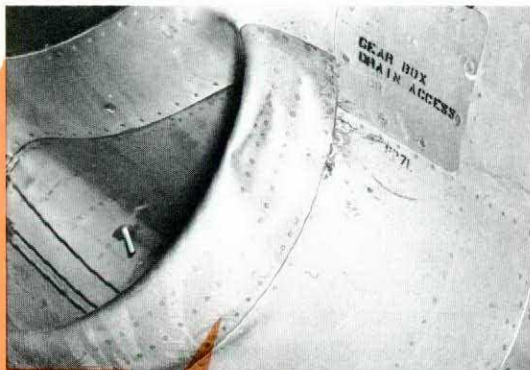
At about 700 feet after take-off "a loud bang was heard throughout the aircraft". The pilot states that no evident malfunctions resulted and so he continued the flight. This was incautious of him, to say the least, for after landing at an enroute base he elected to have repairs made to his damaged aircraft.

Incautious indeed, considering the extent of the damage shown in these photographs.

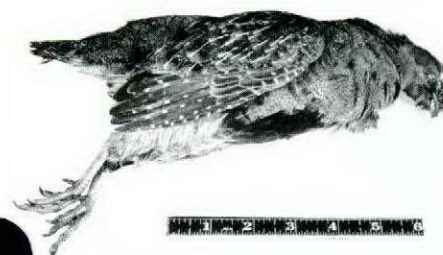
Member of the flock of partridge causing birdstrike. This one succumbed to a bulletstrike.

On the takeoff roll a CF104 passed through a flock of partridges at about 200 knots. One entered the engine with the resulting damage shown here. Fortunately the pilot was able to get the aircraft stopped without further damage (see Good Show).

The pictures speak for themselves, another graphic illustration of the need for airport bird control.

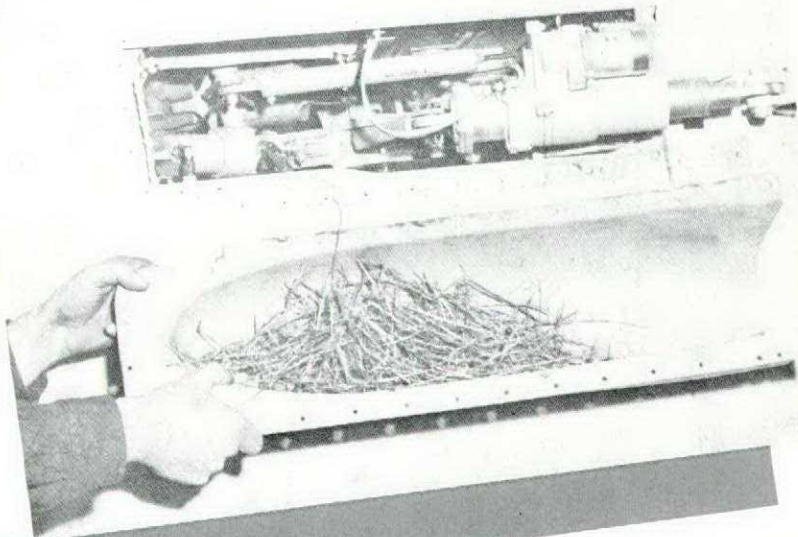
The fairing on the Tracker's rudder actuator is an ideal nesting place.
