New ideas need publicizing. NDT is not exactly new but for the Canadian Forces it is coming of age as it solves an increasing number of problems relating to aircraft inspection and testing. F/L Chamberland, in his article on NDT in this issue, makes the point that NDT has arrived but that more familiarity with its capabilities is needed. Full recognition of its importance is given in CFP144 Aircraft Maintenance Policy which says (article 417) "It is the ultimate aim of the Canadian Forces to have effective NDT facilities available to aircraft maintenance organizations". With that sort of support it can't miss!

Contaminated hydraulic systems are of continuing concern to those who fly and to those who buy. Apart from the flight safety aspect which remains of prime importance, consider this quote from F/L Glydon's article in this issue: "...hydraulic pumps installed in civilian airline jet transports are normally reaching a life in excess of 2500 hours. The same model pump installed in an RCAF fighter aircraft has a mean time between replacement of less than 500 hours". Hydraulic system contamination, then, is not only a hazard but a cause of unnecessary equipment waste.

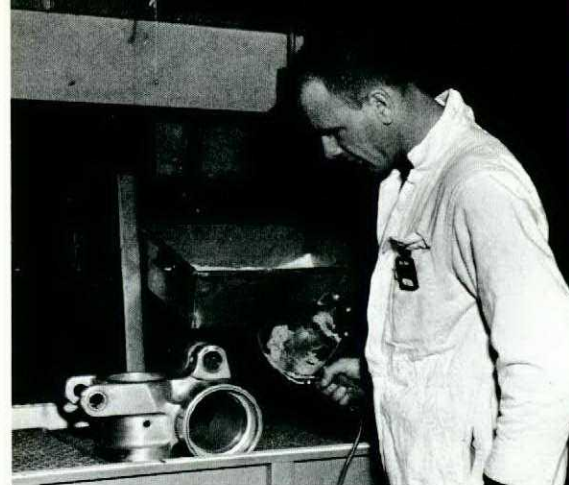
Magnetic particle inspection of a spider of a Dakota propeller. Note black light unit above the part. Technician directs flow of magnetic ink.

This method is widely used to detect surface discontinuities in ferro-magnetic (iron-based) materials. It operates on the principle that, under the influence of a magnetizing current, leakage of magnetic flux at the lips or edges of a defect will cause extra poles to appear at each side of the crack. If the part is sprayed with magnetic ink (suspension of iron filings), the iron filings will adhere to the extra poles developing at the discontinuity, making it more readily detectable. The

sensitivity of this method is greatly enhanced by employing fluorescent magnetic particles and black (ultra-violet) light, causing the defects to actually glow under the light. Magnetic particle inspection is simple to use, inexpensive, and reliable. Unfortunately, it is limited largely to surface discontinuities - although it can be used for sub-surface defects when special precautions are observed. Components must be dismantled and the surfaces carefully prepared.

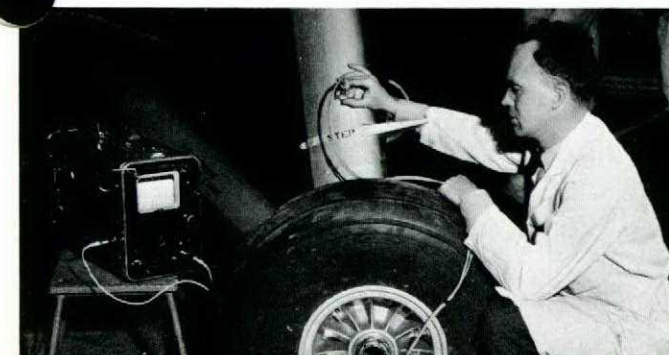
An Otter strut is mapped during the development of an ultrasonics inspection procedure. The equipment response in each area is recorded for comparison later suspect struts.

When sound energy is propagated through solid materials, its predictable path of travel can be converted into a visual read-out on a cathode-ray oscilloscope. A defect in the material will cause deviations from the normal path; this can be seen by the technician. Ultrasonics is a very sensitive method, requiring a highly-trained technician to interpret the visual traces on the oscilloscope. It can be either a brief or long task depending on the complexity (particularly the geometry) of the structure to be examined. Ultrasonic examination is economical because no consumables are involved

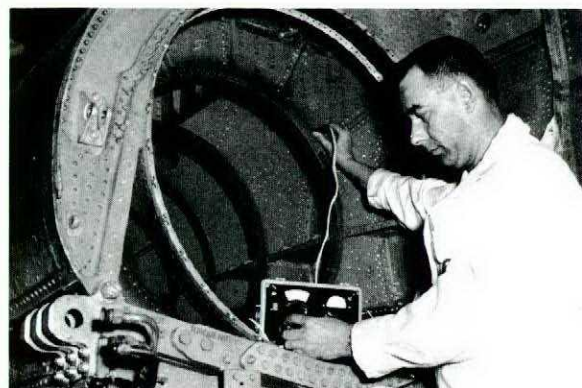
Eddy current conductivity check for strength reduction on aging structure - a CF100 tunnel liner.

- ▣ determination of heat damage to CF100 tailpipe tunnel liners
- ▣ T33 control shelves
- ▣ inspection of Yukon wheels for cracks in the locking ring groove.

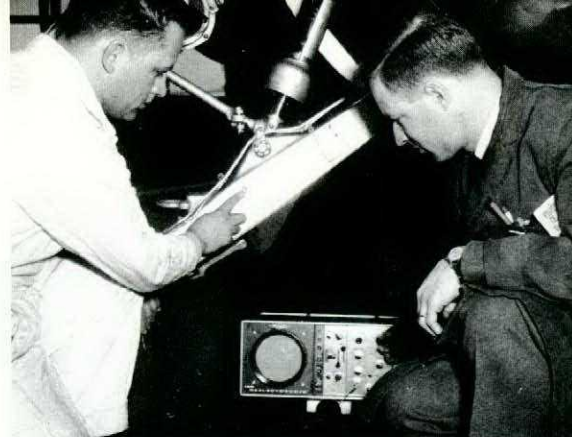
A CF104 main landing gear forging is inspected by ultrasonics.

In recent months the CF104 has presented technicians of the NDT Centre with several challenging inspection problems. Failures were reported to the drag-strut assembly, the main landing gear forging, the speedbrake actuator, and hydraulic servo units. Calls for help were received by the NDT Centre. So far, NDT has provided a quick, reliable method of inspection for the drag-strut assembly and MLG forgings. On-the-spot ultrasonic inspection of the drag-strut assembly has been done by MRPs at Cold Lake and the Air Division wings.

Operational capability of CF104 squadrons would have been affected if these inspections had not reduced the two-day inspection time of the conventional "strip and look" to one hour by ultrasonics. At the time of writing we are busy developing an X-ray technique for use at the unit, to determine the position of a damper nut on the hydraulic servo. If successful, we can reduce the pressure on repair-and-overhaul of these components.

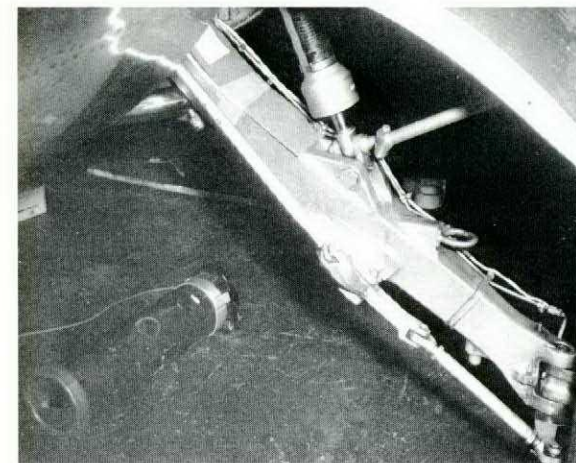
CF104 main landing gear forging is X-rayed. The film envelope is taped to the gear; the radiation source is below.

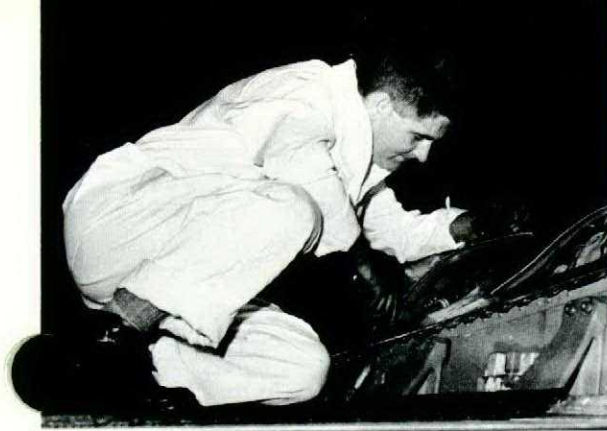
While performing a visual check of the flight controls during a periodic inspection, Cpl Ogilvie, an airframe tech, discovered a badly-cut fuel line. While inspecting the CF104's starboard aileron control cable for excessive play and freedom of movement, Cpl Ogilvie was sure he felt the cable rubbing against something within the fuselage beyond his line of sight. Extending his inspection through a small access panel in an area obscured by cables, pulleys and plumbing he was able, with a flashlight to locate the cause. The aileron control cable was rubbing across a fuel transfer line, which was nearly cut through, leaving a 3/4" gash. (See Gen from 210 for story).

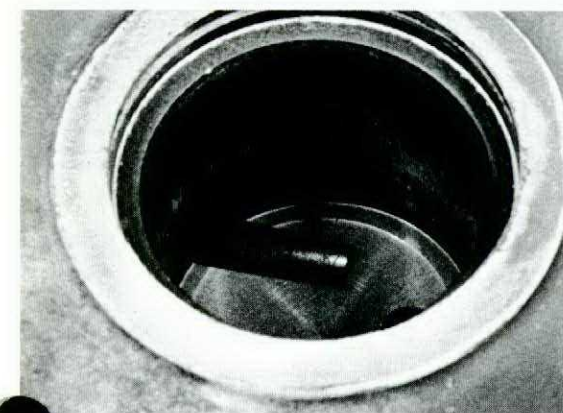
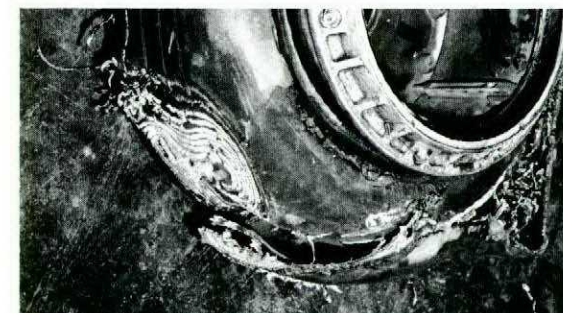
set-up of CF101 brake cylinder scored by contamination. This minute damage was tell-tale sign of failure; the brake pistons - no longer free to travel - imparted a braking force sufficient to blow the tire (below). The aircraft ran off runway, coming uncomfortably close to being a write-off.

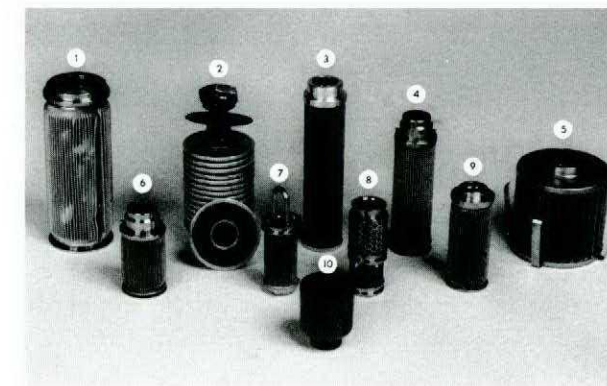
No.	DIA (inch)	LENGTH (inch)	APPLICATION	TYPE OF MEDIA	VALUE	FILTRATION RATING (microns)	
						ABSOLUTE	NOMINAL
1	1 1/4	4	CF101 hydraulics	woven stainless steel mesh	50	25 approx	10
2	2	3	CF101 CSD (engine oil)	woven wire mesh - biscuit or water element	100	80 approx (suspect)	
3	1	4	general - hydraulics	resin-bonded fiber	3	-	10
4	1	3 1/2	CH113A SAS hydraulics	woven stainless steel mesh with sintered steel particles on outer surface	150	15	1.5 (MIL-F-8815A; a very tight spec)
5	2 1/4	2 1/4	Tutor fuel	woven wire mesh	35	-	80
6	1	1 1/2	CH113 hydraulics	woven wire mesh	75	25	10
7	1/4	2	Tutor engine oil	woven wire mesh	35	80 (suspect)	-
8	1/4	2 1/4	CH113 - T58 engine oil	wire mesh screen	35	150 (suspect)	-
9	1	2 1/2	CH552 hydraulics	woven stainless steel mesh	100	25	10
10	1 1/4	1 1/2	Tutor reservoir air filter	sintered monel metal particles	20	-	25 approx

Different dirt-loading materials, flow rates, pressure differentials and test conditions will result in entirely different dirt capacities. Of interest, are the different types of filtering media. Wire mesh is a surface-type re-usable element media, and although it can have an absolute rating if the mesh is bonded to avoid spreading, the dirt capacity will be limited. Fiber elements have random depth-type voids and are in general, a disposable filter. Dirt capacity is higher, but unless ideal fiber and bonding materials are used they are prone to rupture, fiber loosening, and are not always adapted to absolute ratings. Another type is the semi-depth filter which will have fine metal particles bonded on top of wire mesh. This is an excellent re-usable filtration media; it has an absolute rating, provides a torturous path for fluid flow to trap particles and fibers, and can absorb more dirt than wire mesh.

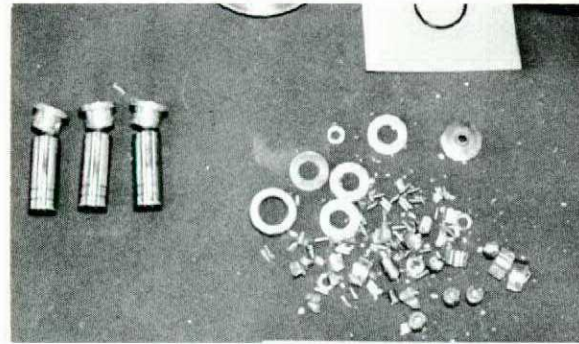
Hydraulic pump failure – the aftermath.

When you think of contamination, you think of pumps. Fluctuating pressure or excessive peak pressure indicates sticky stroking and compensating pistons or pressure control mechanisms, which in turn, indicates dirt, or wear caused by dirt. Displacement or wear of pumping pistons causes internal leakage and higher case pressures; this blows shaft seals or even cracks housings. Further pump wear causes flaking and ultimate disintegration of moving parts, thus contaminating the entire system.

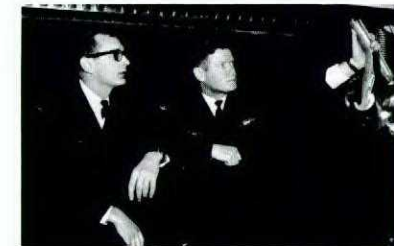
F/O Clermont and WO2 Frost examine repaired nosewheel.

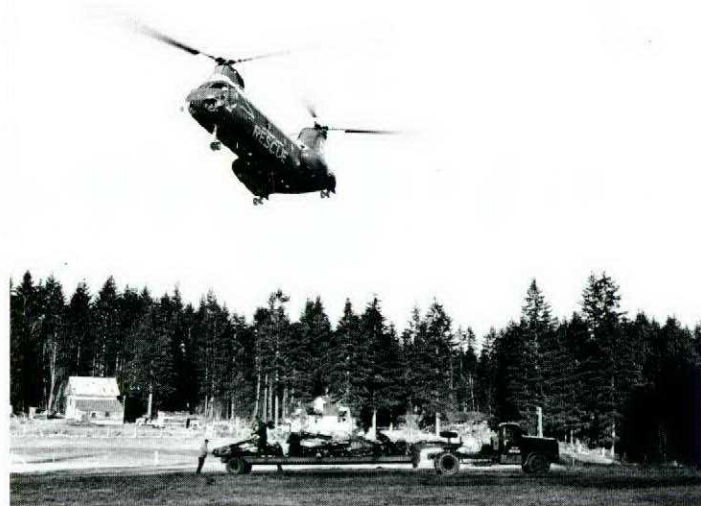
Helicopter lowers tail section of Tutor on truck.

A CH113 helicopter extracts a net loaded with wreckage.

A Tutor had crashed into a stand of 100-foot timber on Vancouver Island. The accident investigators were somewhat awed by the amount of logging and road building required to retrieve the wreckage before their examination could proceed. During a short conversation with F/L Al Winter, a chopper pilot with 121 Composite Unit at Comox, a quick solution was devised. The next day F/L Winter and F/L Dan Campbell, their two crewmen and two para rescue men arrived at the accident scene and made short work of recovering the wreckage.

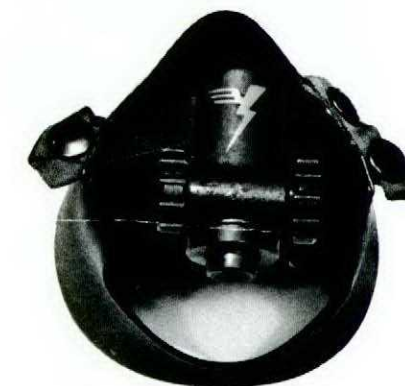
Modified Pate suspension - prototypes tested in 1964

In the Mar/Apr issue, we commented on the USAF O₂ Mask and made some comparison with the MS22001 - the standard mask of the Canadian Forces. The article pointed out some of the reasons why the MS22001 mask is preferred over the USAF MBU-5/P but it did not mention a recently approved modification to the MS22001 mask. The metal pressure plate on the Pate suspension is to be replaced by a wrap-around fibreglass pressure plate.

- ▶ Improves mask retention during ejection.
- ▶ Permits the use of masks with damaged retainer lugs.
- ▶ Permits the attachment of the suspension to mask configurations which do not have retainer lugs.
- ▶ Prevents distortion of the pressure plate, after handling and usage; this distortion reduces the effectiveness of the initial mask fit.

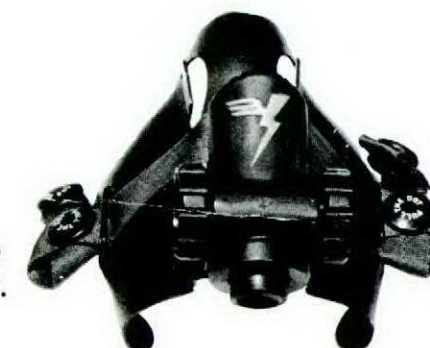
Standard Pate suspension - adopted by RCAF around 1957.

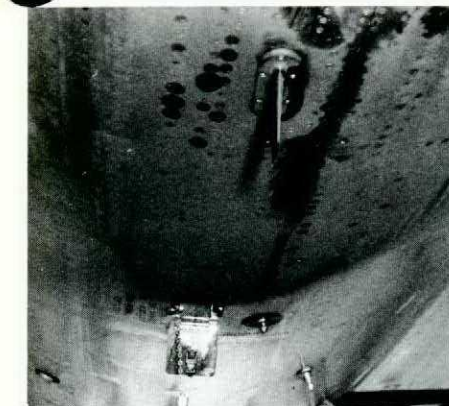
Note black soot on underside of fuselage.

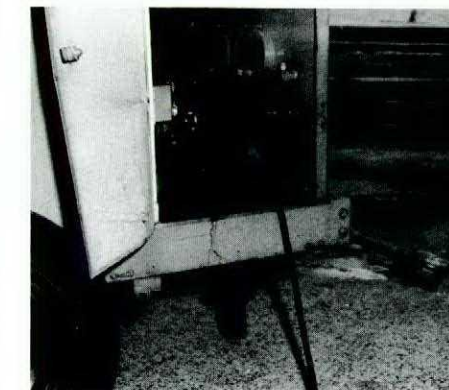
Scorching shows location of fire.

from the oxygen cart to the aircraft was broken at approximately the midpoint. Soot was found around the replenishing point both inside and on the outside skin of the aircraft.
