FLIGHT COMMENT

MAY • JUNE • 1969

NDT at the crossroads

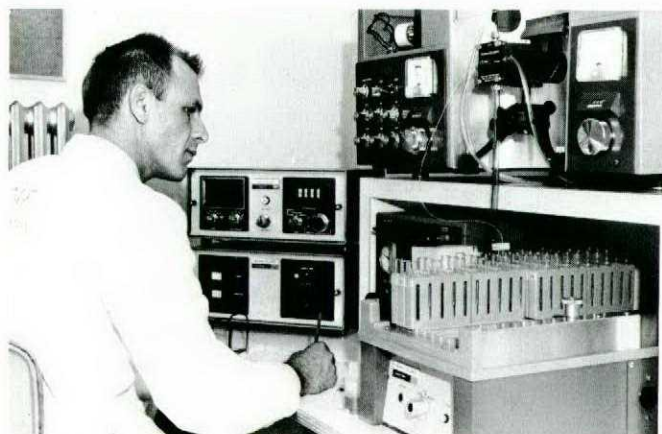
Technician at the AMDU spectrometric oil analysis laboratory runs all samples through an atomic absorption spectrometer. This machine can measure traces of metal in the oil down to parts per million; abnormal rates of increase in metal contamination of an engine's lubricants alerts technicians to possible trouble.

AMO 00-10-14, Aircraft Spectrometric Oil Analysis Program, (SOAP) was published in Aug 1968 to describe the program and regulate its implementation. Spectrometric oil analysis means the determination of aircraft component wear condition by accurately measuring the metallic elements contained in used-oil samples. A definite correlation exists between the metallic contaminants in a lubricating oil and the mechanical condition of the mechanism which this oil serves. SOA is based on these well-proven facts:

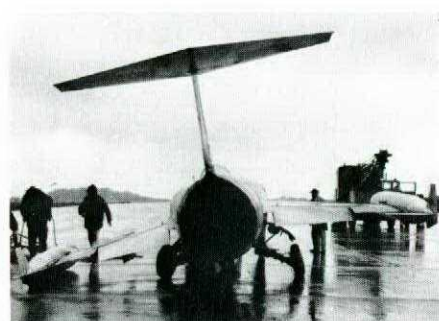
all H-links on the base were examined; 11 were found suspect. To determine if it was progressive cracking or merely tool marks, these links were later X-rayed.
