The aim of the FLIGHT SAFETY PROGRAM is to prevent accidental losses of aviation resources

### CANADIAN FORCES HEADQUARTERS

# 1969 ...that was some year!

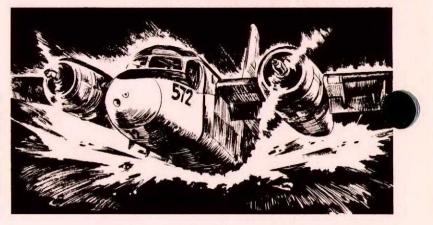
## NIGHT DITCHING

The ordeal began with a collision on the flight deck during a 'bolter'. Damage sustained by the wing and aileron caused a serious restriction in lateral control; the Tracker could not be held on the glide path during a series of approaches that followed. Now, under maximum stress, with fuel running low (alternates had been out of range from the start) the pilot was faced with a night ditching.
