FLIGHT COMMENT

CANADIAN FORCES DIRECTORATE OF HEADQUARTERS FLIGHT SAFETY

- 2 The conversation piece
- 4 Good Show
- 6 Beeper snooper
- 7 Cannon plugs
- 8 Bird control and avoidance
- 10 What's new in life support equipment
- 12 Interrupted procedures
- 14 An FSO speaks
- 16 Helicopter PFLs
- 18 Rotor wash-watch out!
- 21 On the dials
- 22 Take it off
- 23 Gen from 210

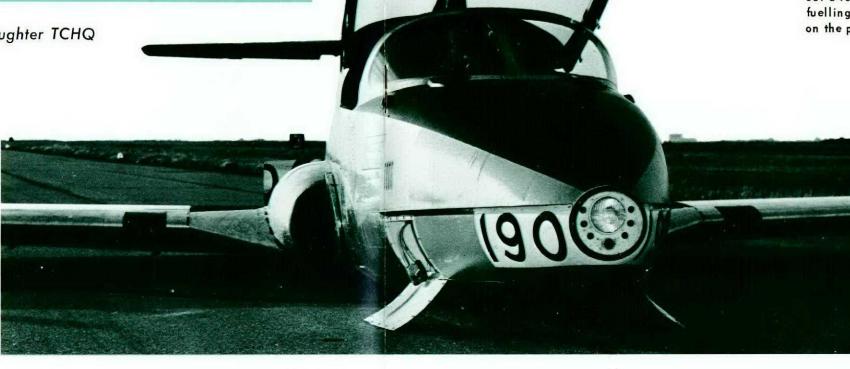
In this instance, the only indication I had as to the position of the landing gear, was the position of the gear selector handle. The lights were useless because the sun was from the rear; the indicators were difficult to see from my side of the cockpit, and the warning tone was not working because we were doing power-on approaches."
