# FLIGHT COMMENT

MAY • JUNE • 1970

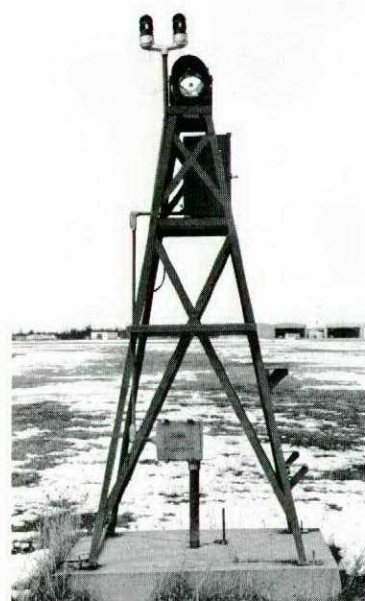
Projector -

The readouts provide RVR values from 1000 to 6000 feet:

- ▶ above 4000 feet, in 500-foot increments
- ▶ from 1000 feet to 4000 feet, in 200-foot increments

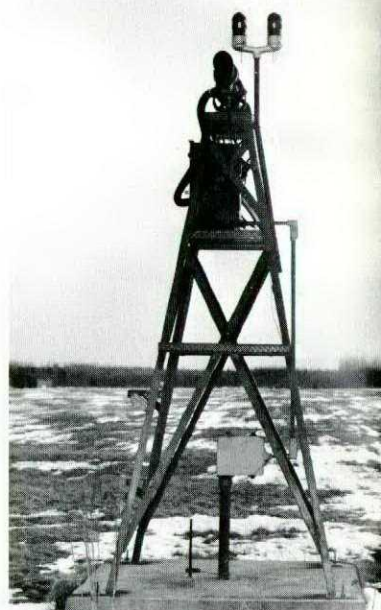
Receiver -

New readings are presented at intervals of 48 seconds, as well as when runway lighting intensity is changed to or from the two high settings.

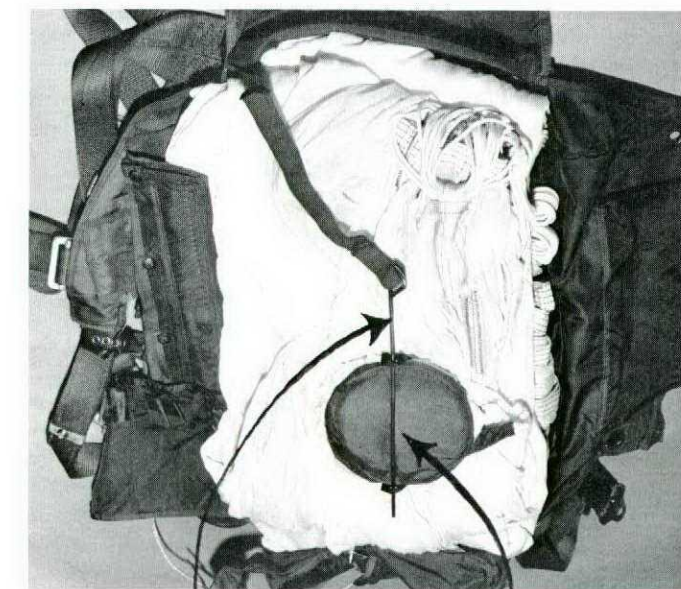
Packing rod and safety flag

Pilot chute (compressed for packing)

Taking the latter course, the pilot flew back to his home base where he returned the chute for repacking. At the S.E. section a technician found that a packing rod had been left in the chute - in a position that would have prevented deployment of the pilot chute, thereby delaying main chute opening and further reducing chances for a successful low-level ejection.

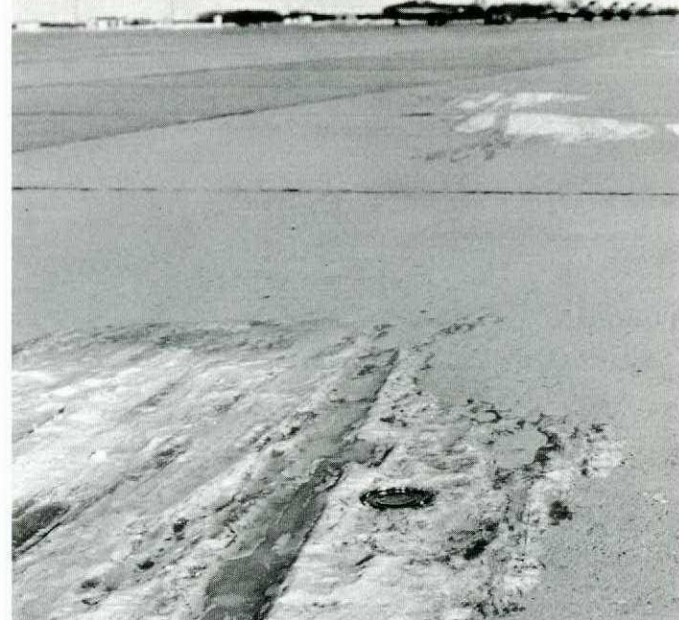
Lid laying in wait

The marks matched perfectly

During the mid-morning turn-arounds identical circular cuts were discovered on the tires of both a Tutor and a T33. Air Traffic Control was alerted and a thorough runway FOD check conducted; sweepers and snow blowers had been in action during the morning and it was suspected that perhaps a broken runway light had been blown onto the runway. But several searches, including one by men on foot, turned up nothing. Possibly the FOD had been swept away - in any case flying continued during the rest of the day without a recurrence of the tire damage.

The great coffee-can lid search began and sure enough, in the centre of the taxiway leading back to the line, a lid was found frozen in a patch of snow and ice, its razor edge ready to cause more damage.

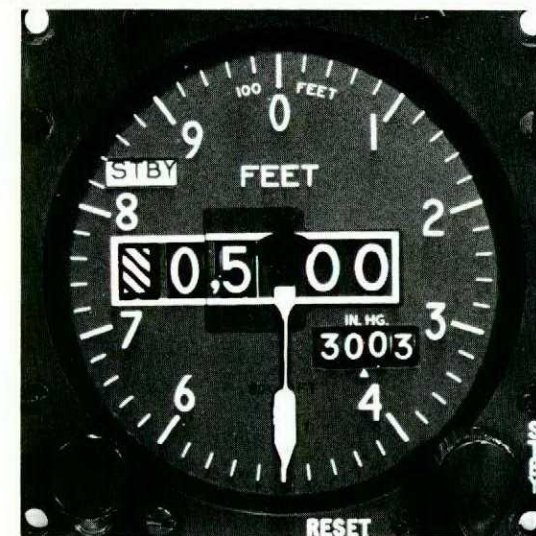
Each revolution of the single pointer designates a one-thousand foot altitude change and the speed of the pointer indicates to the pilot the rate of change. On the left side of the instrument is a three-digit readout which indicates hundreds, thousands and tens of thousands of feet. (The two zeros on the right are fixed.)

The system consists of two units; an AAU19/A servoed altimeter with a pressure back-up, and a computer indicator, signals from which drive the servoes in the AAU19/A. The computer has a cam which corrects for the position error vs Mach curve. The system accuracy from -1000 feet to 80,000 feet is  $\pm 25$  feet or 0.25%. This will allow IFR flight with a separation of 1000 feet above FL 250.

In the coming year, pilots of all fixed-wing aircraft which normally fly above 10,000 feet will encounter the Servoed Digital-Pointer Altimeter System. This system combines the best of both the digital and the analogue systems.

**OPERATION.** The AAU19/A will be mounted on the left instrument panel in aircraft with side-by-side seating, and in the front cockpit in all others. On start-up the altimeter is on STBY; switching from the back-up pressure mode to the servoed mode is accomplished by turning the reset knob. (In the event of power failure or failure of the servo or computer, the unit switches automatically to the STBY mode.)

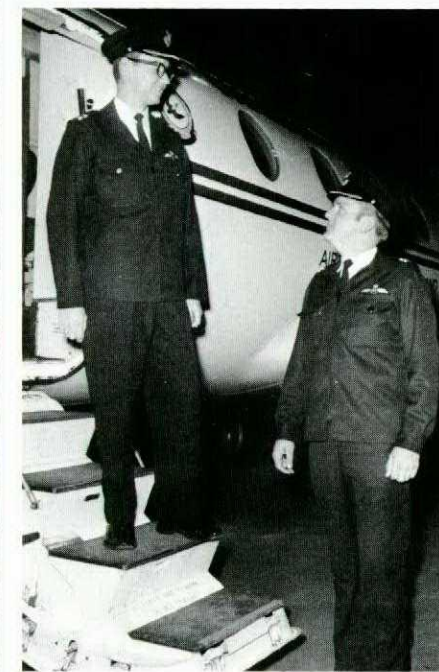
New two-piece transport flying suits on user trials.

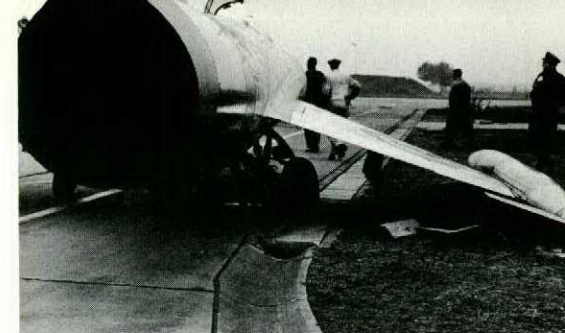
CF104, H-LINK FAILURE A fully-manned crew was towing the CF104 to the tarmac area in front of a repair hangar. As the aircraft was turned from the taxiway to the tarmac the starboard wheel dropped into the gutter along the edge. The driver

of the towing vehicle was unable to pull the wheel out of the gutter and then was unable to stop the aircraft before it struck a concrete block. At this point the H-link failed and the starboard wheel folded rearwards. The towing procedures at this unit, established and accepted by common usage, were in fact contrary to base orders. All concerned assumed that the driver was in charge
