FLIGHT COMMENT

JULY • AUGUST • 1971

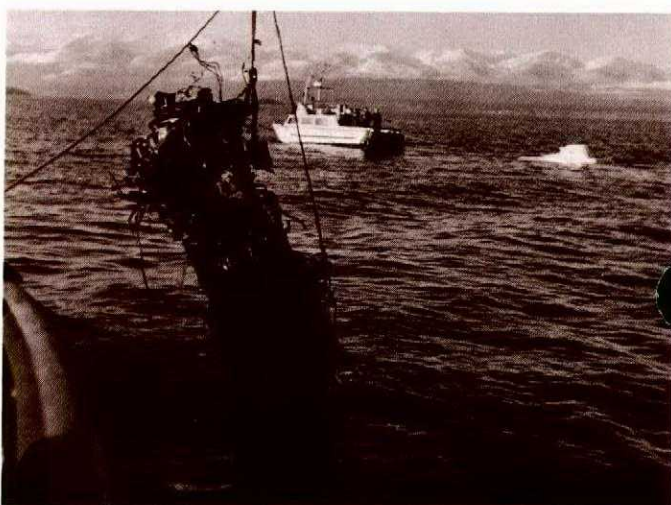
Wreckage recovered after being located by the submarine, PICES II, shown in the background.

The strip investigation of the right engine showed that a third-stage compressor blade had failed due to metal fatigue. The wipe-out of the number 1 (low pressure) compressor split the compressor casing in several places allowing blades to escape at high velocity. An uncontrollable fire then developed in the number two and number three cell area.

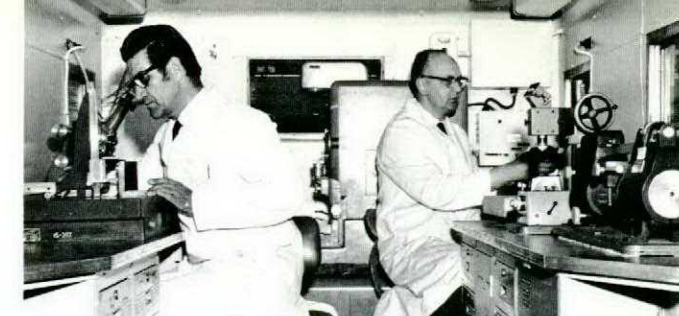
The Mobile Laboratory permits calibration of safety inspection devices on site or in other laboratories, as well as certification of inspection equipment used in plants producing aircraft components.
