# FLIGHT COMMENT

SEPTEMBER • OCTOBER  
1971

- 2 The Devil at Six O'clock
- 4 CBs! You lose when you tangle with these
- 6 Good Show
- 8 How lucky can we get?
- 9 An FSO speaks
- 10 Lost and found
- 12 Airsop's fable
- 14 Autorotation training
- 18 QETE electrical lab
- 20 On the dials
- 22 Gen from 210
- 23 Letters

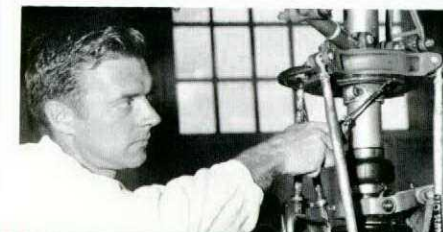
Cpl W.R. Lanctot

Four pound steel bar with markings of the United States Army Air Force may have been lying loose among the aileron cables for 25 years.

While washing the wing centre section under the fuselage during a periodic inspection of a Dakota, Cpl Lanctot heard a slight thud when he tapped the skin. Sensing something unusual, he removed panels from the area of the flap hydraulic jack and found a four-pound steel rivetting bar lying loose in the centre section. This bar was marked "USAAF" which would indicate that it might have been there for some time — perhaps 25 years or more.

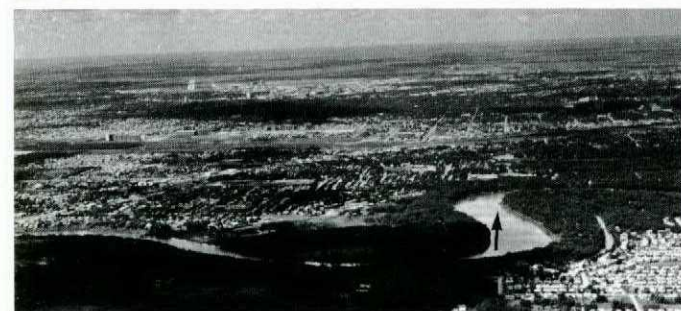
Tip tanks lying on the Red River.

Investigation revealed that when the front "PANIC BUTTON" was actuated with the battery master switch "OFF", the right landing light came on. Similarly, with the landing light "ON", the jettison relay was closed and power was applied to the tip tank ejection solenoids. This indication of a short circuit between the landing light and tip tank jettison circuits was confirmed by subsequent investigation. Examination of a cannon plug in which these circuits are closest together revealed that a fragment of solder was the cause.

In May 1970 a new landing light wiring system was installed in this aircraft. It is possible that the solder found in the cannon plug during the second investigation resulted from poor maintenance procedures. The random movement of the solder in the cannon plug suggests that it may also have caused the first incident. Although the piece of solder was rounded in shape and could have been the result of faulty workmanship, the possibility also exists that it broke

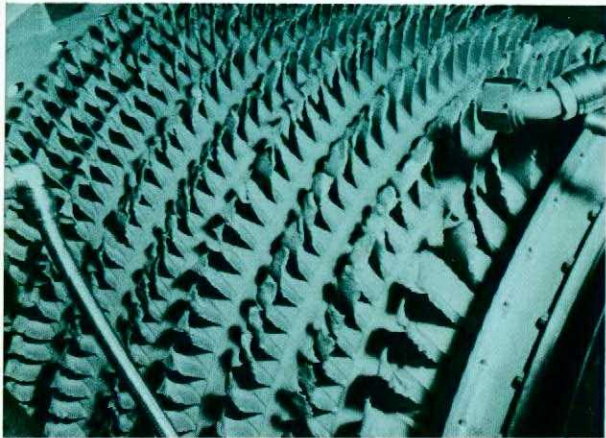
**What:** A punch  
**How:** Left in a CF104 engine area by someone, it was subsequently ingested.

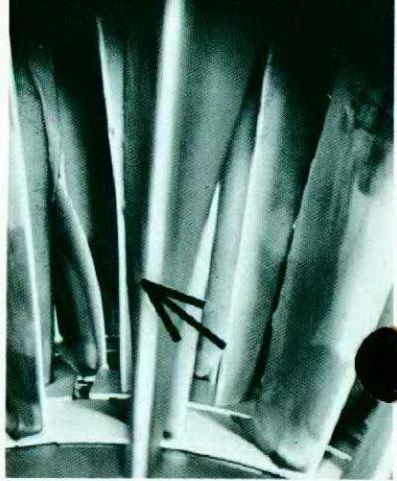
**What:** A drop tank pin  
**How:** The pin was snatched from a technician's hand by the right engine of a Voodoo running at idle power.

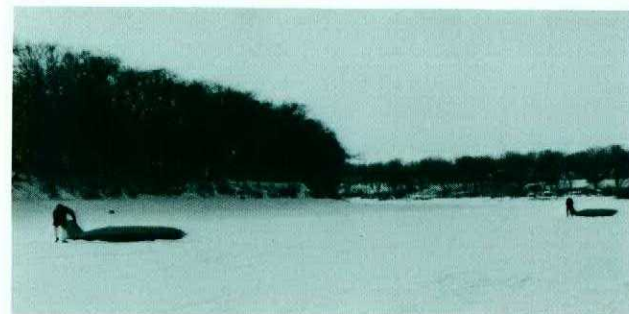
**What:** Fragments of solder  
**How:** Somehow these got loose in a T33 cannon plug and caused a short circuit between the landing light circuit and the tip tank jettison circuit. When the pilot selected the landing gear "DOWN", the tip tanks jettisoned!  
(See story page 8).

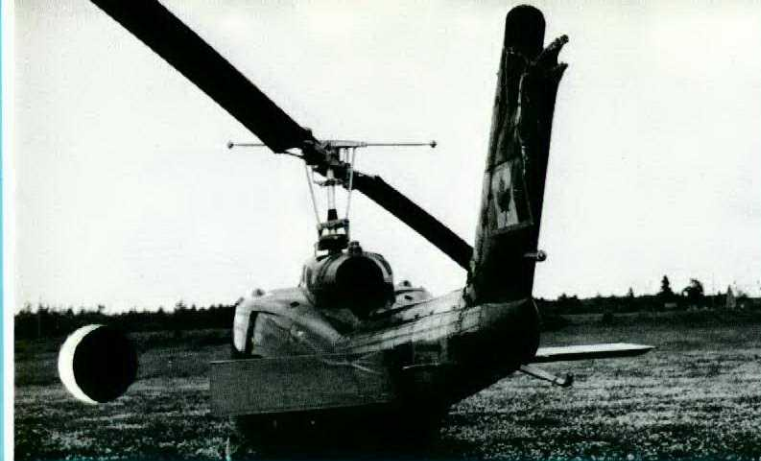
Low-altitude, high-speed autorotations are not as demanding as they seem — as long as proper corrective action is applied. To begin the manoeuvre the throttle is rolled off with the collective at cruise power. After the throttle is chopped the nose is raised simultaneously and coordinated with lowering the collective. A landing attitude is maintained until airspeed dissipates and as the helicopter begins to settle, collective is used to slow the rate of descent until the helicopter touches down — either zero groundspeed or roll-on depending on the surface. This manoeuvre can also be done with power recovery instead of touchdown.

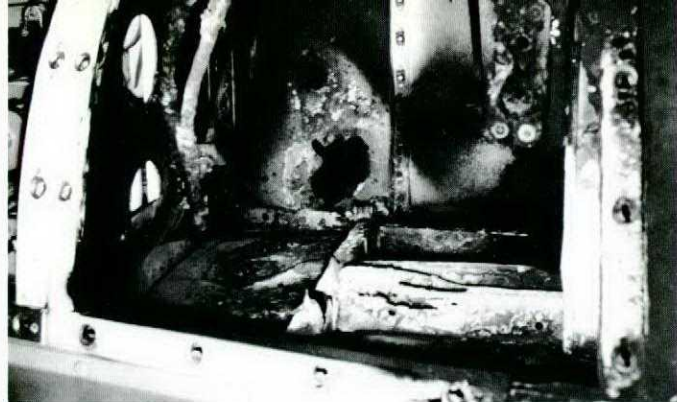
Batteries are usually considered harmless, but when mistreated they can react violently. This aircraft battery compartment shows the extent of damage caused by a Nickel-Cadmium battery failure.

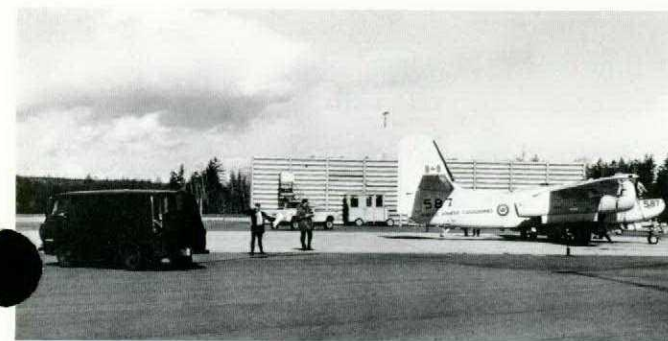
One facet of the QETE Electrical and Electronics Laboratory operation is the provision of field strength and electromagnetic compatibility testing services in the field. Extensive back-up facilities for this type of operation are maintained in the laboratory.

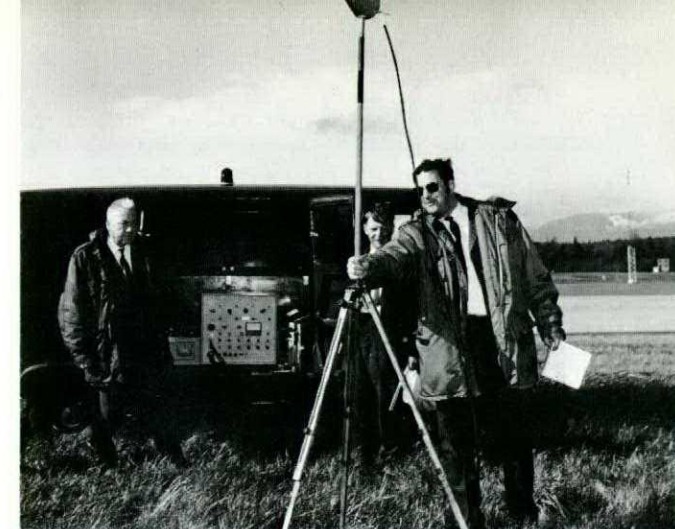
A QETE team performs an R.F. field strength survey at CFB COMOX. Calibrated test equipment accompanied the team in this airlift operation.
