FLIGHT COMMENT

NOVEMBER • DECEMBER

• 1971

Winter woes - part V

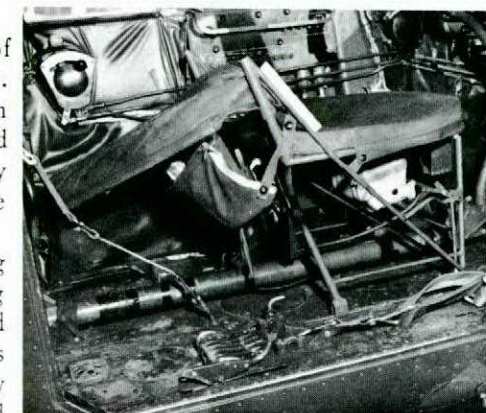
Have You lost These?

There are obviously some lighter-than-normal tool boxes around these days judging by the assortment of tools shown here - all of which were uncovered from CF aircraft in a two-week period this summer. Our previous experience indicates that tools left in the wrong place can have disastrous results.

As he was doing a walkaround prior to his second trip of the day on the aircraft, the pilot noticed a scratch on the engine as he peered through the plenum chamber access panels. When he removed the lower plenum panel to investigate, this pair of side cutters dropped out.

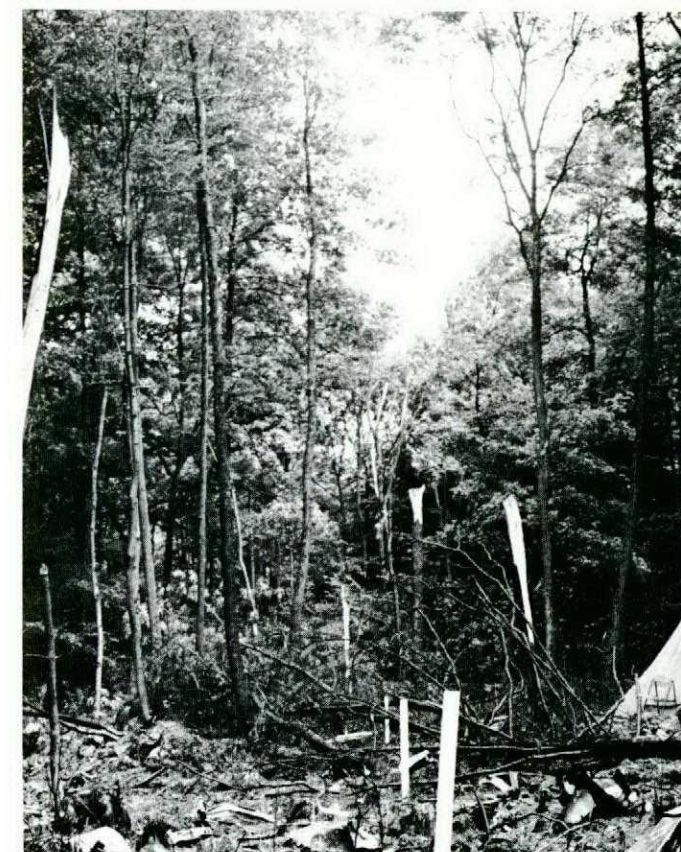
Trail through the tree tops and - impact!

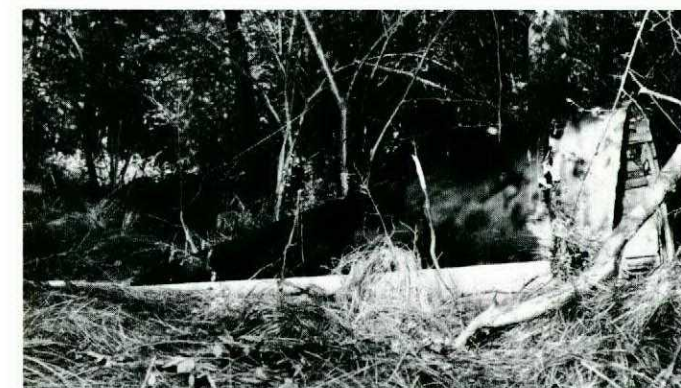
Severed nose cone assembly.

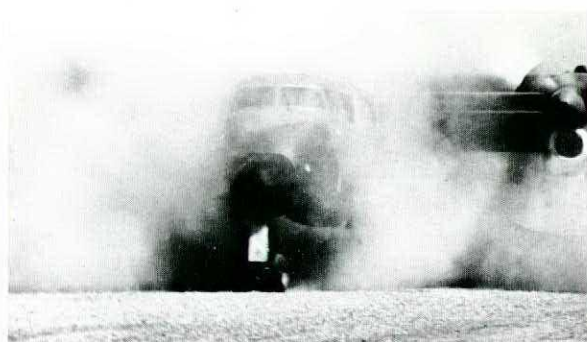
A recent flight safety bulletin carried a photograph of a Buffalo's mouth (engine air intake) clogged up with a fair wad of cut grass. It seems the Buffalo, in a playful mood, was doing short field landing practice on a STOL strip covered with loose, cut grass. All this playful exercise evidently made him hungry, so with the assistance of a friendly visitor (pilot type applying reverse thrust) he gobbled up a greedy mouthful of grass that he could neither swallow nor spit back. Although all this probably made breathing a bit difficult, he was able to saunter back to the ramp where with the assistance of some other visitors (Maintainer type) the ill-advised meal was removed and normal breathing restored.

This comment can best be described as a "half truth", that is, it does have some basis in fact. Certainly, any dry fibrous material such as grass or straw which gets past the Inlet Guide Vanes (IGVs) and enters the compressor will be mulched and pass through the engine without causing failure or serious damage. However, the grass ingested in this incident was so long that it hung up on the IGVs and almost completely blocked the engine inlet. Had takeoff power been selected with this much blockage, it is virtually certain that a compressor stall would have occurred.

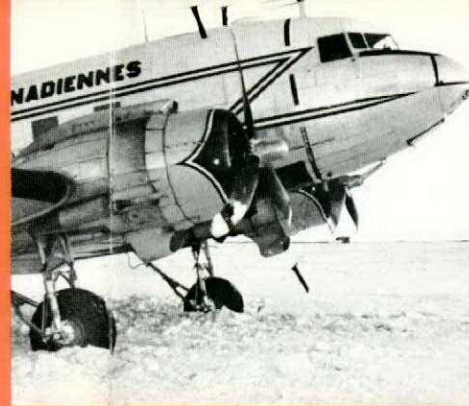
Pilot's failure to correct a swing as he landed in a strong crosswind resulted in his Dakota plowing into the infield and tipping onto its nose when it encountered deep snow.

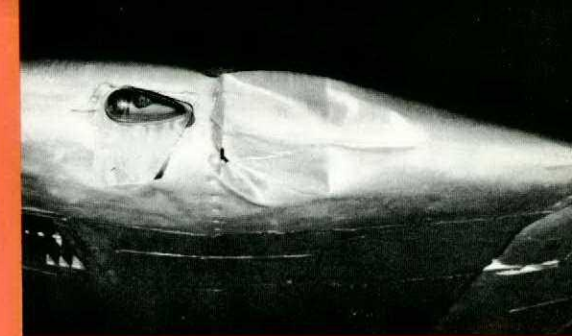
Slippery, ice covered tarmac and poor judgement by a towing crew resulted in the Cosmo wing crunching into a hangar door. The aircraft had been pulled out to allow the removal of another aircraft. Apparently the crew felt that since it cleared the doors on the way out, it should clear them on the way back in, an assumption that has embarrassed many towing crews in the past - during all seasons.

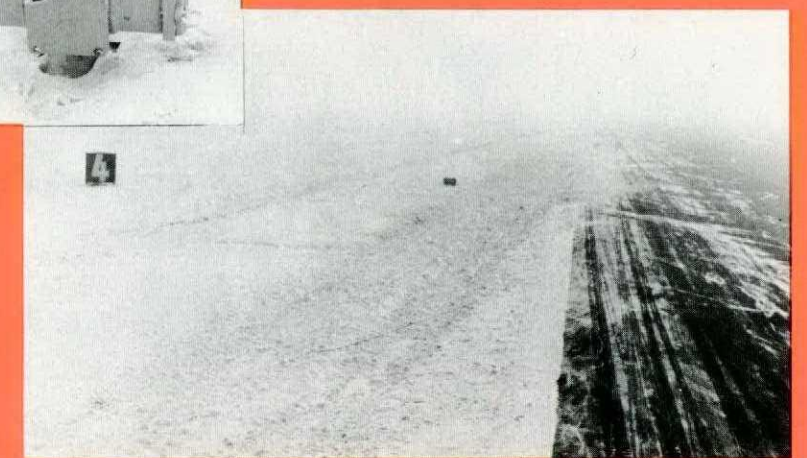
Winter fog, a frequent hazard at this overseas base, obscured the runway and contributed to a 4000-foot excursion through the toolies for a Yukon crew before they regained the runway during an after-landing roll.

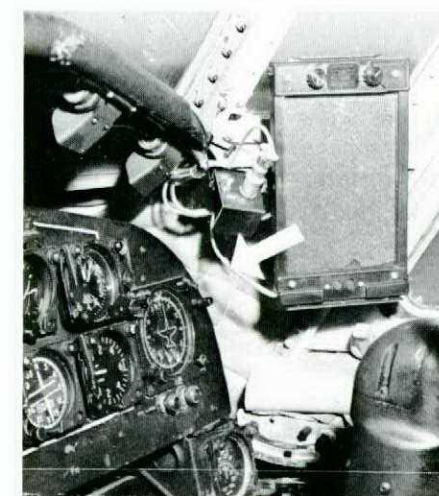
Correct cable routing for co-pilot's letdown holder - cable behind switch bracket.

ARGUS, MURPHIED LETDOWN HOLDER As the co-pilot was checking the movement of the flight controls prior to takeoff, the yoke on his side caught in the power cable to the letdown holder. The power cable had been routed incorrectly between the holder and the switch bracket, permitting a loop to form which snagged the co-pilot's yoke.
