FLIGHT COMMENT

JULY • AUGUST 1972

How Not to Break Your Aeroplane

Loadmeters Advertise Battery Trouble

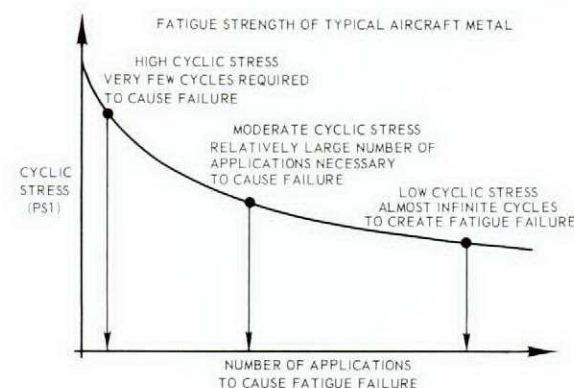
Figure V - Strength Characteristics

If a structure is subject to repeated or cyclic loadings that are well below the normal limit load, it will eventually fail. Naturally, higher loads require fewer applications to cause failure and lower loads will require almost an infinite number of applications to cause failure, Fig. V.

This failure is caused by minute cracks which grow slightly during each load application until the cross section is reduced and finally this lower than ultimate load will cause failure. This over-simplified look at fatigue is only meant to show you we have a problem - but it is not a simple one to control. As I said earlier, these new metals do not stand up well to fatigue especially when cyclic loads are high. When we add to this that no deformation or evidence of exceeding the limits occurs until we approach the ultimate load factor, you can see what a box we are in. Our maintainers trust that you and I will not exceed the limits and that if we inadvertently do, that we will report it. Treat your charger with tender love and care - you and I will be glad we did.

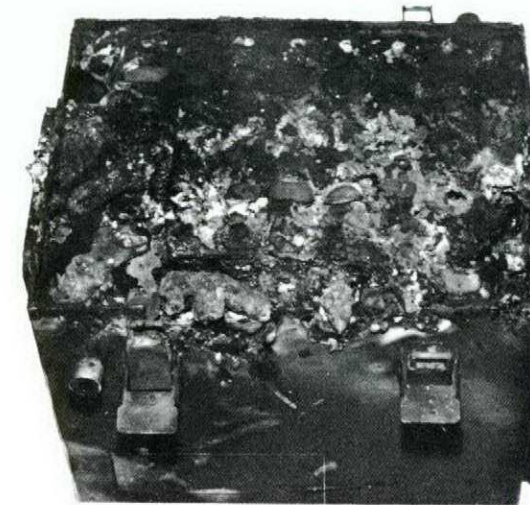
The damage was caused by this battery going into thermal runaway, a result of high ambient temperature and electrical overstressing.

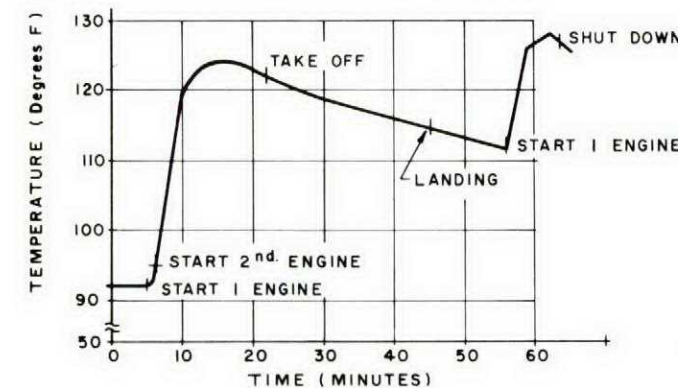
Fig. 1

FALCON BATTERY START - INTERNAL TEMPERATURES

90 degrees. As can be seen from figure 1, the Falcon battery temperature rises approximately 30 degrees during a start which when added to an ambient temperature of 90 degrees puts it well into the damaging temperature range. For this reason the Falcon and CUH-1H helicopter may be self-started only when no ground power is available and this should not be allowed to happen frequently.

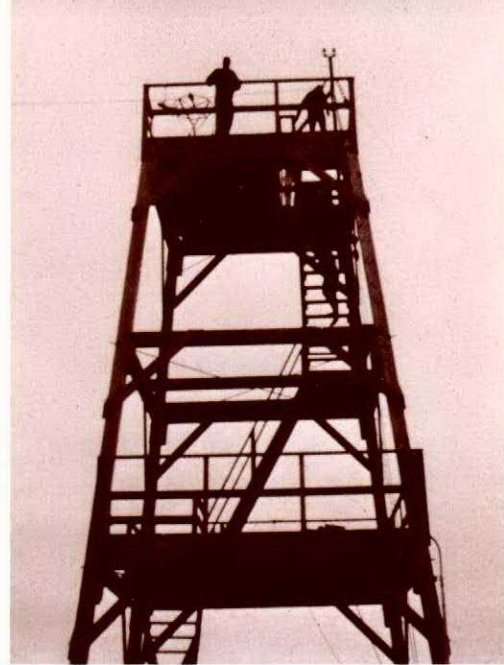
The 50-foot tower from which the simulated para-water entries are made.

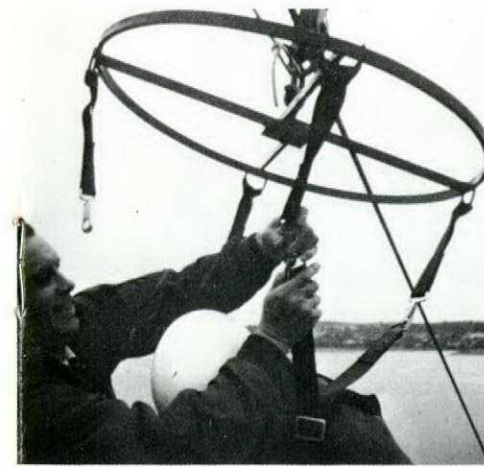
The parachute harness is attached to the cable car ring at the top platform of the tower.

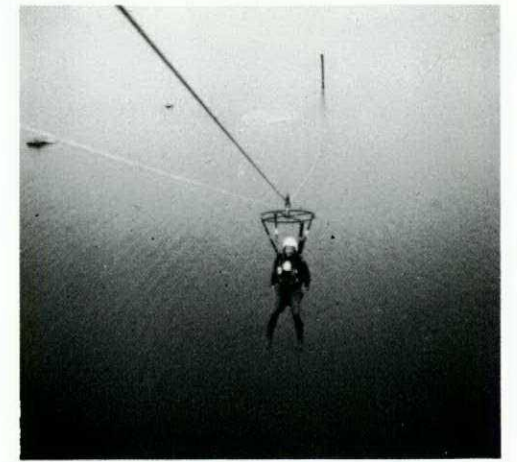
Ready for final descent. Floating parachute canopy, one- and ten-man life rafts can be seen in the water.

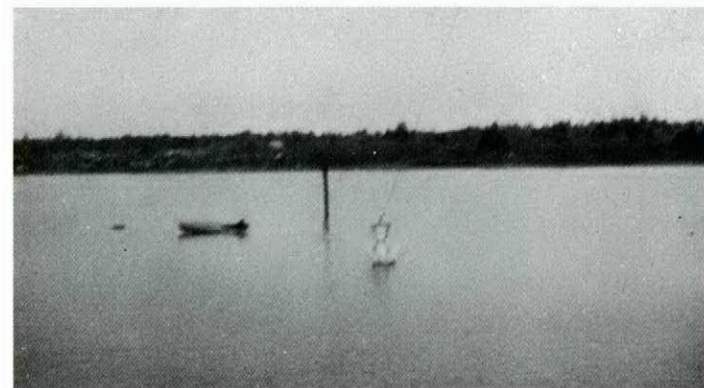
Into the water with the safety boat standing by.

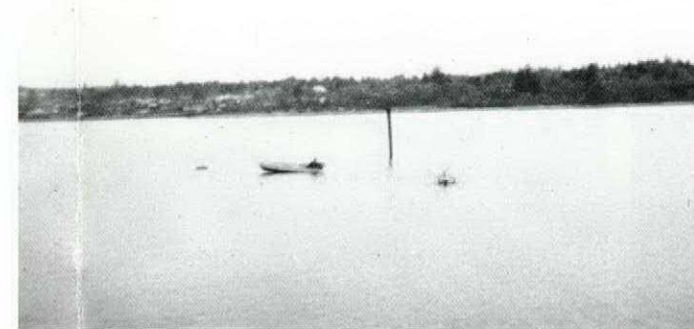
After splash down candidates are required to swim under the parachute canopy from one side to the other by following a seam.

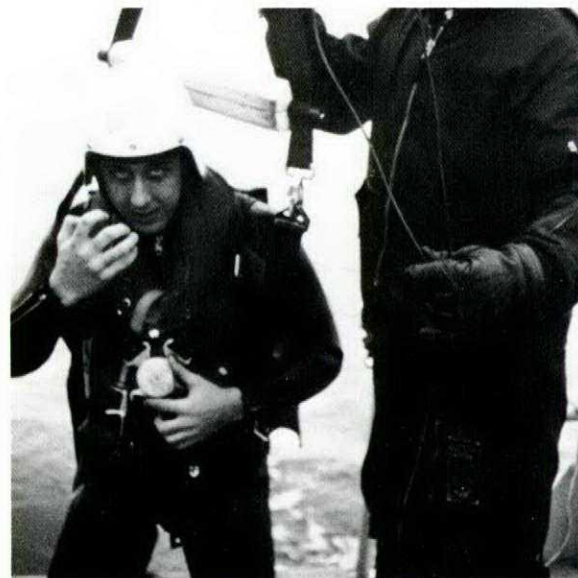
At sea on a diving Tender. Hooked to the towing yoke and listening to last minute instructions.

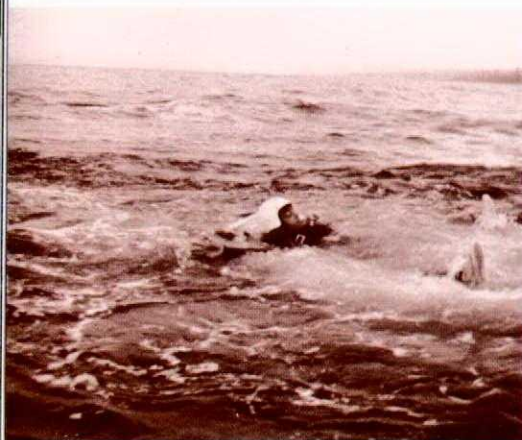
At the end of a 30-foot rope, the candidate practises the drag position—onto his back, legs well apart, head down looking at his toes and seat well down in the water.

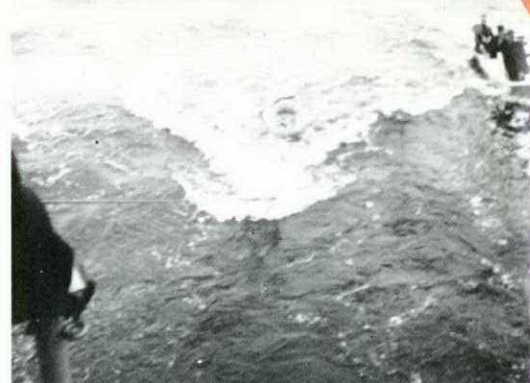
Second run. Note that the life raft (attached to the Mae West) is in tow on this run. On the second drop the candidate releases the QRB as his feet hit the water. Experience at the school has shown that the safest procedure is to ensure the leg straps are released to prevent them from becoming entangled and causing the individual to be dragged feet first after rolling out of the harness.

IMMEDIATELY ON CONTACT WITH THE WATER, RELEASE THE SEAT PACK (Most other types of aircraft are equipped with a different seat pack and consequently the procedure varies.) THEN SQUEEZE THE QRB VERY HARD WITH BOTH HANDS. There will be a short period of time when the parachute lines are slack and the QRB will be easiest to open. If one hand is injured the QRB should be released by reaching across the QRB with other hand and hooking three or four fingers behind the release mechanism and pressing down on the face plate with the palm/heel of the hand. The QRB should not be released until contact is made with the water.

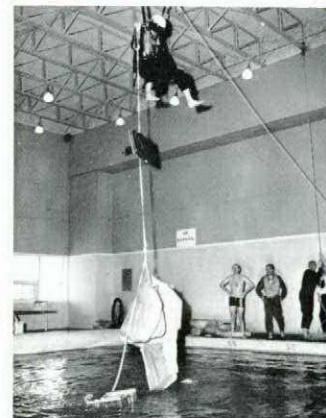
At Chatham CF101 crews go through a dinghy drill annually (an ADC requirement). Here a CF101 seat pack is deployed with the pilot giving the contents the "once over" from his peculiar vantage point.

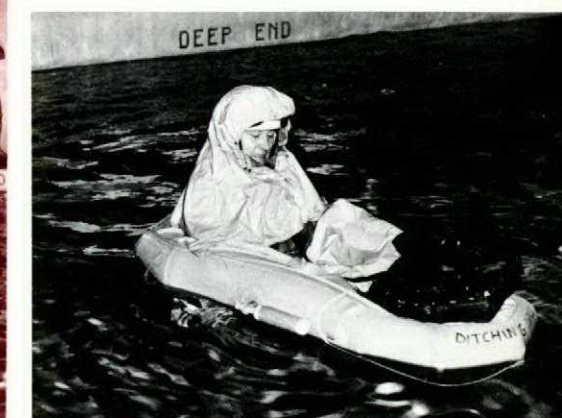
CF101 pilot, Capt B.C. Dixon, buttoning up after house-keeping chores. The sea anchor has been deployed, dinghy bailed out and checked for proper inflation. Survival equipment should be stowed inside the dinghy under the splash shield.

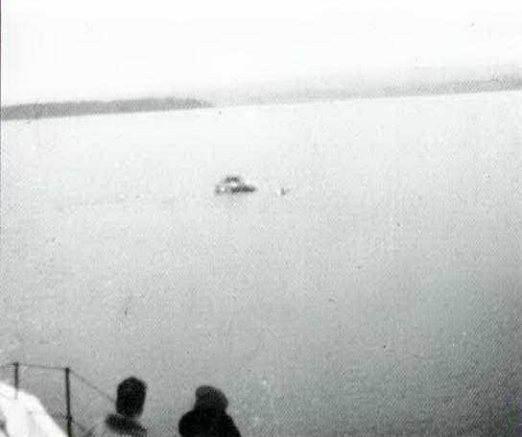
Multi-place life raft practice, using six-man and ten-man rafts. This exercise, simulating an aircraft ditching, takes place at sea, preferably out of sight of land.

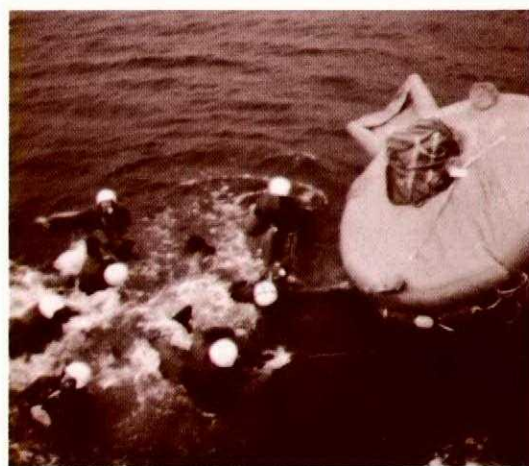
The crews are put over the side at half mile intervals. As they go into the water, two men simulate various injuries and are instructed not to help themselves.

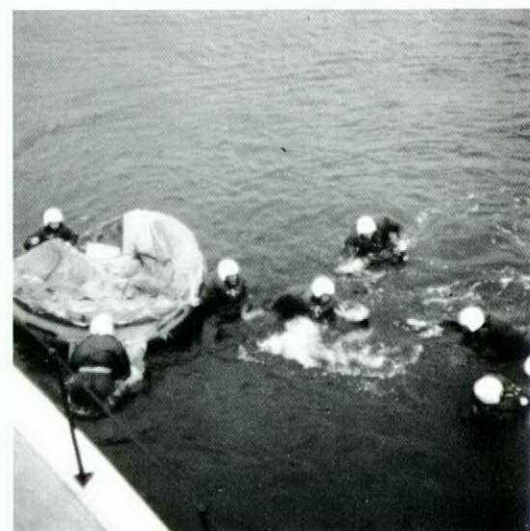
The crew have uprighted the life raft and the injured are being pulled towards it.

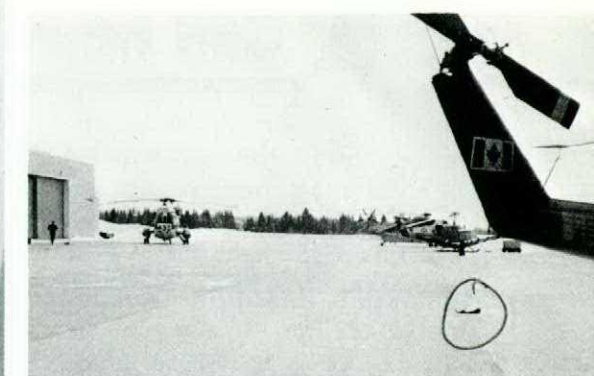
despite a comprehensive preventive campaign after the first. No injuries resulted which is fortunate indeed since shrapnel from the five blades was found almost 1000 feet from the contact point. Needless to say, the cost of replacement items to return this aircraft to operational status was significant.

To get to the allocated parking spot where a marshaller was waiting, the pilot had to taxi between a hangar and two parked aircraft, one a Sea King with the rotor engaged. The pilot was aware of the hazard, but was sure that he had adequate clearance. In addition, a crewman on board had positioned himself between the two pilots to check clearances and monitor loading and unloading.

Do you have the picture now? One rotating object and a large stationary one—less than an ideal taxi area most will agree. The pilot thinks there is sufficient rotor clearance and assumes the arm signals of the onlooker are directions to the parking spot. By his presence in the cockpit the crewman probably gives added assurance to the pilot's belief that he has clearance. At the instant the pilot becomes aware of the signals of the ground crewman, the rotor blades strike the hangar.

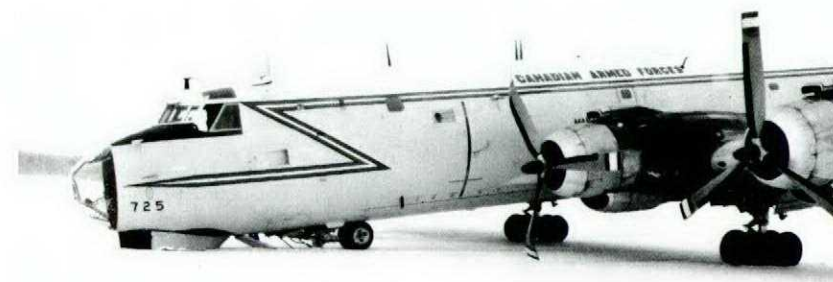
ARGUS, LANDED SHORT During a VFR approach the aircraft touched down approximately 60 feet short of the threshold, bounced onto the run-

way and came to rest 4200 feet from the button—minus the nose gear.

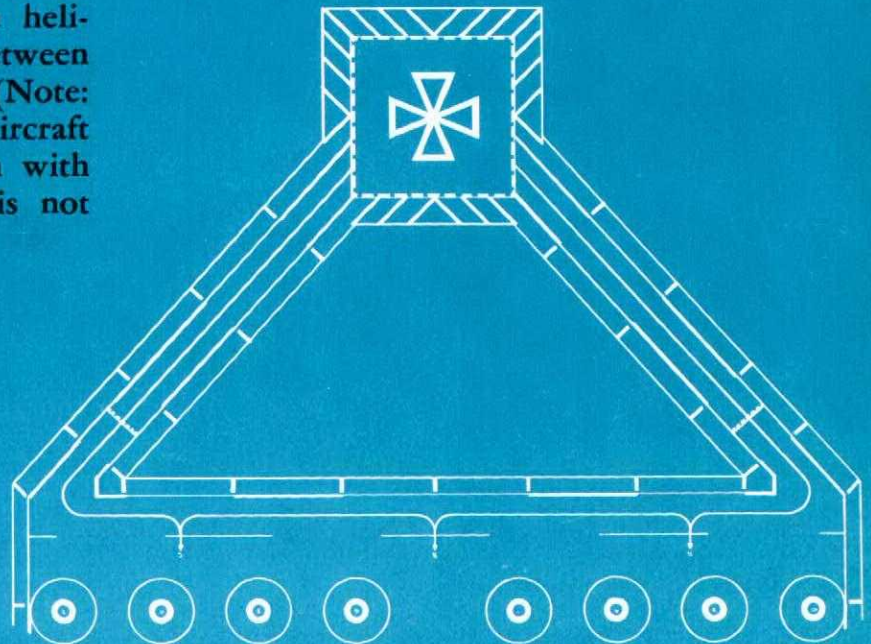
Proposed standard layout for helicopter parking areas on heliports. Minimum separation between outside circles — 20 feet. (Note: Positive clearance between aircraft or damage from rotor wash with large transport helicopters is not guaranteed.)
