FLIGHT COMMENT

MARCH • APRIL 1973

The Art and Science of Saving Your Head

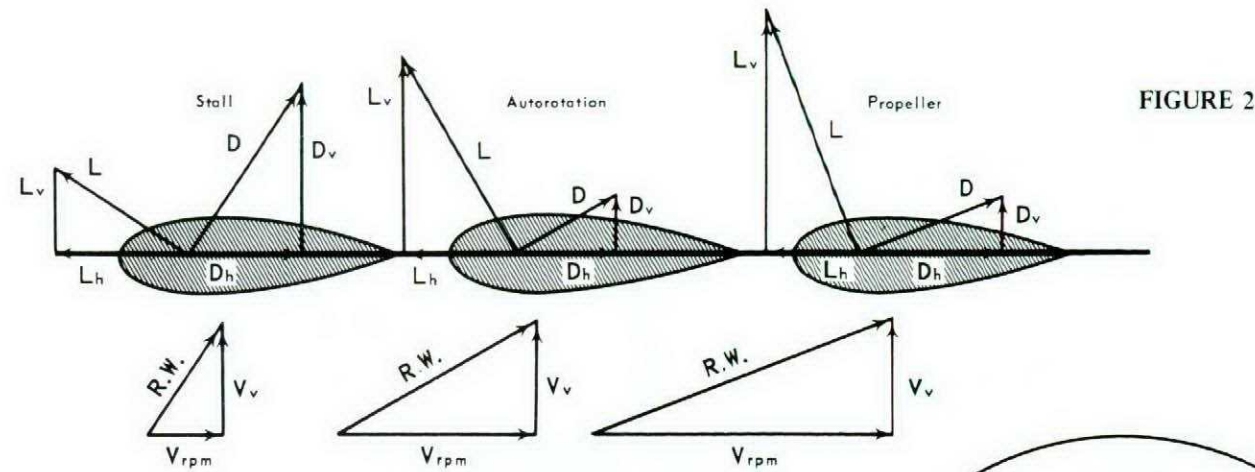
FIGURE 2

Near the circumference of the rotor disc is found the propeller region. In this region the V_{rpm} is quite high due to the large radius. The distinguishing feature of this region is that the D_4 is greater than L_4 so that this region contributes a net force to decelerate the rotor. These regions, their typical airfoil sections, and the accompanying aerodynamic forces are shown in figure 2.

Figure 2 represents a condition of vertical autorotation. The stall and autorotation regions will be displaced slightly during autorotation at some forward speed.

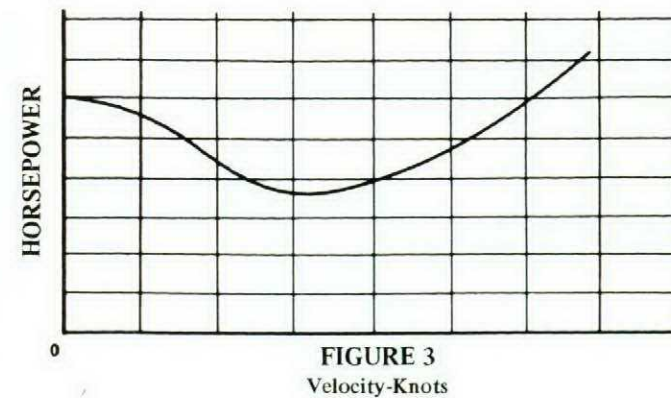
FIGURE 3
Velocity-Knots

combined with the rpm of the rotor, can be computed as horsepower. A simple plot of the horsepower needed to drive the rotor at its autorotation rpm at all forward speeds may be made. Figure 3 shows a typical plot. It can be seen that more horsepower is required to autorotate at zero knots forward speed than at moderate forward speeds. As the speed continues to increase, the power reaches a low point and then begins to increase, eventually reaching a value which is greater than that of zero forward velocity.

Thus it can be seen that the minimum rate of descent will occur at a moderate forward speed. The speeds implied in figures 3 and 4 are true airspeeds. If the autorotation is being made against a headwind, it would be possible to descend vertically over a point on the ground, with a rate of descent less than that indicated for vertical descent. A tailwind would have an opposite and more dangerous effect.
