# FLIGHT

## COMMENT

5/1995

The Canadian Forces  
Flight Safety Magazine

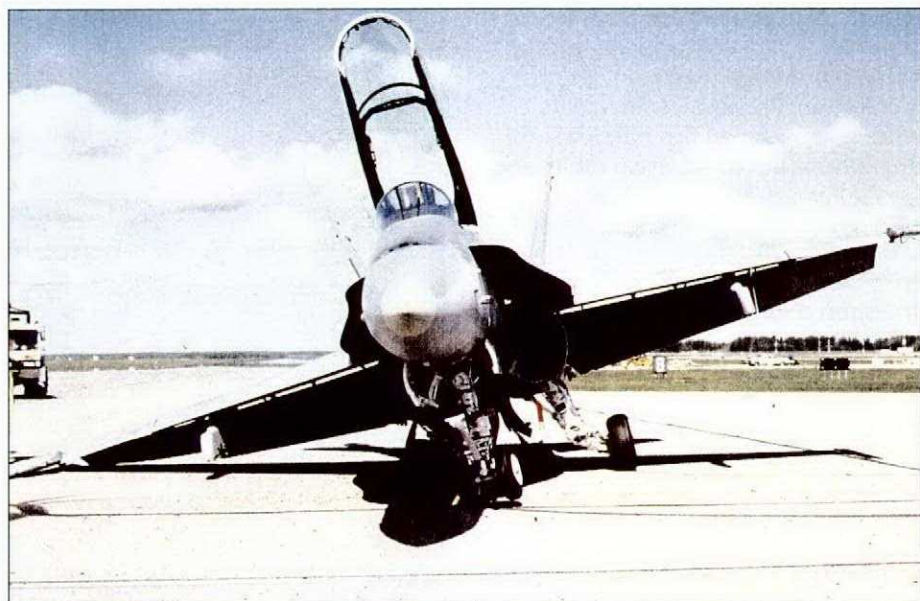
Front view of the aircraft.

The mishap aircraft, a two-seat CF18 with an instructor pilot in the rear cockpit and a student pilot in the front, had returned from a routine training mission and was conducting a landing on Rwy 22. The approach was normal; however, shortly after touchdown the pilots felt the right wing of the aircraft begin to settle and were alerted to a problem by the sounding of the landing gear warning tone. In addition, the warning light in the landing gear selector lever illuminated while the right main landing gear light extinguished, giving the aircrew a definite indication of an unsafe main landing gear.

The initial investigation into this accident identified a failure of the "jury link connecting lugs" to the main landing gear side brace assembly, as well as a badly bent connecting link from the planing link assembly.

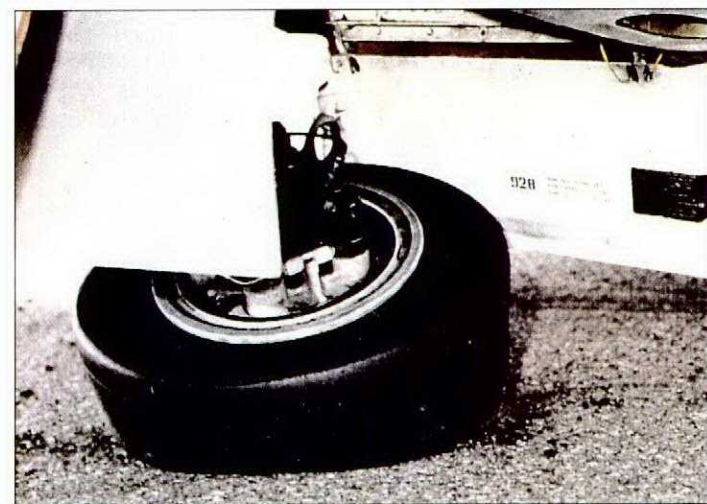
Left rear view of RH main landing gear wheel.

right wing from striking the runway while at high speed, the rear seat pilot advised air traffic control of the emergency situation. Directional control was maintained for approx 4500 ft, whereupon the right wheel rim began to dig into the runway surface causing the aircraft to violently rotate through approx 270° of turn. Shortly thereafter the aircraft came to a stop, still on the runway, and the aircrew

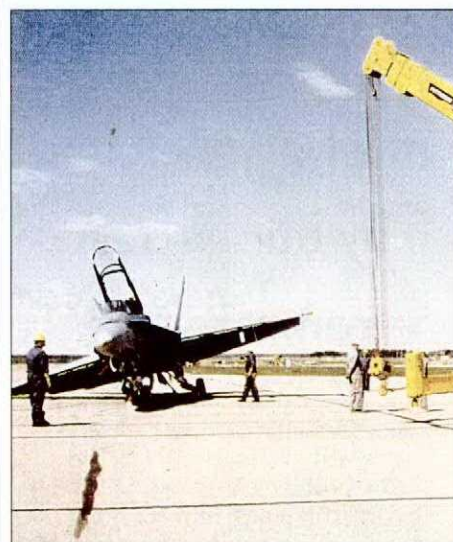
Recovery of CF188928.

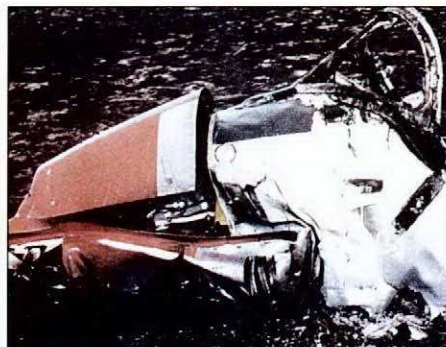
Forward fuselage.  
Note: Position of access panels and step.

Detailed technical investigation by the Quality Engineering and Test Establishment (QETE) determined that the engine's Number 2 bearing had failed leading to a catastrophic engine failure. Though the cause of the bearing cage failure cannot be absolutely proven, there is now evidence that small spherical plastic bead used for cleaning may have contaminated the bearing and caused its deterioration.

A disturbing aspect of this accident was the failure of the ejection system to ensure a clean separation of occupant and seat.

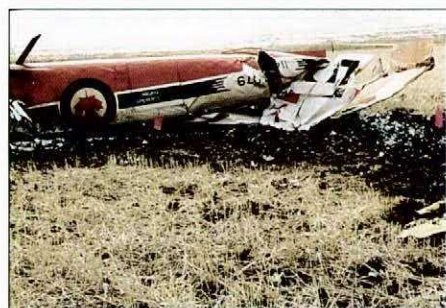
Tail section of CT114079.

Quality Engineering and Test Establishment (QETE) determined that the engine compressor experienced a stall due to a fatigue failure of the Variable Geometry System (VGS) Feedback cable. The failure of this cable would result in the engine performance observed in this accident. All cables were quickly replaced to prevent a recurrence of this event. ♦

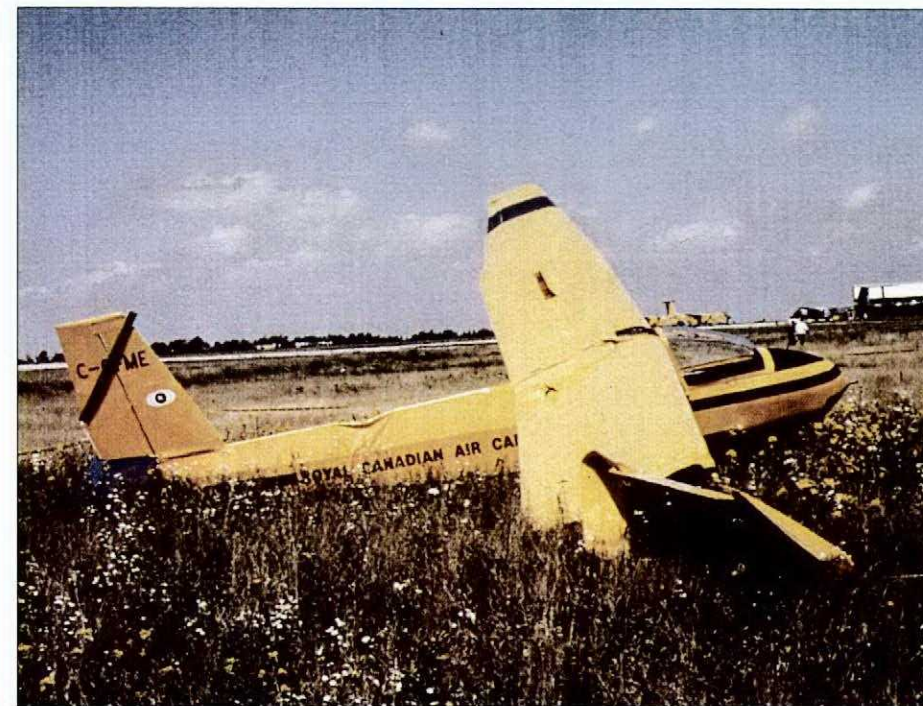
Damage to the aircraft.

The student glider pilot was on a Solo 11 mission completing an approach to Runway 16. The glider overshot the landing area and came to rest in marshy ground at the approach end to Runway 34. Though the aircraft received damage to the right wing, nose cone, and fuselage, the pilot was uninjured.

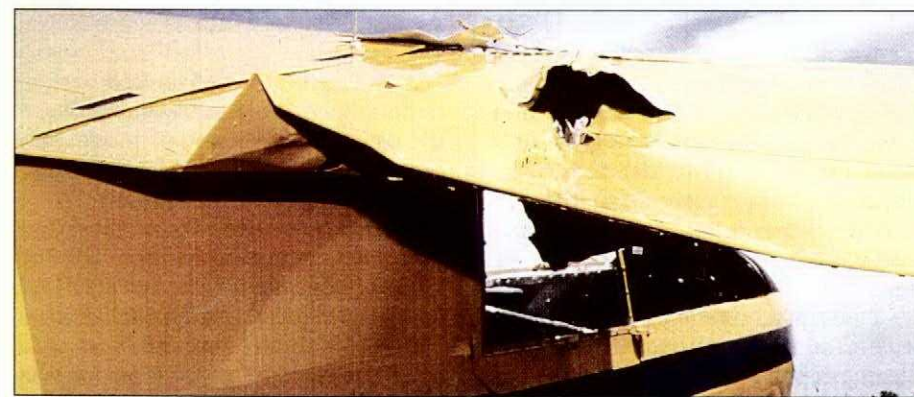
Right wing inboard damage.

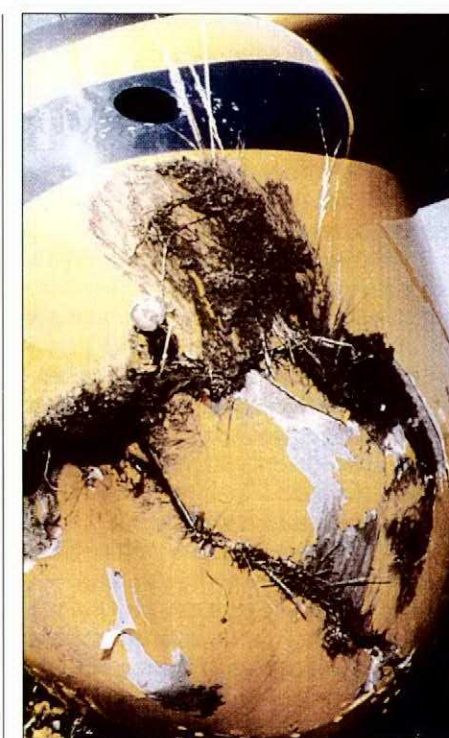
Nosecone damage.
