FALL 2002

Flight

Comment

The Canadian Forces Flight Safety Magazine

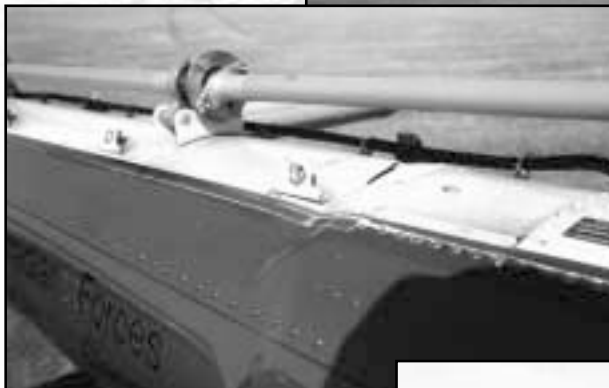
Initial assessment shows the skid gear slightly splayed, flexion of the tail boom in both directions of the vertical plane, the spike box on the underside of the transmission was sheared and both pitch horns were gouged from contact with the aft transmission housing. The aircraft will be sent to third line contractor to ensure alignment of the airframe.

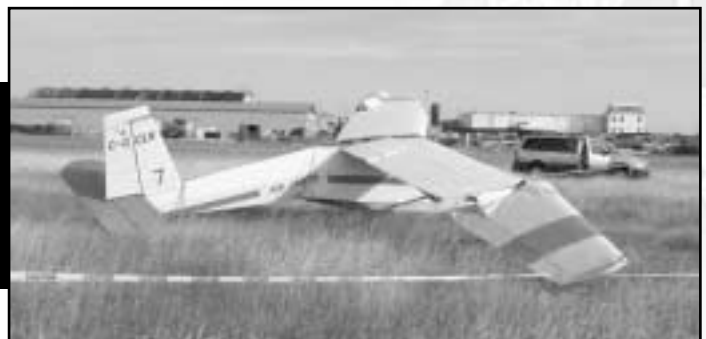
The aircraft received A Category damage. Both wingtips contacted the ground, the right wing broke in two at the inboard end of the aileron and the underside of the nose cone was pushed inward. The left wing rear spar attachment point sheared and allowed the wing to rotate forward causing damage to the canopy frame and to the skylight. The rear fuselage bent at the midpoint and the tail wheel broke-off.

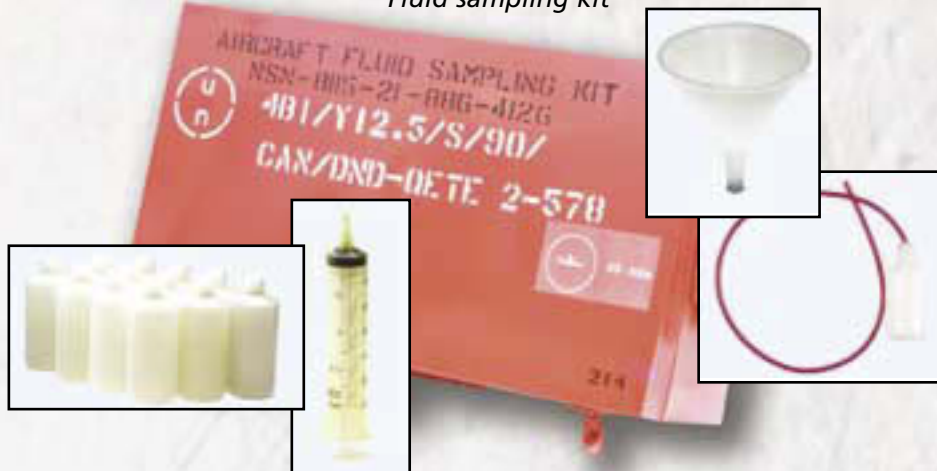
Fluid sampling kit

From your lecture, you remember that the kits were designed and maintained at the Quality Engineering Test Establishment (QETE) in Hull, QC. They contain sampling instructions, twelve 500-ml "plastic" bottles, four SOAP bottles, a plastic funnel, and a disposable syringe all neatly packaged in a red painted aluminium box. **The twelve bottles at one time had been made of glass, but have since been replaced by special fluorinated high-density polyethylene (FLPE).** The reason for the replacement was that a bottle was needed that could safely contain aircraft fuels and which conformed to Transport

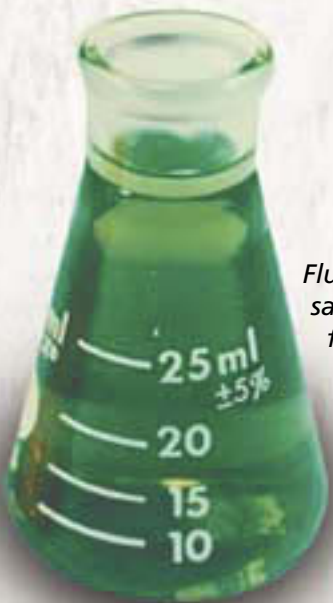
Fluid sampling flasks

(no mixing of sources) was also stressed during the course. From the samples taken, QETE would be able to confirm the fluid identity, confirm any contaminants that may be present, and give an indication to the health state of a particular aircraft system.
