ISSUE 3 2006

# Flight Comment

On the Dials — Terminal Arrival Areas (TAAs).....	9
Icing — Aircraft Ground Icing Operations in “FROST” .....	25
Whiteout .....	29
Stick With It! — Innovation in Deicing .....	31

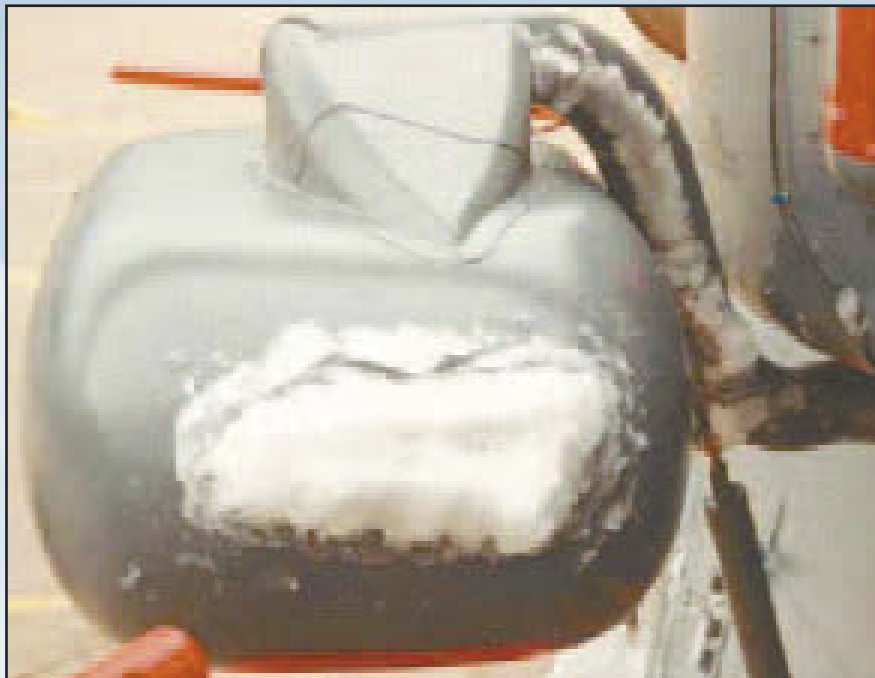
Ice on rescue hoist fairing

For example, ice shedding from the rescue hoist mounted on the side of the *Cormorant* can impact the tail rotor. (It's really the same situation you see on the highway every winter, when ice and hard snow leaps off the top of transport trailers, sometimes hitting the car following behind it.) If ice can hit a critical component, such as the tail rotor, then it must be shown that the component can safely withstand the worst-case ice strike expected. In flight tests in severe icing conditions, the *Cormorant* rescue hoist accreted a one-kilogram chunk of ice—a noteworthy hazard to the tail rotor!

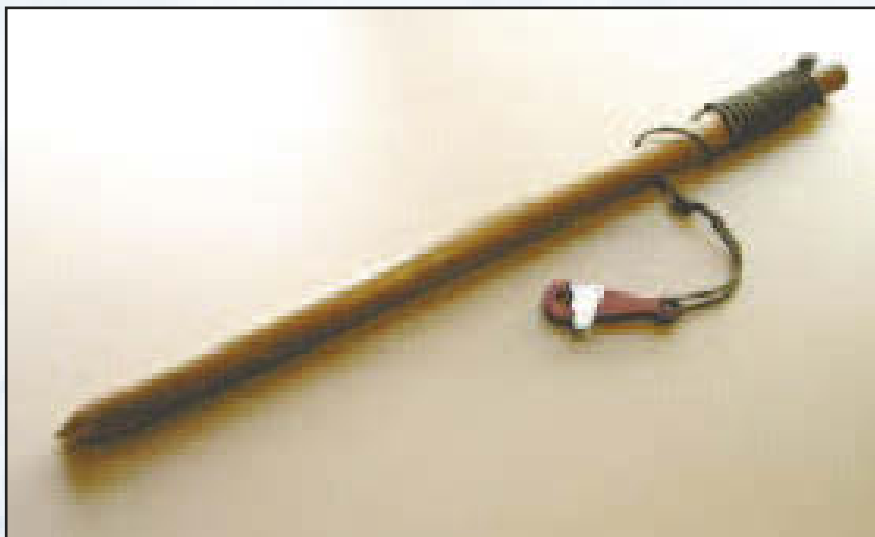
Give it some stick!

DTA gave the basic requirements for this stick to the Standards squadron—that it had to be anchored to the aircraft so it couldn’t be lost into the engine intake or a rotor and how often it had to be used in icing conditions—and the operators designed the stick and a procedure to use it. Despite the NHL strike offering a surplus of hockey sticks, the ultimate design looks simply like a piece of broom handle with a parachute chord at one end to anchor it. Plain, boring, but fully functional! These humble yet brave sticks were rushed into service aboard every *Cormorant* in order to allow the most unrestricted icing operations possible for the remainder of the winter.

The airworthiness review eventually determined that the tail rotor could safely withstand the worst-case ice strike; therefore, clearing ice from the rescue hoist in flight was not necessary. The ever-popular de-icing sticks were thus retired after a couple months of distinguished service. One of these sticks now serves
