Aviation Safety

Letter

Issue 2/2000

The Human Element

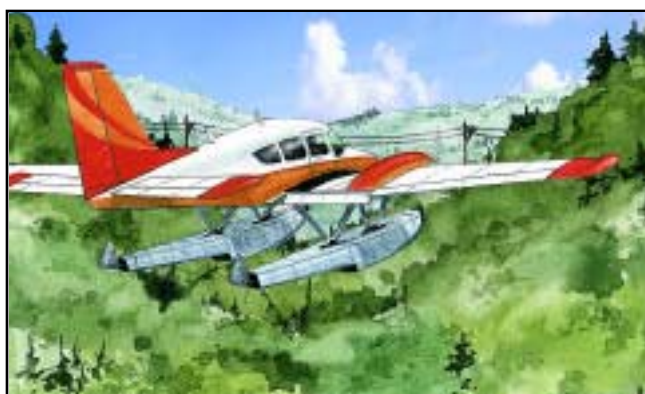
Artist's impression of choices faced by the pilot, who was unable to climb properly after takeoff.

The aircraft took an abnormally long distance before rising out of the water because of its nose-up attitude, which was caused by the fact that the C of G was outside the envelope and displaced aft, and because of the excess weight. This nose-up attitude of the floats in the water caused drag that prevented the aircraft from accelerating within the normal distance during the take-off run. After 8000 ft. of take-off run, which is over twice the distance normally required, the aircraft lifted off, partly because of the ground effects phenomenon.

Then, seeing the approaching obstacles on the shoreline, the pilot pulled back on the controls to try to clear them. The aircraft was travelling at 80 mph, which is well below the recommended climb speed of 120 mph and even below the speed for the best climb angle of 107 mph. Because of its configuration, the aircraft stall speed was higher than normal. It can thus be concluded that the aircraft was in the slow-flying range. The more the pilot pulled back the controls, the greater the drag. Thus, the aircraft could not attain a climb rate sufficient to clear the obstacles on its flight path and it struck the high-voltage lines and a pole.
