Aviation Safety

Letter

Issue 1/2001

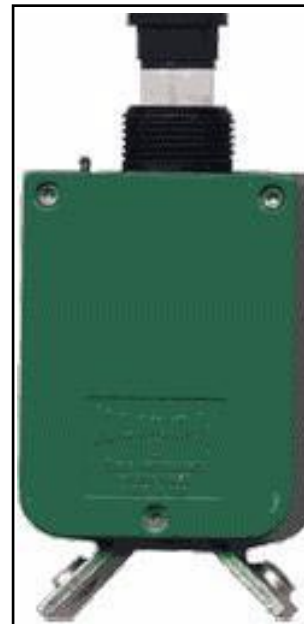
An aviation circuit breaker.

Circuit breakers are not intended to protect the electrical equipment, which may have its own built-in protection or mitigation system, but are intended to protect the wiring and connectors, which would otherwise have no such protection. Aging, vibration, excessive bending, improper installation, heat, moisture, friction, wind blast, and chemicals, such as de-icing fluid, toilet fluid, hydraulic fluid, oil and fuel, can damage the insulation on the wire, if not the conductor itself and any connectors. In addition to disabling the circuit and any associated component, this could also create a fire hazard, possibly in an area where it could be impossible to use extinguishers and that could easily threaten the safety of the flight. With any in-flight fire, especially one in an inaccessible location or close to critical components, an
