## Assessment of Earthquake Effects on Residential Buildings and Services in the Greater Vancouver Area

**ASSESSMENT of EARTHQUAKE EFFECTS  
on RESIDENTIAL BUILDINGS and  
SERVICES in the GREATER  
VANCOUVER AREA**

**February 1989**

**National Research  
Council Canada**

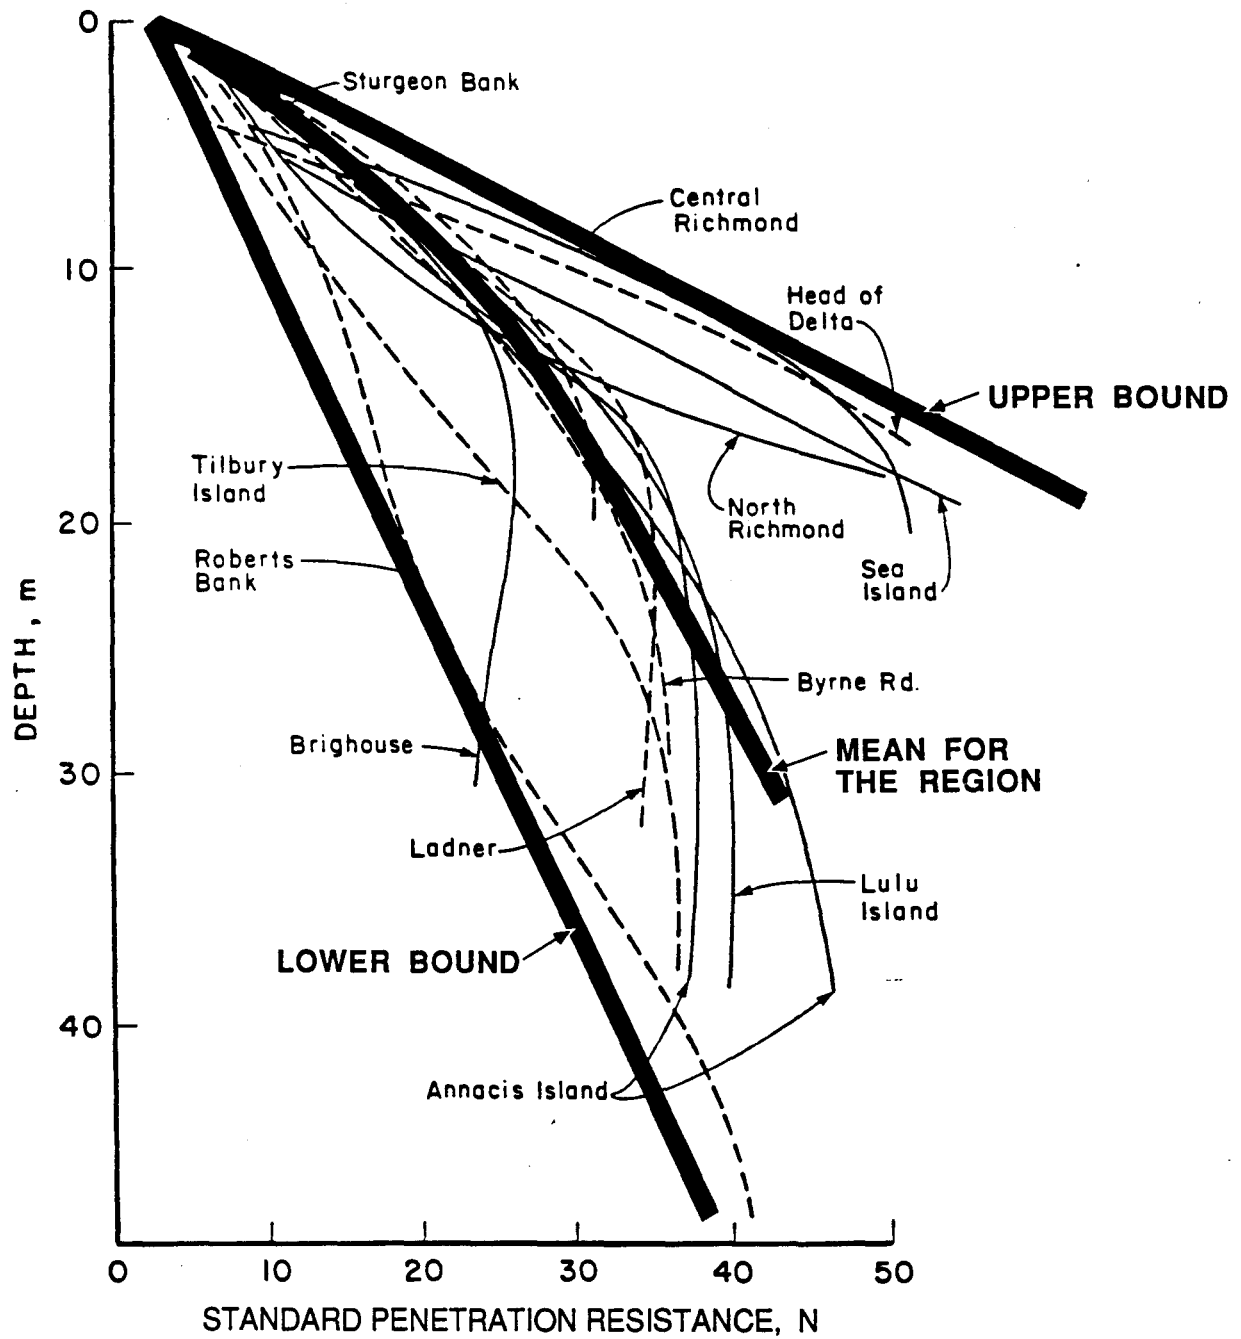
Fig. 5 Mean Standard Penetration Resistance N Values in Richmond and Fraser Delta (9).

The dynamic strength of the alluvial deposit can be obtained from the Standard Penetration Test SPT. Figure 5 shows profiles of regular SPT resistance ( $N$ ) at various sites in Richmond and the Fraser Delta (12).  $N$  can be normalized by the confining pressure to yield  $N_1$  for application in Equation (2).
