Airtightness of Concrete Basement Slabs

REPORT FOR
CANADA MORTGAGE AND HOUSING CORPORATION

G.K. YUILL & ASSOCIATES (MAN.) LTD.

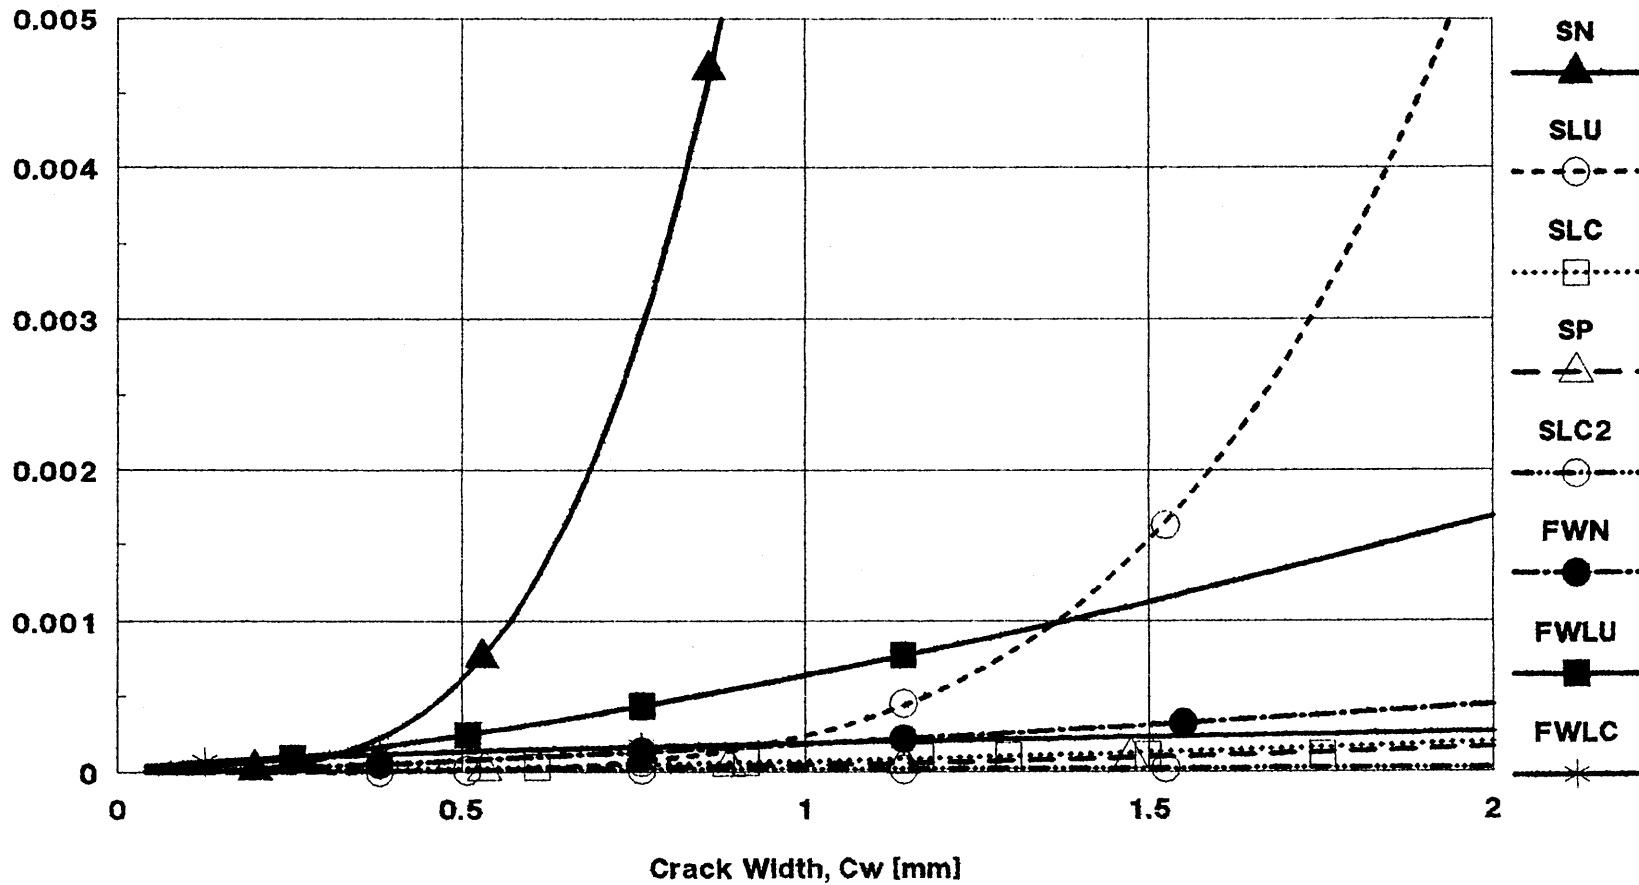
FIGURE 4

Flow Constant vs Crack Width for All Test Specimens

Flow Constant, C [l/Pa s]

Fig. 4 shows the flow coefficient, C , as a function of crack width, for all the cases tested. As can be seen, the slab without polyethylene was much leakier than the other cracked slabs, followed by the slab with uncaulked polyethylene.

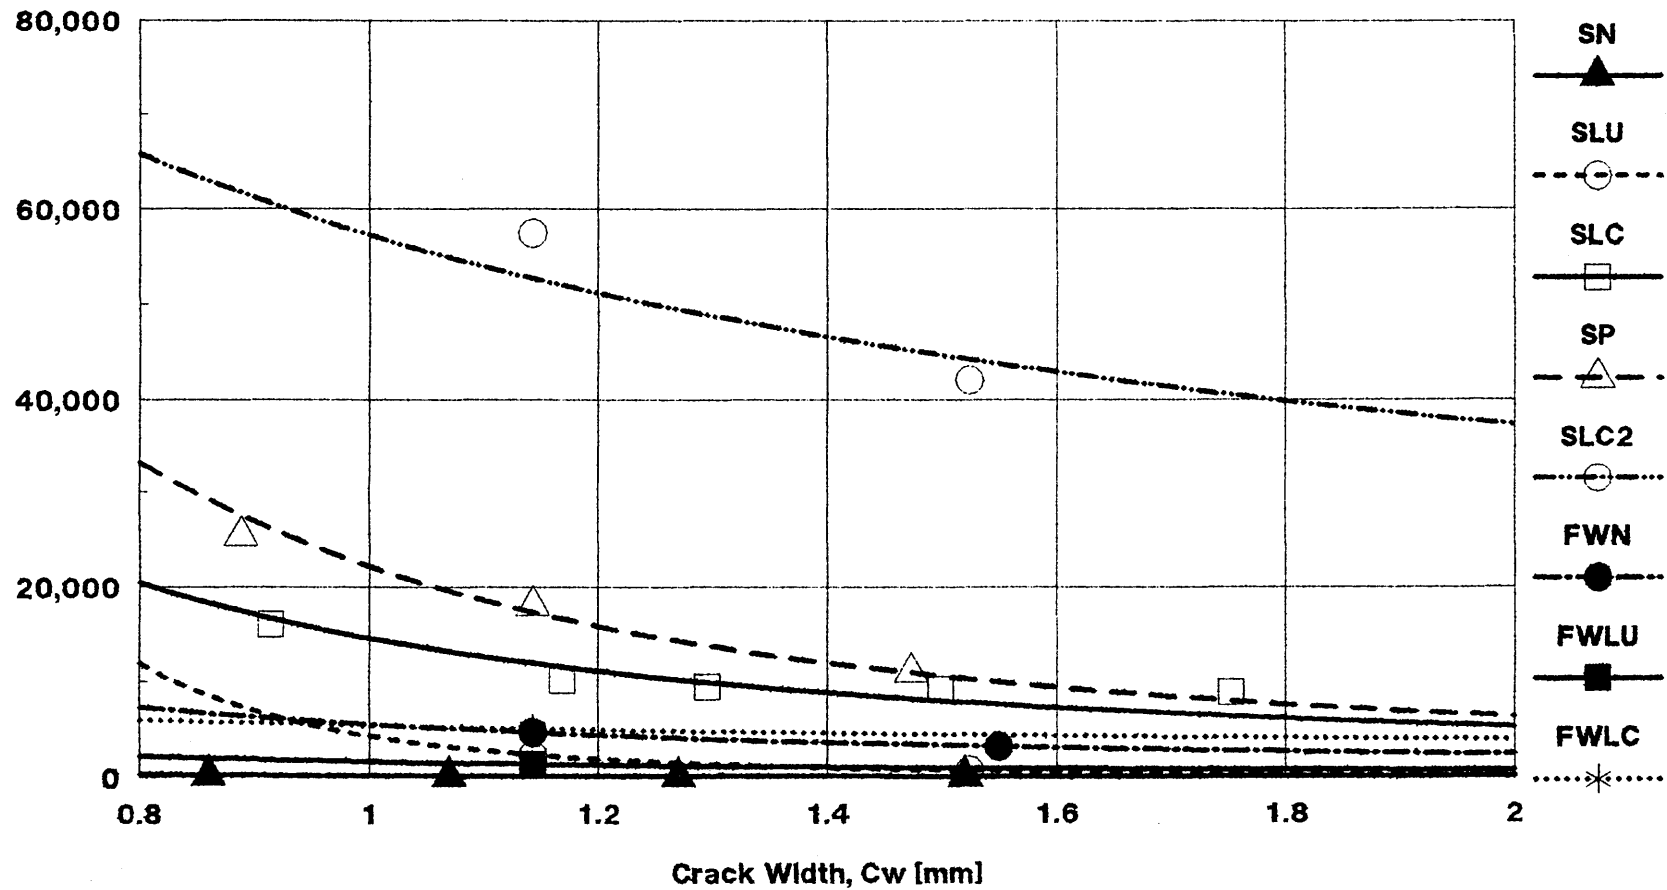
FIGURE 5

Total Resistance to Airflow vs Crack Width
for All Test Specimens

Total Resistance to Airflow, R_{tot} [Pa s/l]

can be introduced. Fig. 5 shows the variation of R with crack width.

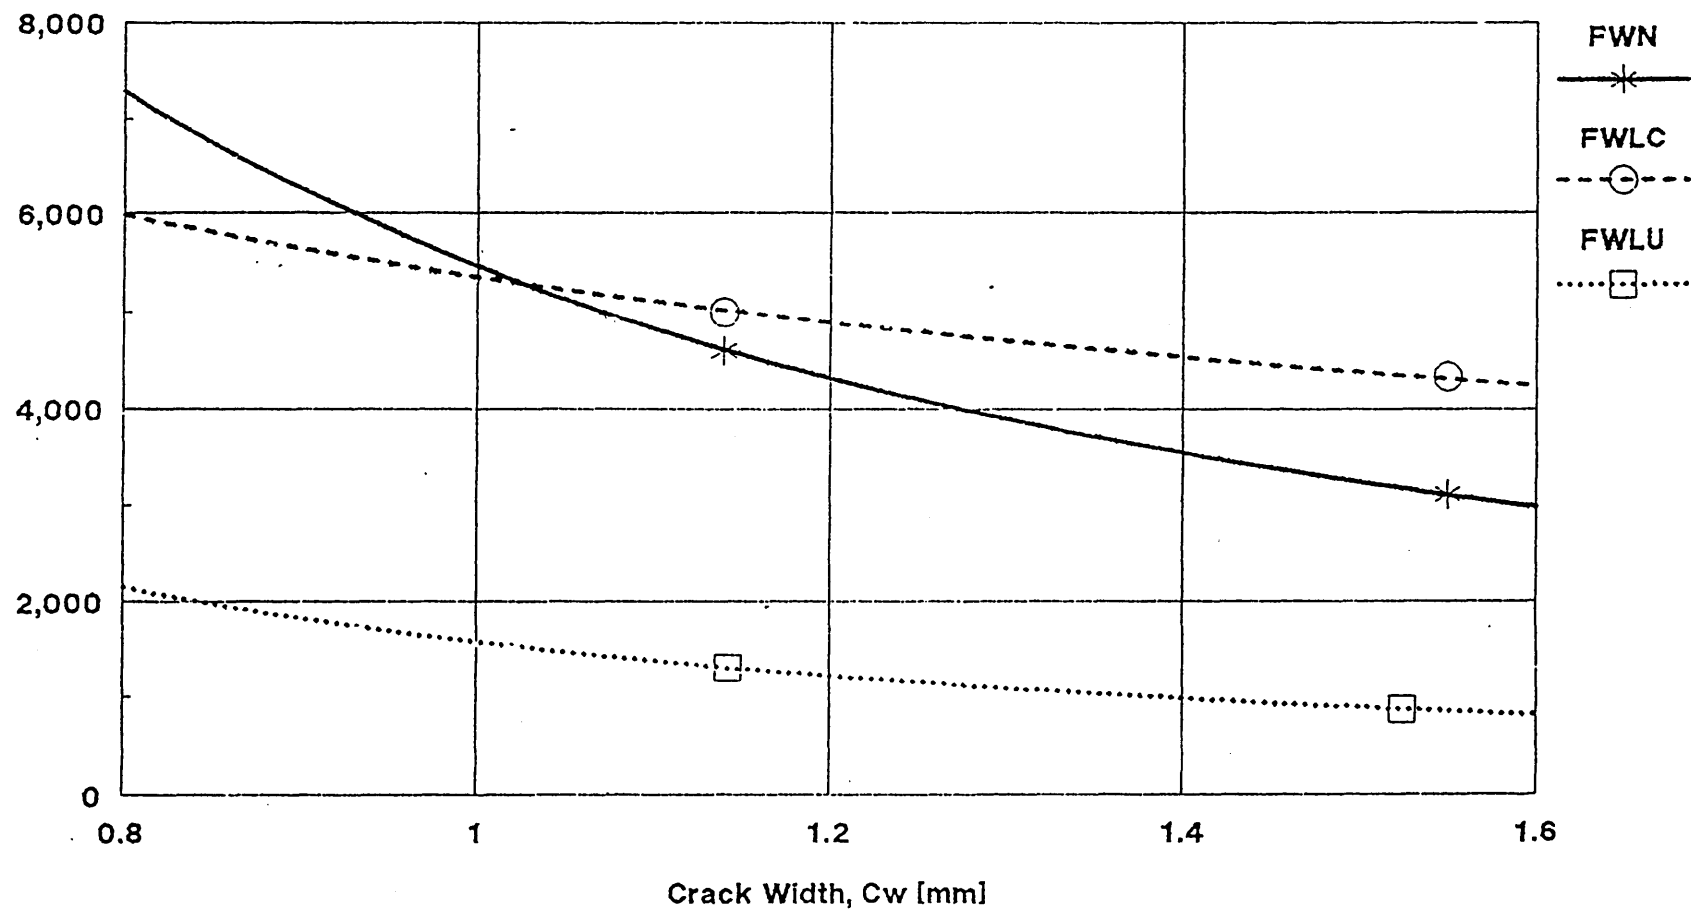
FIGURE 7 Total Resistance to Airflow vs Crack Width for the Floor-Wall Joint Specimens

Total Resistance to Airflow, R_{tot} [Pa s/l]

The results of the tests of the floor-wall joints were less conclusive. Figs. 6 and 7, and Table 2, present these results. As can be seen, the flow resistance of the joint without polyethylene was much higher than that of a crack of the same width. This was probably because of the flow resistance of the floor-footing joint. In real houses, floors get lifted off footings, but in the present tests there was no means of doing so. Therefore, little weight should be given to the results of these tests.

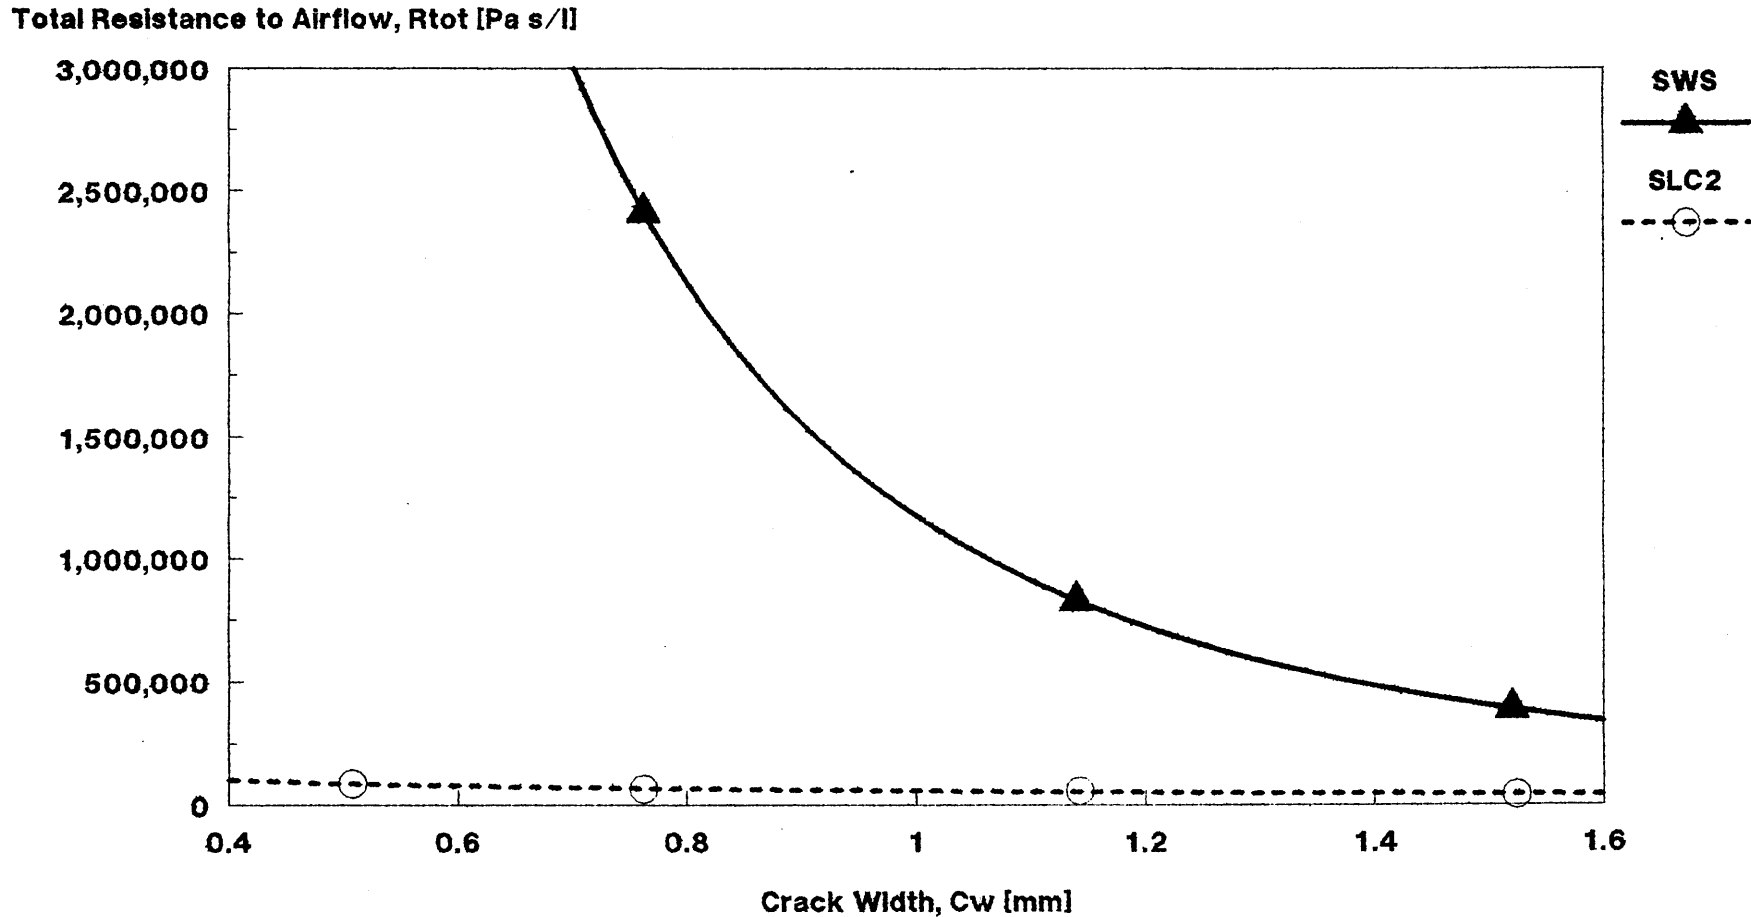
FIGURE 8

**Total Resistance to Airflow vs Crack Width for
the Slabs with Waterstop and the Second with
Lapped and Caulked Poly**
