**Excavations at Lower Fort Garry, 1965-1967;  
A General Description of Excavations  
and Preliminary Discussions,  
by James V. Chism**

Canadian Historic Sites:  
Occasional Papers in Archaeology  
and History — No. 5

National Historic Sites Service  
National and Historic Parks Branch  
Department of Indian Affairs and  
Northern Development  
Ottawa, 1972

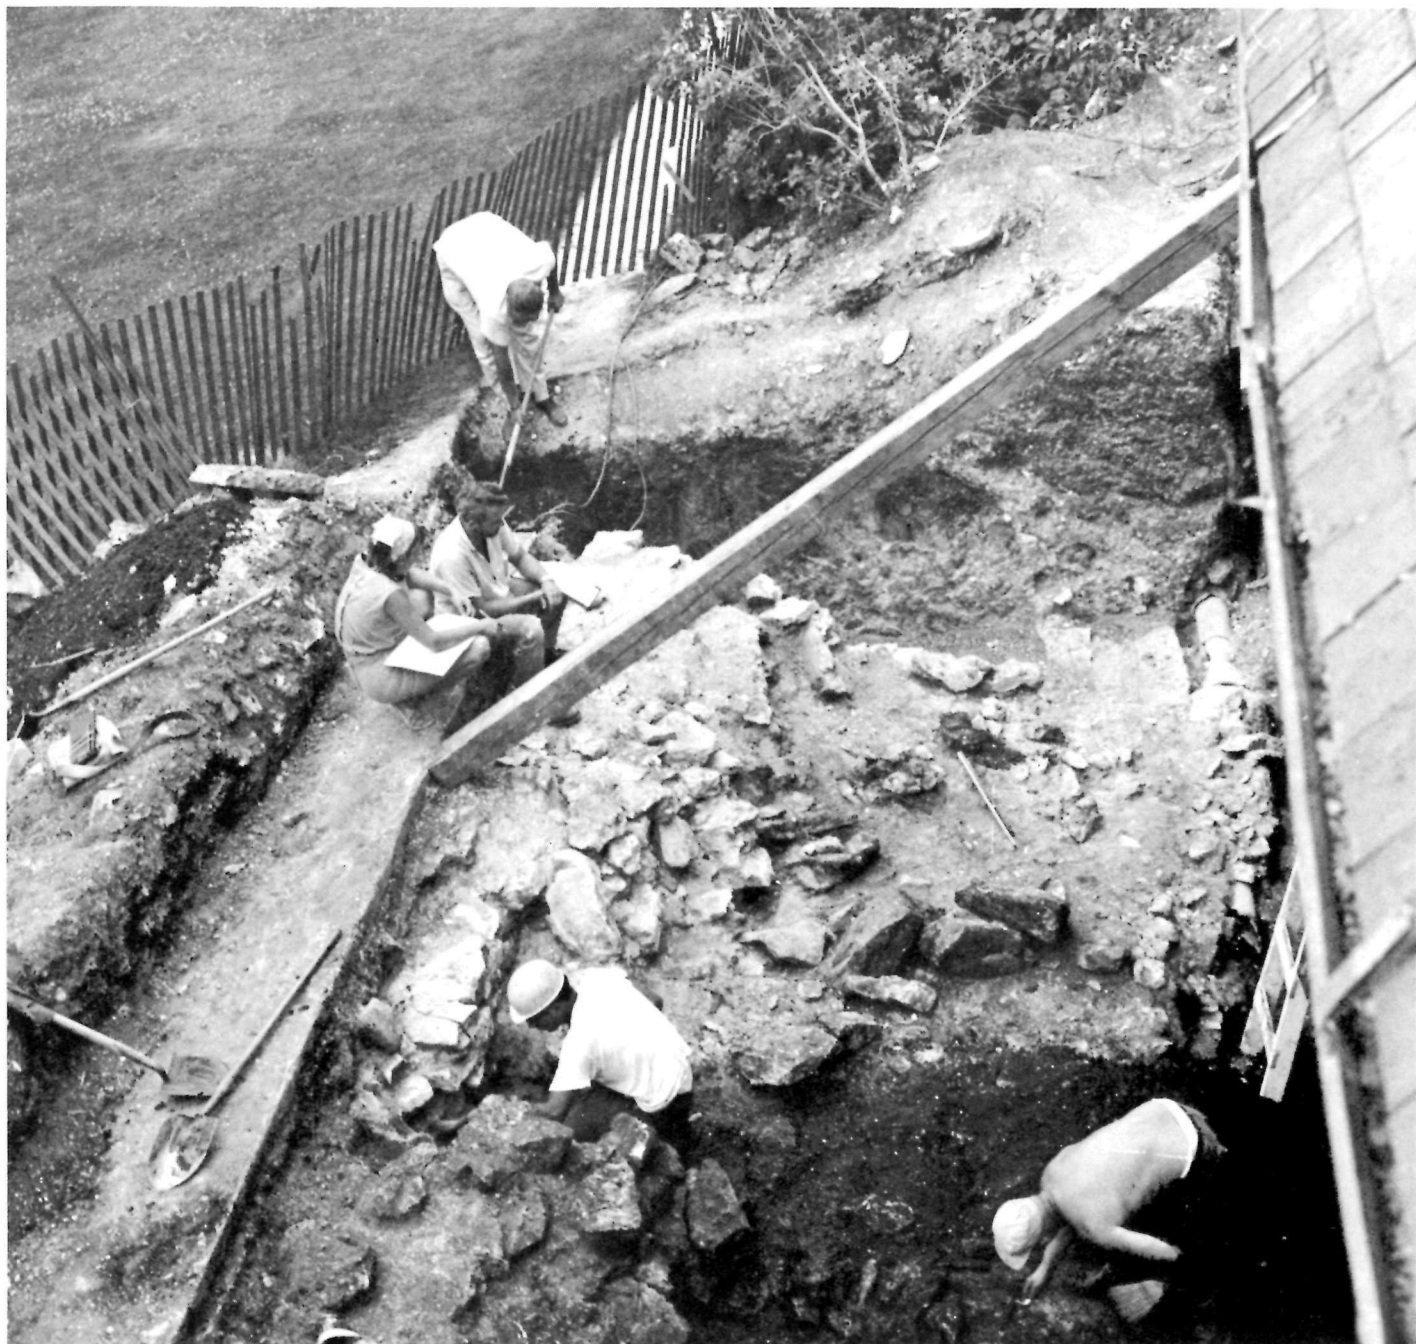
6 Areaway along the west wall of the Big House.

The lowest layer of fill in the areaway was an angular gravel and clay mixture. Its thickness and slope varied according to the configuration of the underlying rubble bordering the house. This fill was roughly level and approximately 0.1 ft. thick and 4 ft. wide. A ceramic drain 0.62 ft. in diameter covered loosely with dolomitic limestone was found in this strip. A trench for this drain cut through the ground outside the north end of the areaway. Drain tiles of this style would probably not have been locally available until the last quarter of the 19th century. The body of the tile is strikingly similar to material recovered for the project by James Henderson at the site of the 1879 to 1910 Doidge Pottery in East Selkirk, Manitoba some 8 miles from Lower Fort Garry (Henderson 1970). The 1969 discovery of a dolomitic limestone slab with

a 0.1 ft. wide, 0.2 ft. deep cut channel and another by Priess in 1968 indicate that an earlier and very different drainage system was in use while the areaway was open. Priess has been able to uncover more details of the earlier system and suggests that it connected to a system which ran under the Big House itself. The remainder of the fill consisted of patches of black and grey clays, sometimes with angular and rounded gravels. The angular gravel was crushed dolomitic limestone which was probably produced at the fort quarries, and the rounded gravel probably came from the gravel ridge north of the fort enclosure. Flower beds placed on the filled areaway contained a mixture of fill and post-fill material to a depth of 1.5 ft.

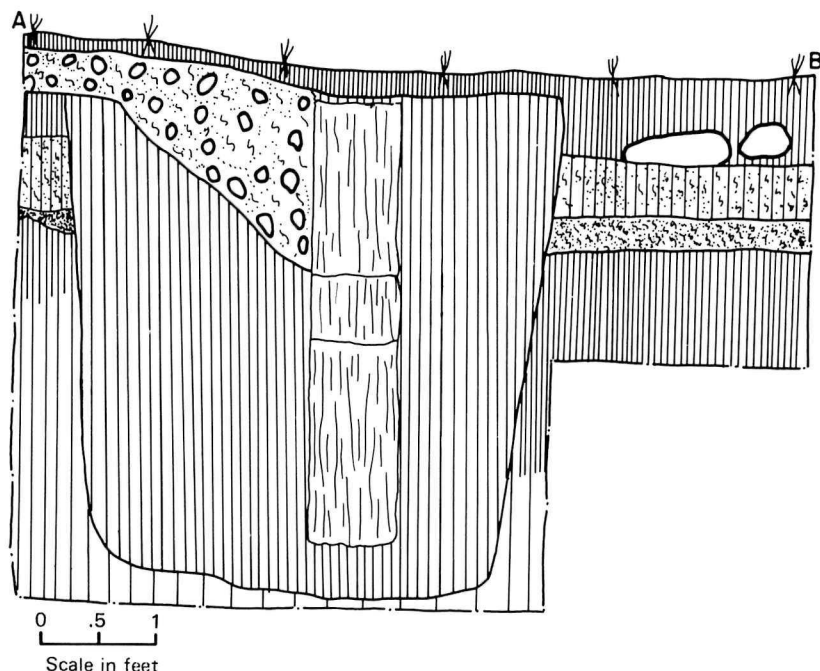
13 Profile of the prison palisade.

its bottom, and finally through a black undisturbed soil. The trench contained mixed gravelly fill. Although one was sure that some of the uppermost portions of the soil was a sod dressing, a clear delineation could not be made. Because the trench cut through all except the uppermost part of the dark top soil, all layers except the top one may be interpreted as clearly pre-dating June, 1870.

The second layer from the surface contained mixtures of clay and mortar and may be interpreted as a mortar puddle. This probably reflects the relative dating of nearby construction sites pre-dating the palisade. The underlying undisturbed soil exhibited the characteristic natural profile for the site.

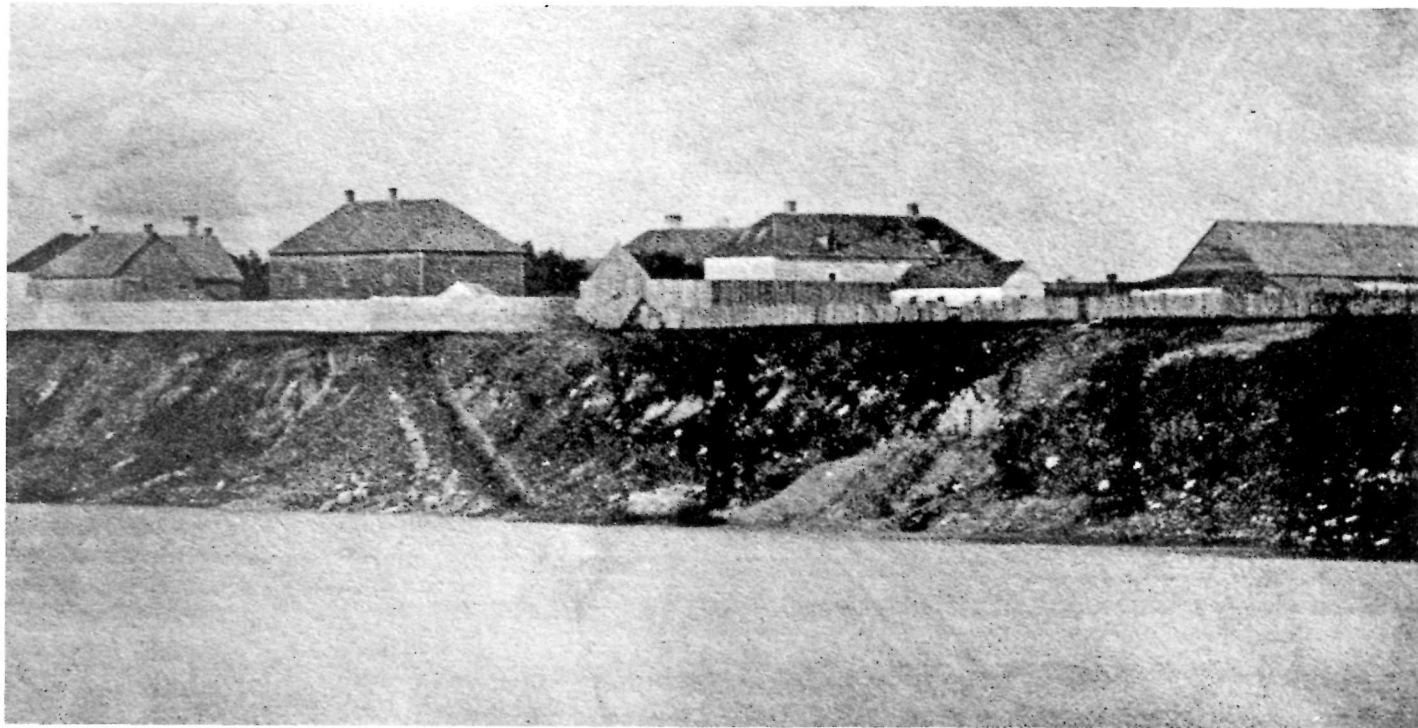
14 Lower Fort Garry from the northeast,  
ca. 1871-80 (*Public Archives of Manitoba*).

The palisade is shown in an 1873 drawing (Fig. 9) and a photograph dated between 1871 and 1880 (Fig. 14). The height of the palisade was clearly no less than 10 feet. The palisade has a gable-like addition to offset the height of the north wall of the fort where the two intersect northeast of the penitentiary.

Photographs show the building clearly. A photograph of 1871-80 vintage (Fig. 14) and another taken in 1880 (Fig. 15) show a two and one half storey structure with weatherboard siding and distinctive half windows under the eaves. Two draw-

The stableman's residence was not found, although the 1874 Dominion survey map (Fig. 3) and photographs of about 1871 (Fig. 14) and 1880 (Fig. 15) confirmed Watson's location. It

"half-timbered" construction as exemplified by the annex of the Big House, as well as solid stone construction. A photograph dating from 1880 (Fig. 7) confirmed the rubble-filled nature of this stable's superstructure and along with another photograph of 1871 to 1881 (Fig. 14), indicated lean-tos against the east, west and north walls.

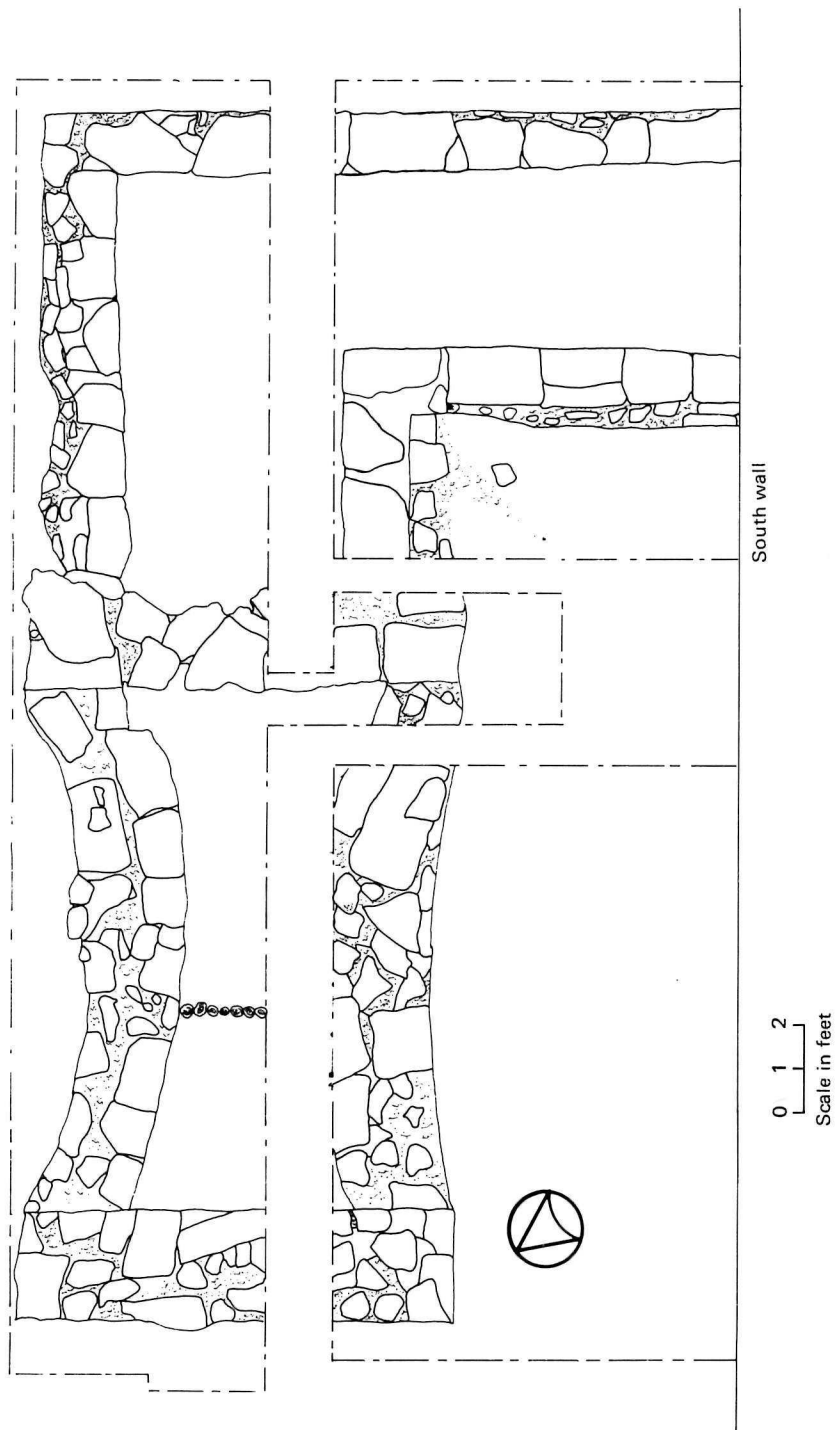
19 Plan of troop latrine.

The eastern section consisted of the remaining portion of the long leg and the entire short leg. The north foundation was 11 ft. to the turn and the south foundation was 5.5 ft. long to where it turned. The east foundation was then 15.5 ft. and the west foundation 9.1 ft. The nature of stonework changed from the wide and mortared vertical wall of the

western section to an unmortared or perhaps lightly mortared retaining wall with an 85° slope and a fine rubble fill between the stone facing and the earth behind. The facing consisted of a single thickness of squared and split-faced limestone set in uneven coursing which approached random coursing when large or small inclusions were made. The rubble placed behind this facing was to bring unlike-sized facing stones into line. Also unlike the other section, slump from horizontal pressures was practically nonexistent.

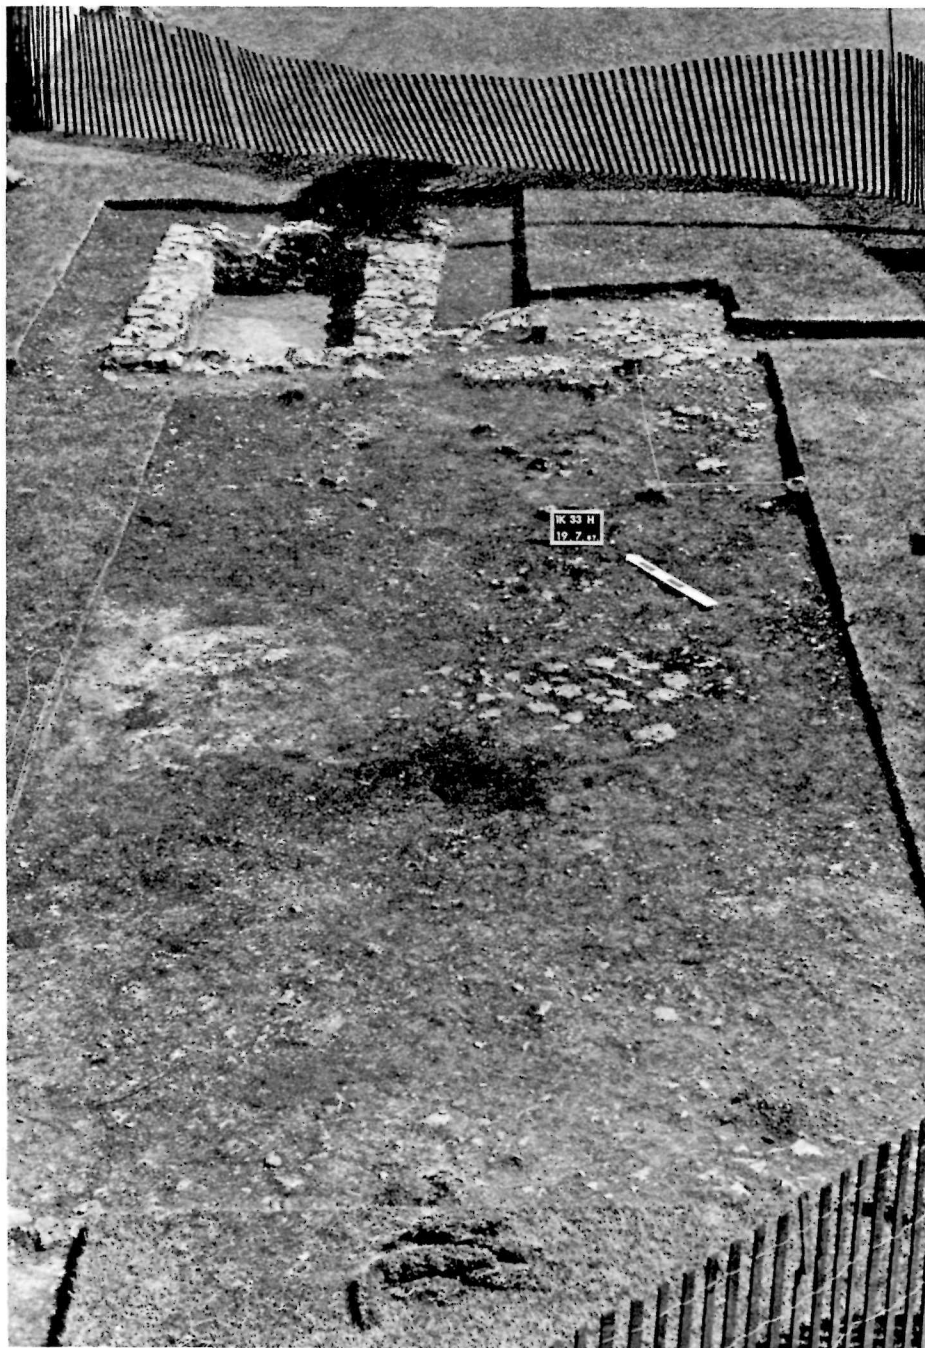
- 21 Area north of the southwest bastion with the smokehouse-oven foundations as viewed from the bastion.

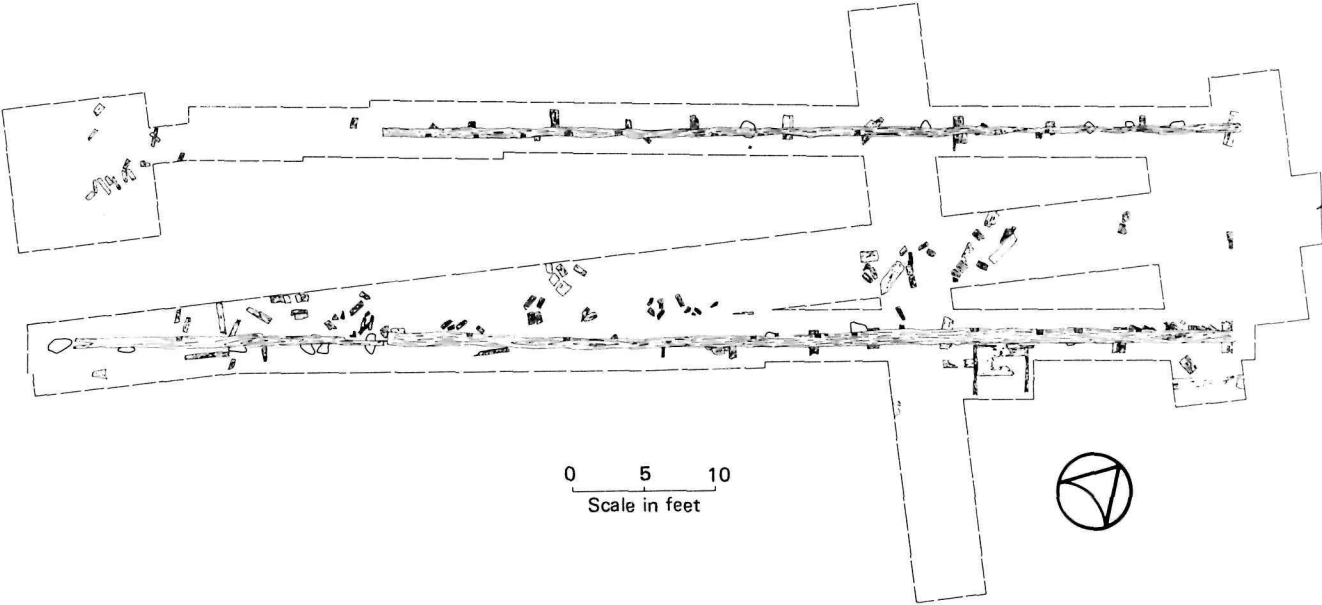
22 Plan of the troop canteen.

Excavation uncovered a very fragmentary situation (Fig. 22). The north and south walls were missing and a 22 ft. to 23 ft. portion of the west wall was also gone. Measurements taken on the remaining wood gave a length of 82.5 ft. for the east wall and 60.3 ft. for the west wall. The building was 15 ft. wide. The oak sills were 0.7 ft. to 0.9 ft. square. As was so often the case, these figures represented the logs' deteriorated and compressed dimensions rather than original size.

The sills and sub-sill supports had been laid on this levelled floor. Notches were cut in the inside edge of the sills apparently to hold the floor joists, which were set on 3.3 ft. to 10 ft. centres. They were fastened by clasp-headed wrought nails. The notches were 0.38 ft. to 0.4 ft. wide and 0.2 ft. to 0.3 ft. deep. The joists were probably larger than the above dimensions which might represent only the size of the tenon. No joists were found. The sills had been packed with clay to hold them in place. This clay appeared in profile as a distinct yellowish layer easily separated from other layers.

A wooden stoop was found along the exterior of the east wall. It consisted of north-south running plank fragments laid on two 0.22 ft. wide by 0.2 ft. thick and 3.5 ft. long east-west running joists spaced 3.2 ft. apart.

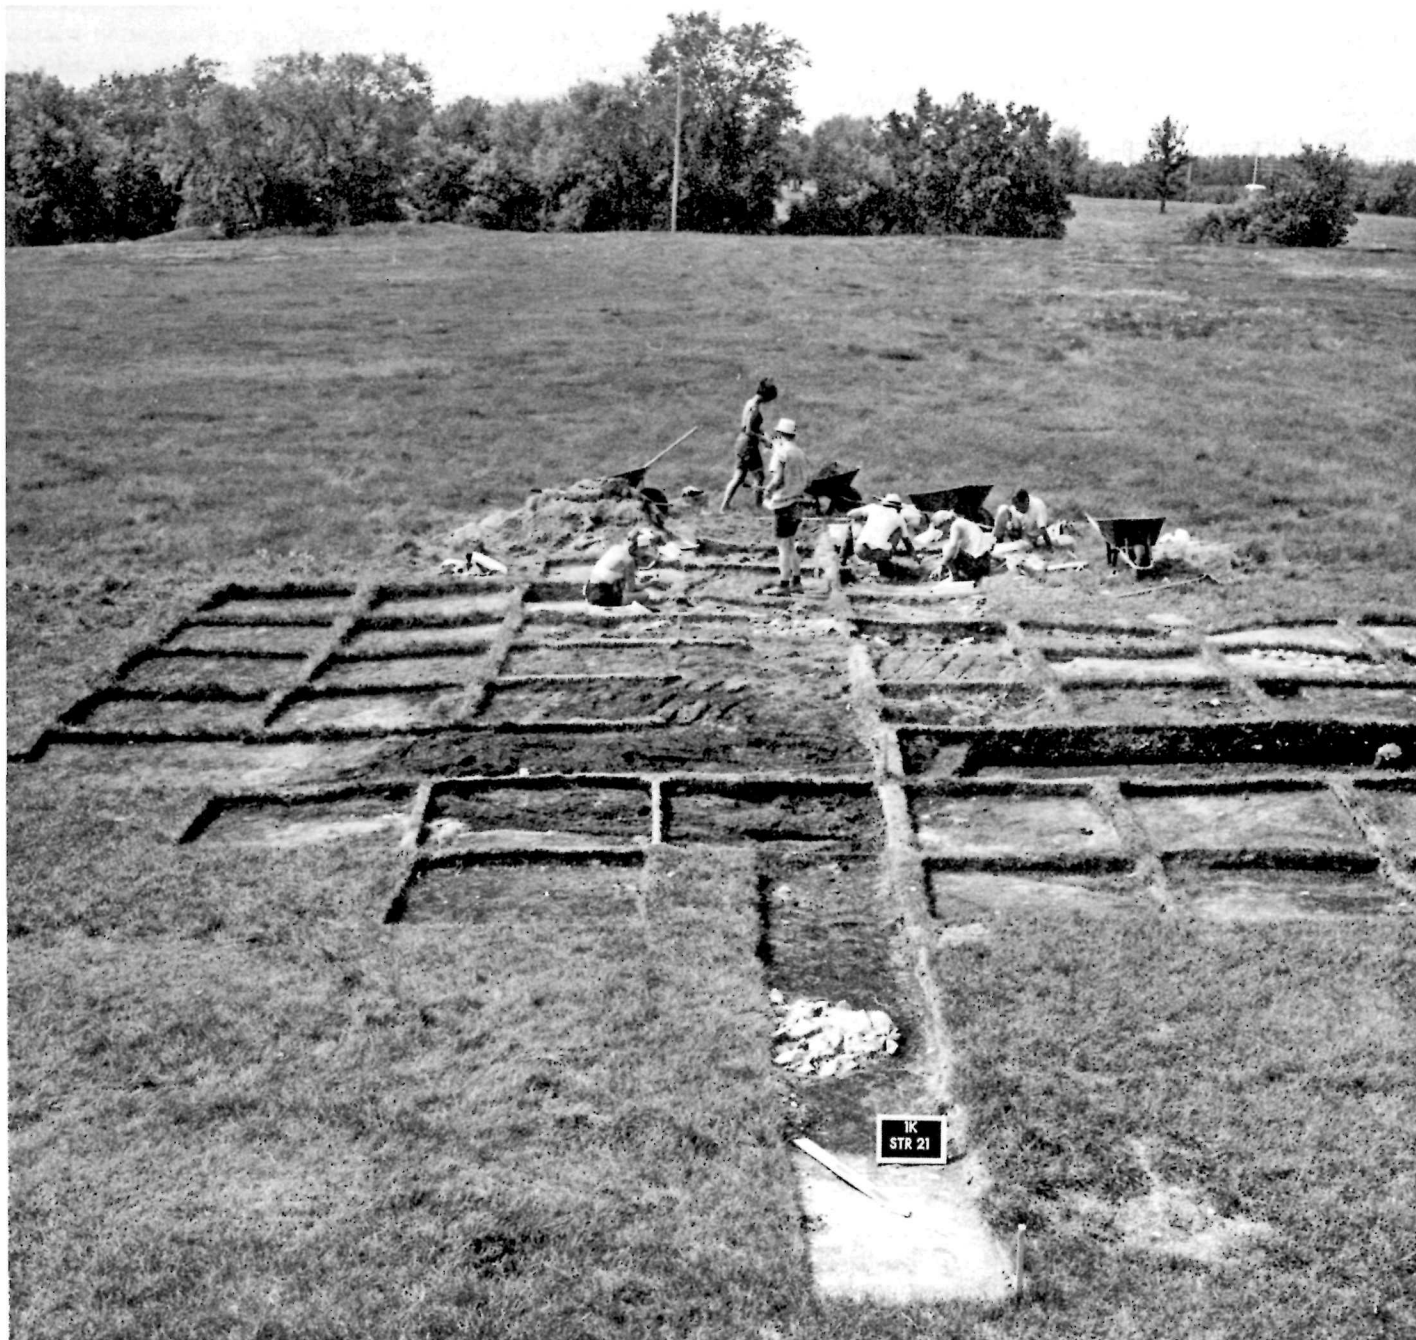
23 Blacksmith shops looking south.

An excavation was oriented toward recovery of structural, functional and dating information at the location of the blacksmith shop south of the fort enclosure (Fig. 4; item 9; Fig. 23). Work was begun here in 1965 and continued in 1966.

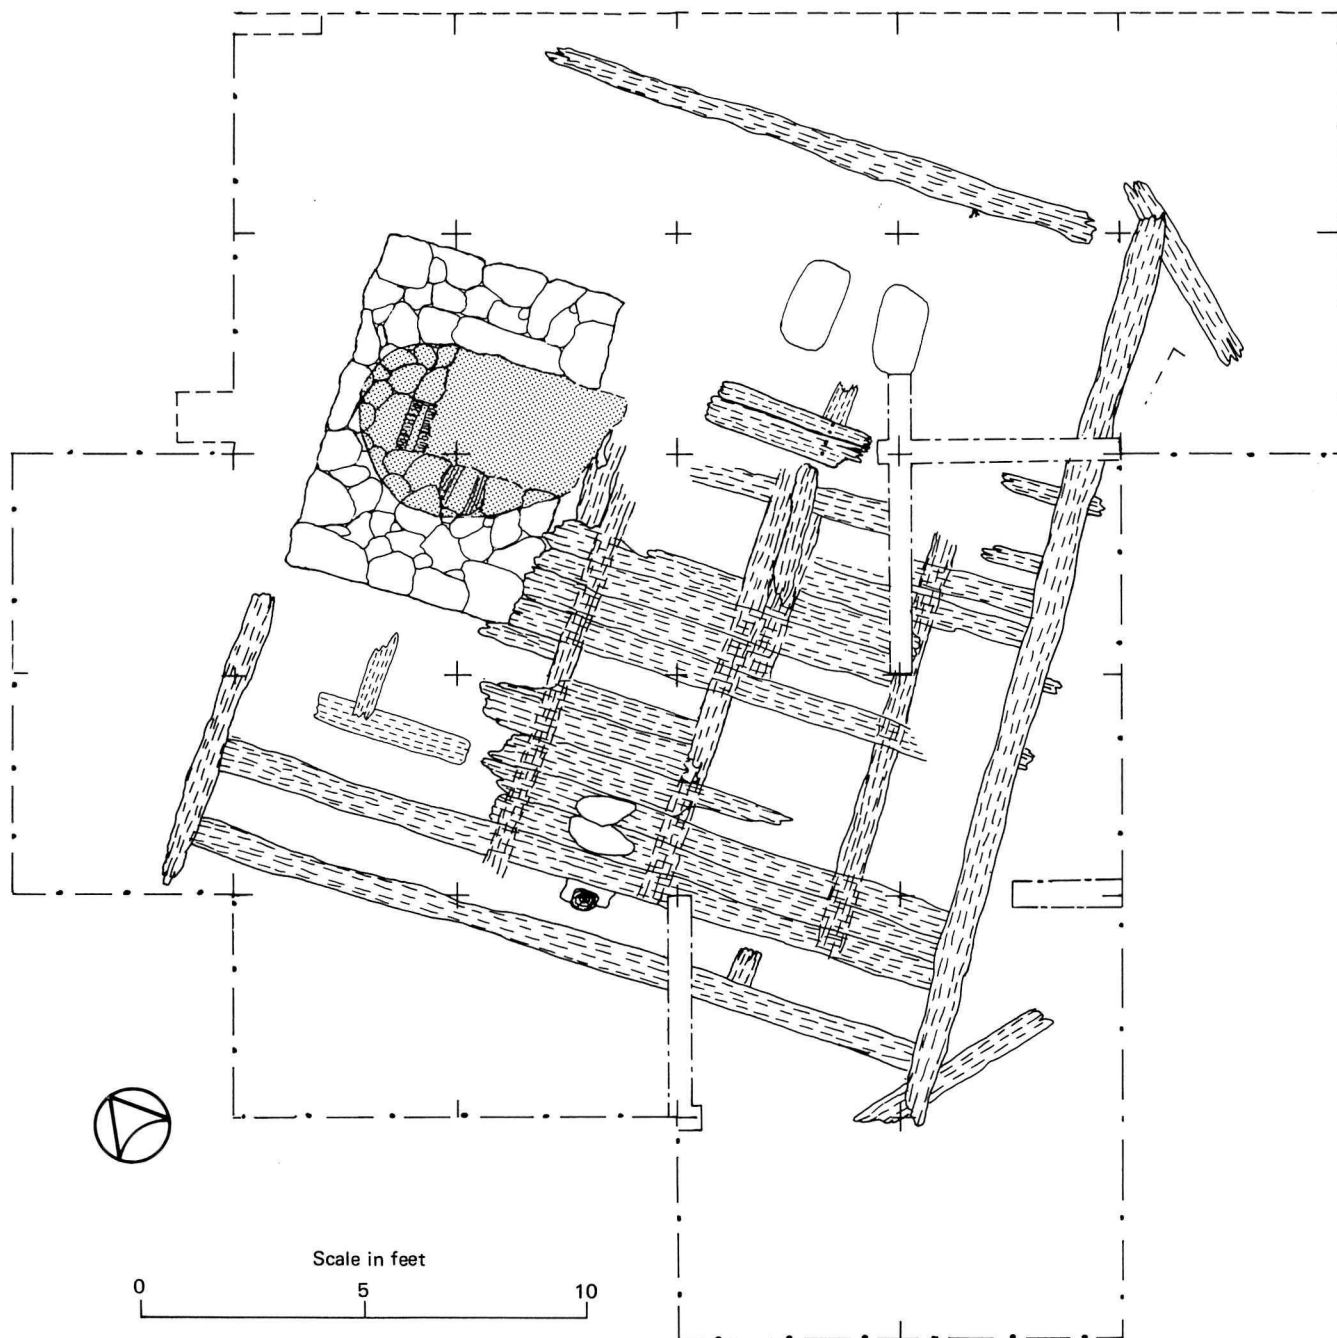
24 Plan of blacksmith shop I.

Excavation clearly indicated that blacksmith shop I was an 18 ft. by 20 ft. log structure (Fig. 24). There was no direct historical evidence found by Ingram which bears on the beginning or end date

Two limestone slabs measuring roughly 2 ft. by 1 ft. by 0.5 ft. were found approximately 2 ft. south of the north wall and on either side of the north section of the second joist line. These have been interpreted as anvil supports. They were probably not used as such for the later shop as they were overlain by rubble which would have created instability in a later anvil. Also, the westernmost of the two stones was partially overlaid by a joist of the later shop.

A number of manually mixed, wire-cut burned clay bricks of slightly different sizes centreing around 0.73 ft. by 6.37 ft. by 0.21 ft. were found. Their location near the forge suggested that they had been used in the construction of the forge. Their presence could be taken to suggest a brick chimney; however, due to the small number found, it is possible that they only lined the breast of the forge.

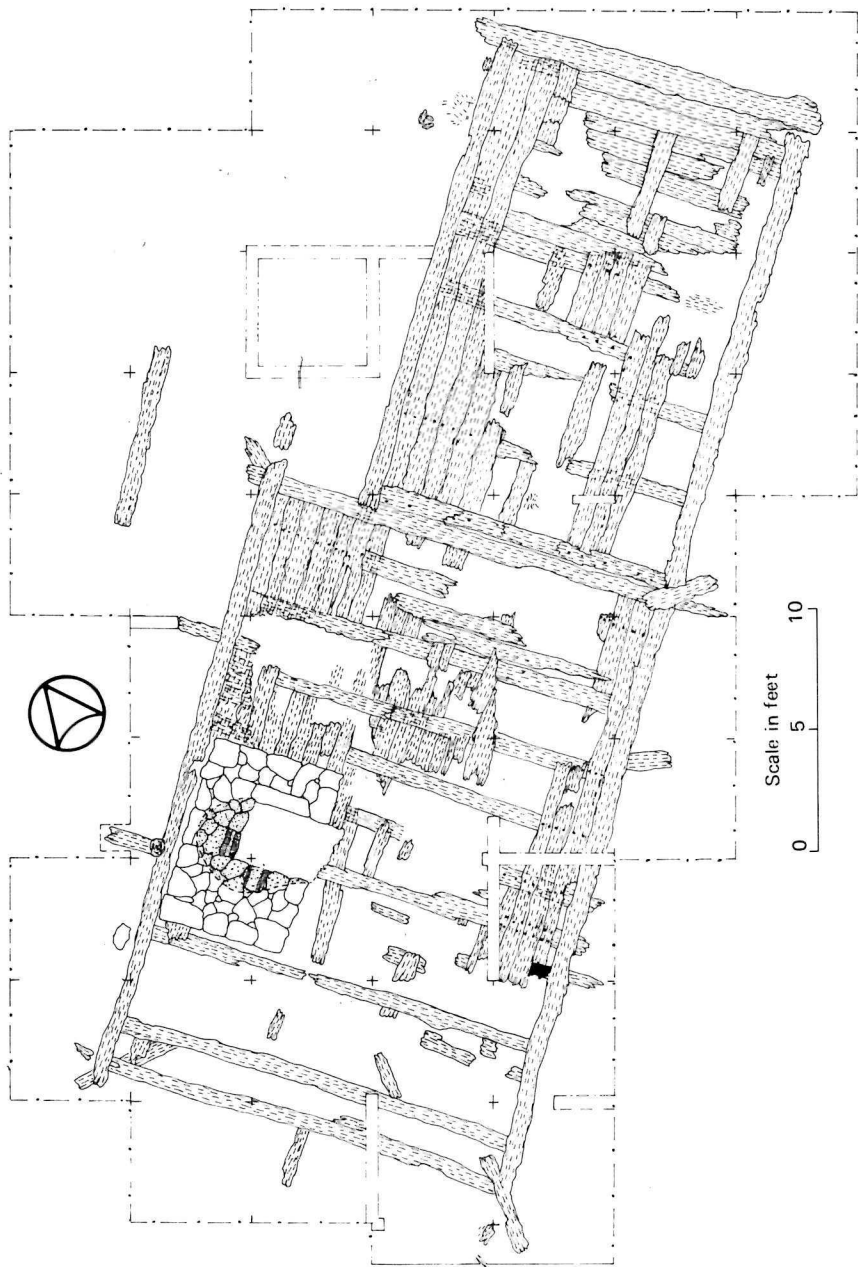
25 Plan of blacksmith shop II.

It appeared that after levelling the rubble of shop I, the first stage of construction for the new shop was to set the joists and plank supports into trenches and set the sills over them. A similar "entrenched" effect might have been gained by settlement into the unstable rubble construction surface. The joists ranged in size from 0.5 ft. to 0.65 ft. wide and from 0.09 ft. to 0.15 ft. thick. In a few instances, the original outside surface of the tree could be detected, suggesting that untrimmed logs have been sawn into planks.

The orientation of shop II floor joists and flooring was at right angles to that of shop I. Also in contrast to the earlier shop, the entire distance between the east and west sills was spanned by a single plank for each joist.

Sill dimensions as found ranged from 0.75 ft. to 0.95 ft. in width and 0.5 ft. in thickness. Ignoring the thinness of the decomposed sills, reconstructed dimensions clustering around the one foot mark would not be unreasonable for the sills. The sills extended beyond the corners for an estimated distance of 1.5 ft. to 3 ft.

The north-south oriented flooring of the main structure was 0.5 ft. to 0.8 ft. wide and had a found thickness of 0.05 ft. to 0.09 ft. Floorboards were nailed to the joists with two nails at each joist using chisel-pointed rosehead and clasp head wrought nails. Only the sixth joist was noted to have four nails holding single boards to the joist. There was no sign of extra wood at the north and south ends of the floor for nailing, nor was there any indication that the floor did any more than abut the north and south sills. There appeared to have been some patching between the first and second joists from the north.

The annex to blacksmith shop II appeared to have been much more lightly constructed than the main shop structure. The sills for this 21 ft. by 14 ft. addition were quite thin as measured. Again, one is unsure as to just how much thinness is a result of decomposition and being so near the surface that all traffic compacted and scattered it. The oak sills ranged in width from 0.6 ft. to 1.0 ft. and were as thick as

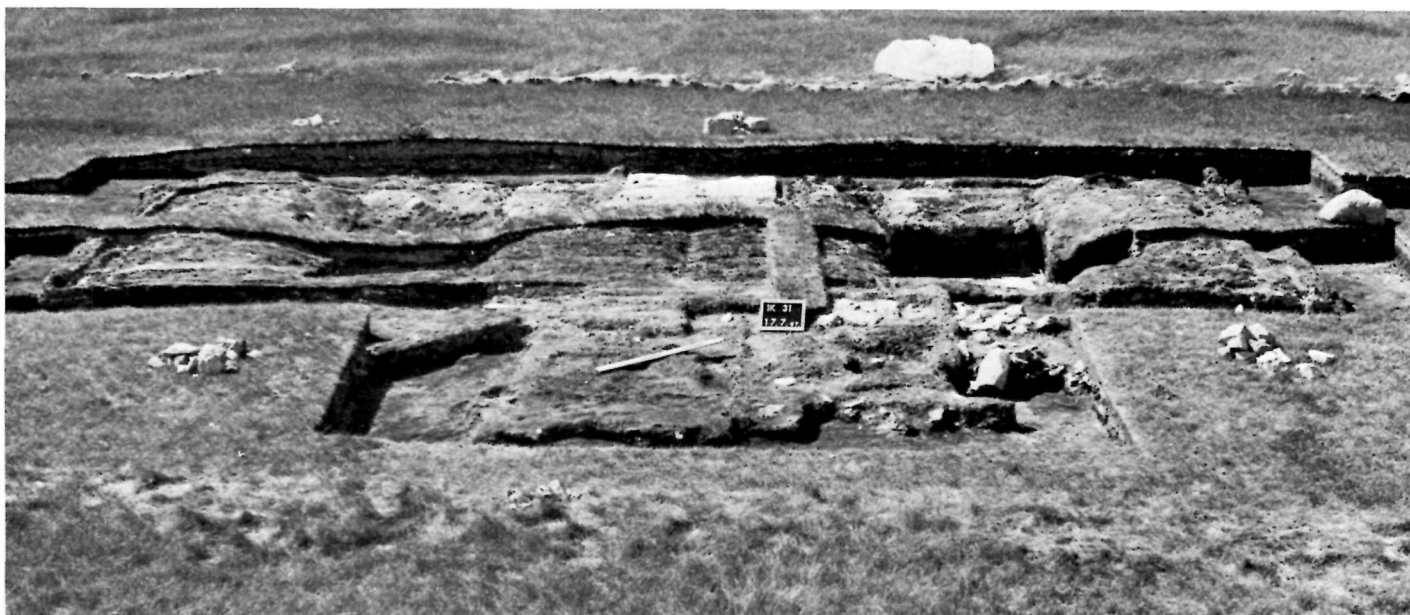
27 The farm manager's residence looking west.

Evidence recovered in excavation indicated a small log structure with either a porch or an additional room, two cellars and a chimney, possibly with a fireplace (Figs. 27, 28). The actual evidence con-

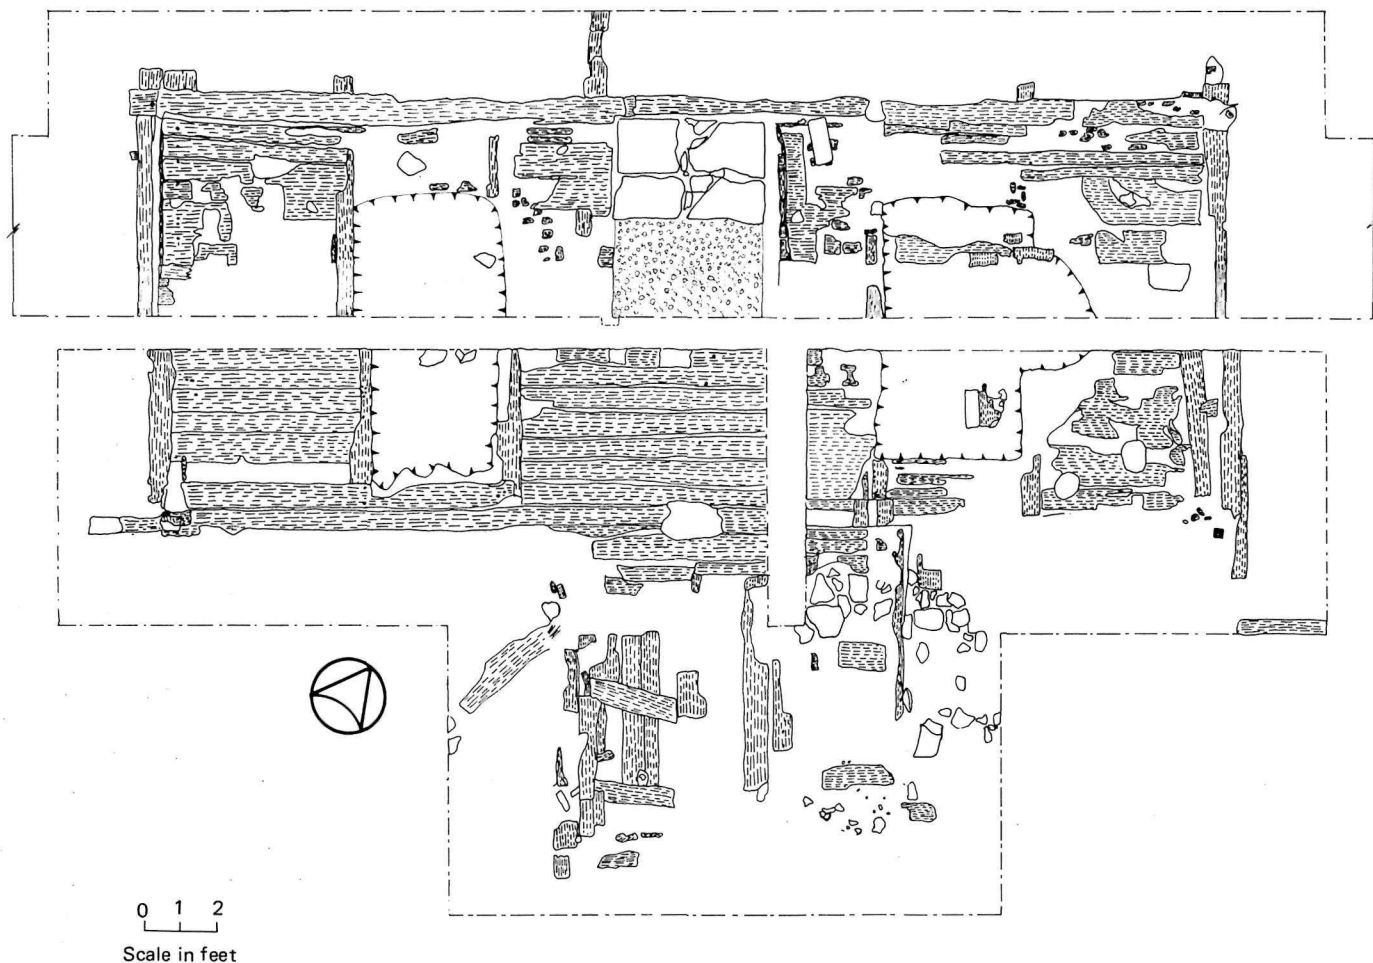
28 Plan of the farm manager's residence.

The structure uncovered was 12 ft. by 30 ft. with a north-south long axis. The squared oak wall sills which were 0.5 ft. to 0.65 ft. wide by 0.3 ft. to 0.5 ft. thick had been lapped and pinned at the corners with the sills extending beyond the corners.

Because the joists began immediately inside the sills, the north-south running 0.4 ft. to 0.8 ft. wide by 0.1 ft. to 0.15 ft. thick flooring was supported where it abutted the north and south walls. This flooring was pinned to the joists by what had probably been a pattern of two rose-head or clasp headed wrought nails per board at a joist. The joists were sitting partially buried in a bed of clinkers, charcoal and other debris, which

The south cellar had an east-west long axis and was 3 ft. deep. It appeared to have been disturbed more than the north cellar and length was difficult to determine. It was 4 ft. wide and probably had an original length of 7 ft., but may have been as long as 8 ft. Wood sheeting on the sides and near the floor suggested that this cellar may have been wood lined as

The undressed stone apron located against the west wall was 2.85 ft. by 4.04 ft. with a north-south long axis. A chimney base of the same size abutted it to the east. Possibly a fireplace faced onto the apron but no burned area was detected. This appeared to be an unusual heating arrangement because the apron was against the wall with the chimney base interior to it.

Although somewhat scattered, joists and fragments east of the east wall probably indicated a porch. The area was 7.5 ft. to 10 ft. by 9 ft. to 10 ft. as found and probably represented a porch of 8 ft. by 10 ft. with a north-south orientation and floorboards 0.8 ft. wide by 0.1 ft. thick.

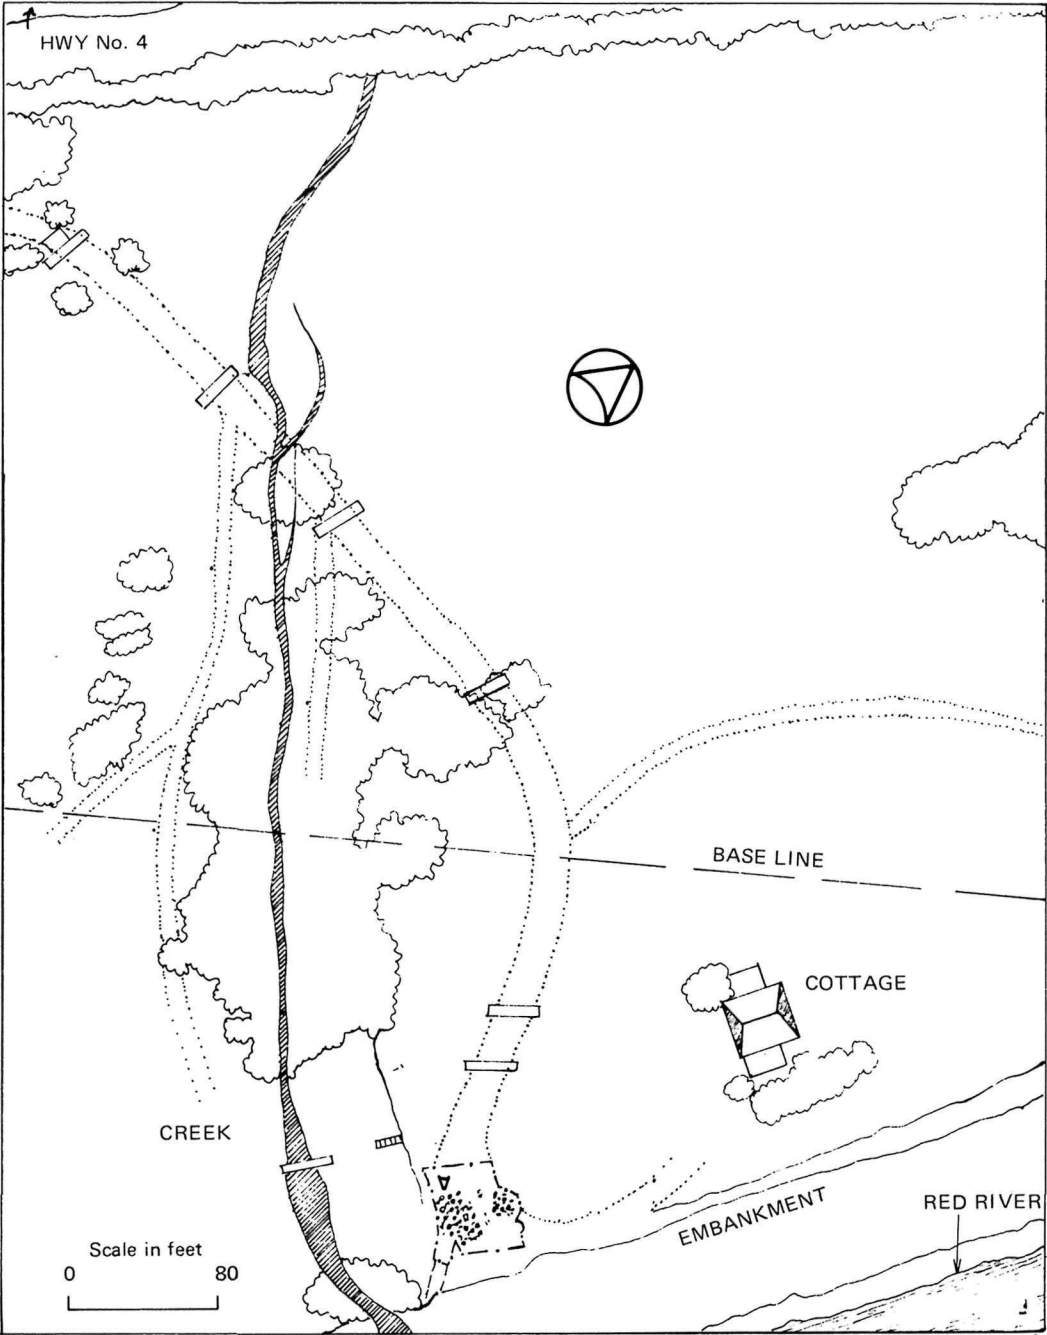
32 Plan of roads in the south field.

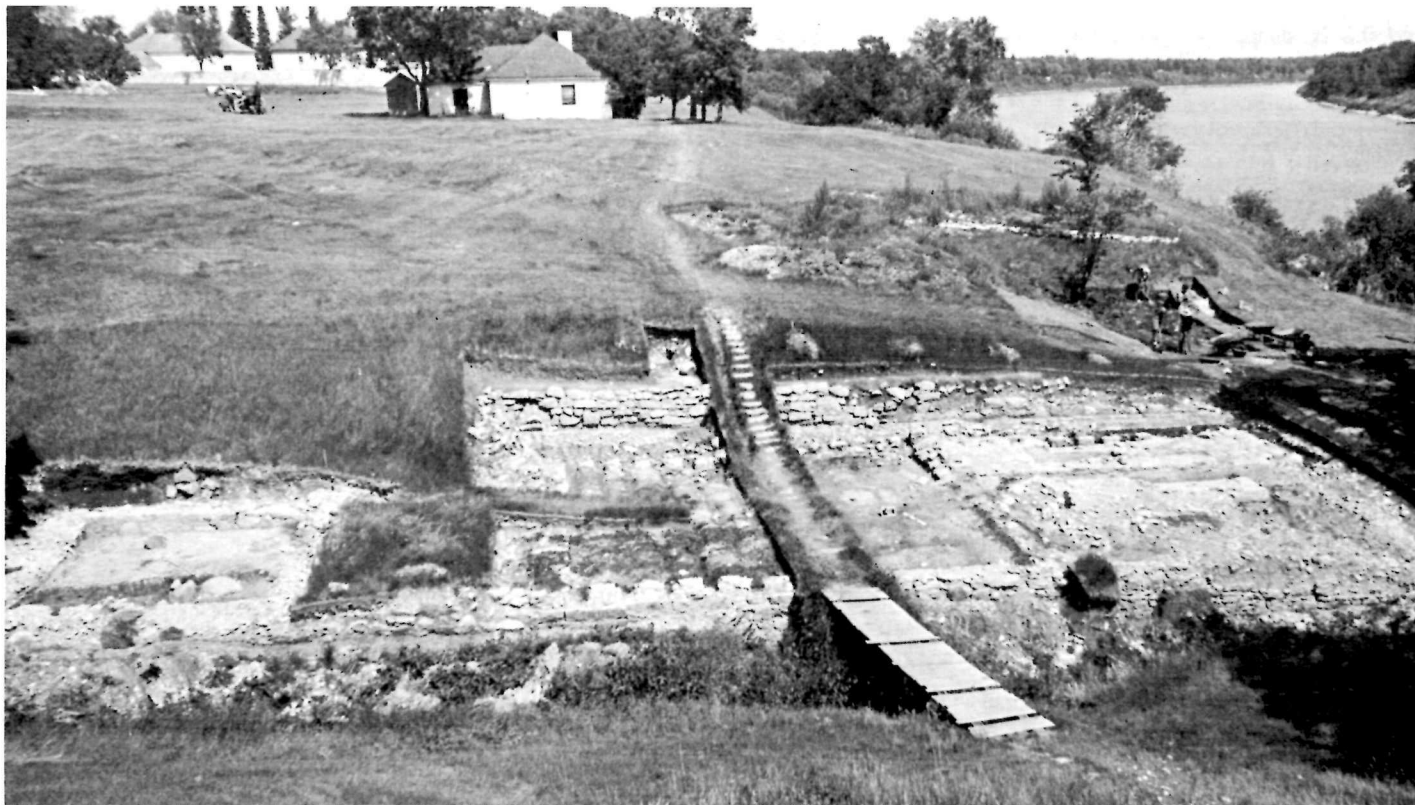
37 Malt barn-gristmill-sawmill-lathe room on the right malt kiln on the left. The distillery-brewery-storehouse is in the right background in this northward facing photograph.

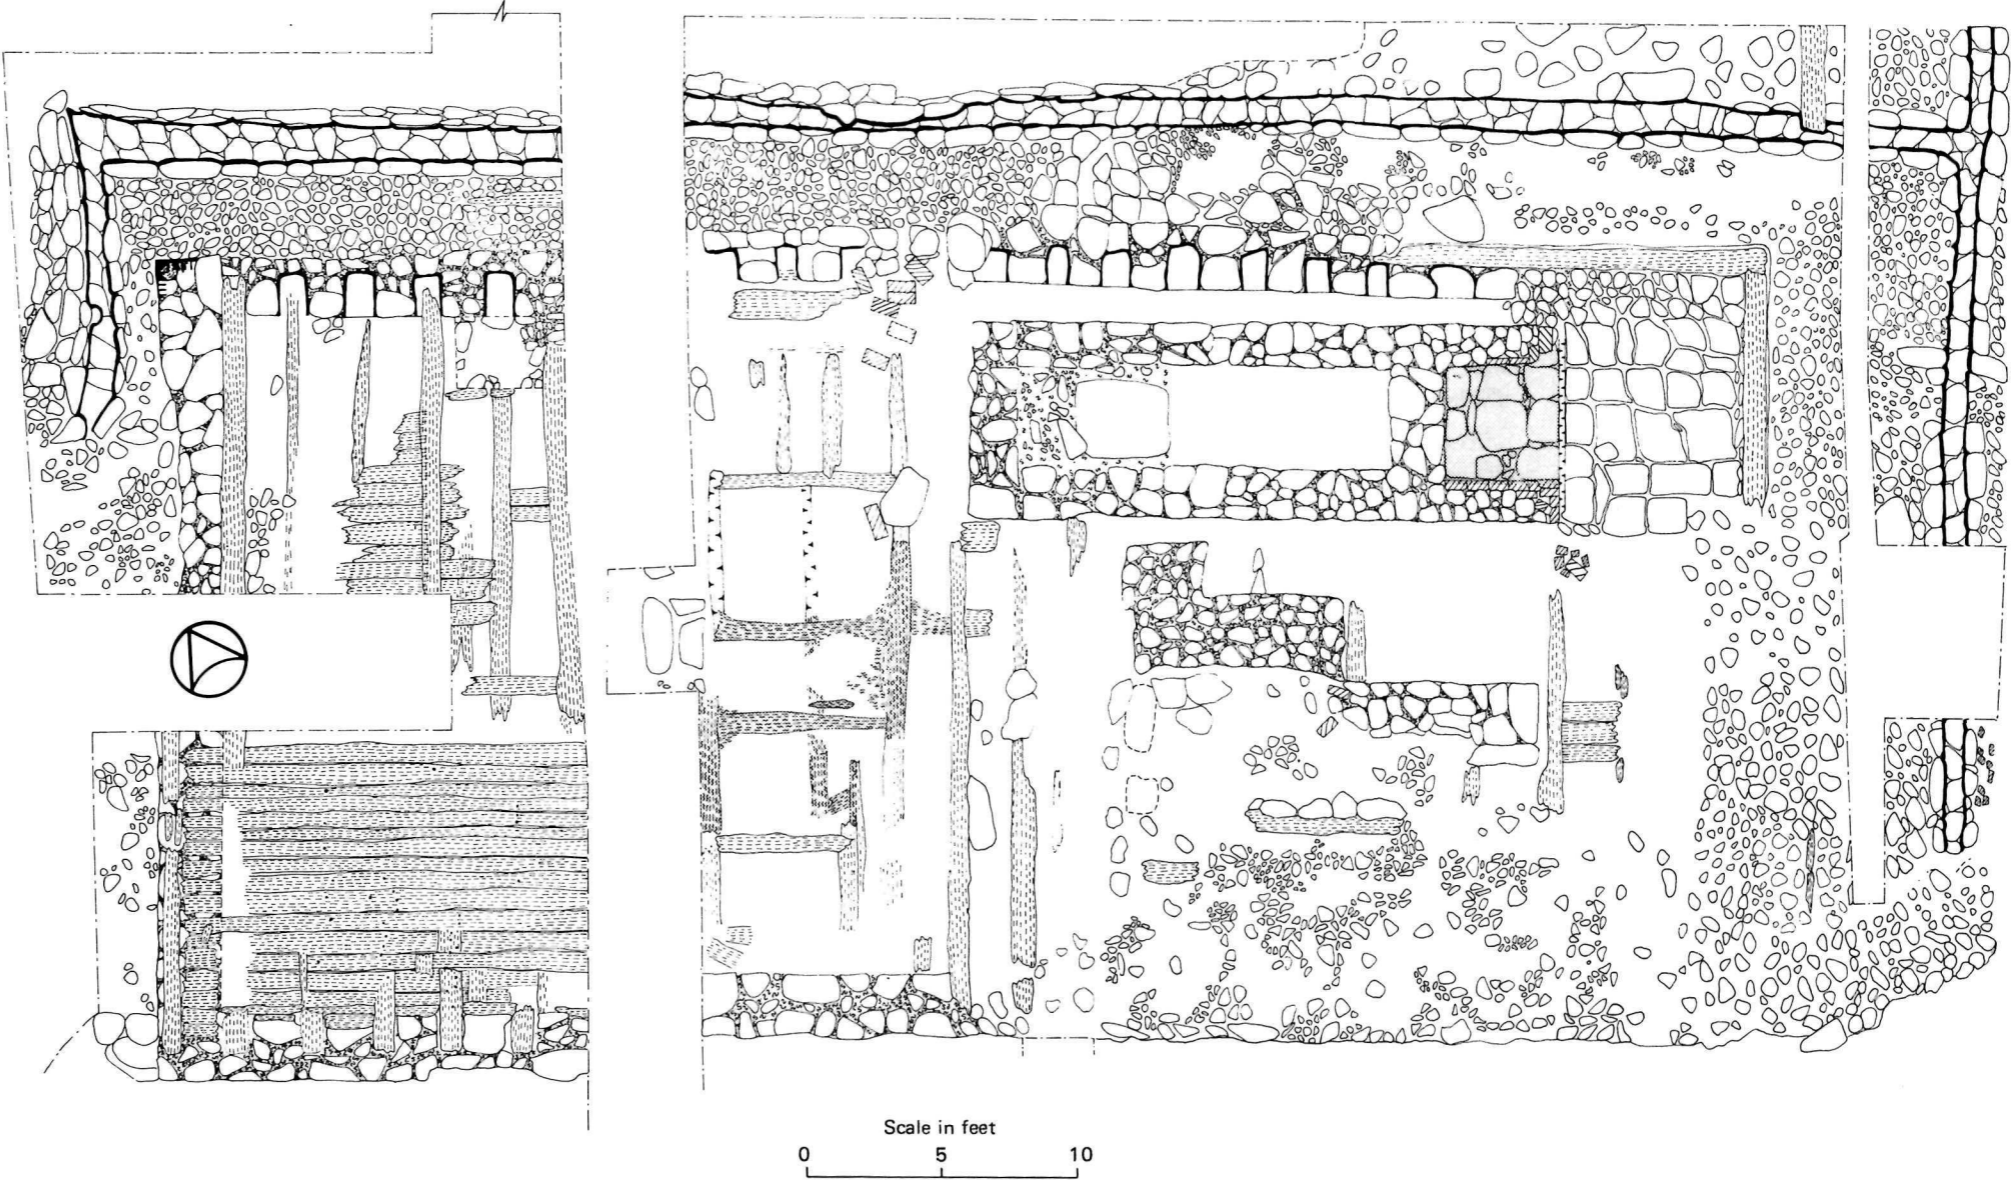
38 Plan of the malt barn-grist mill-sawmill-lathe room.

A 30 ft. by 60 ft. rectangular limestone foundation with an east-west long axis was uncovered. The southeastern corner of the structure had been heavily damaged by water action and was almost

The foundation wall was 2.3 ft. to 2.5 ft. wide. Along its north, east and west sides it was 1.75 ft. deep, but was 5.9 ft. deep along its south side along the creek. The south wall clearly functioned as a retaining wall bordering the creek. Additional stones were detected to the east and west of the ends of the building which suggested that the retaining wall had extended beyond the limits of the building walls. Along the interior edge of the western 50 ft. of the north foundation and the western 16 ft. of the south foundation was a series of notches 0.9 ft. to 1.2 ft. wide by 0.7 ft. to 1 ft. deep by 1.3 ft. to 1.8 ft. long, set on 2 to 2.5 ft. centres. These notches were for keying north-south running floor joists.
