**Excavations at Lower Fort Garry, 1965-1967;  
A General Description of Excavations  
and Preliminary Discussions,  
by James V. Chism**

Canadian Historic Sites:  
Occasional Papers in Archaeology  
and History — No. 5

National Historic Sites Service  
National and Historic Parks Branch  
Department of Indian Affairs and  
Northern Development  
Ottawa, 1972

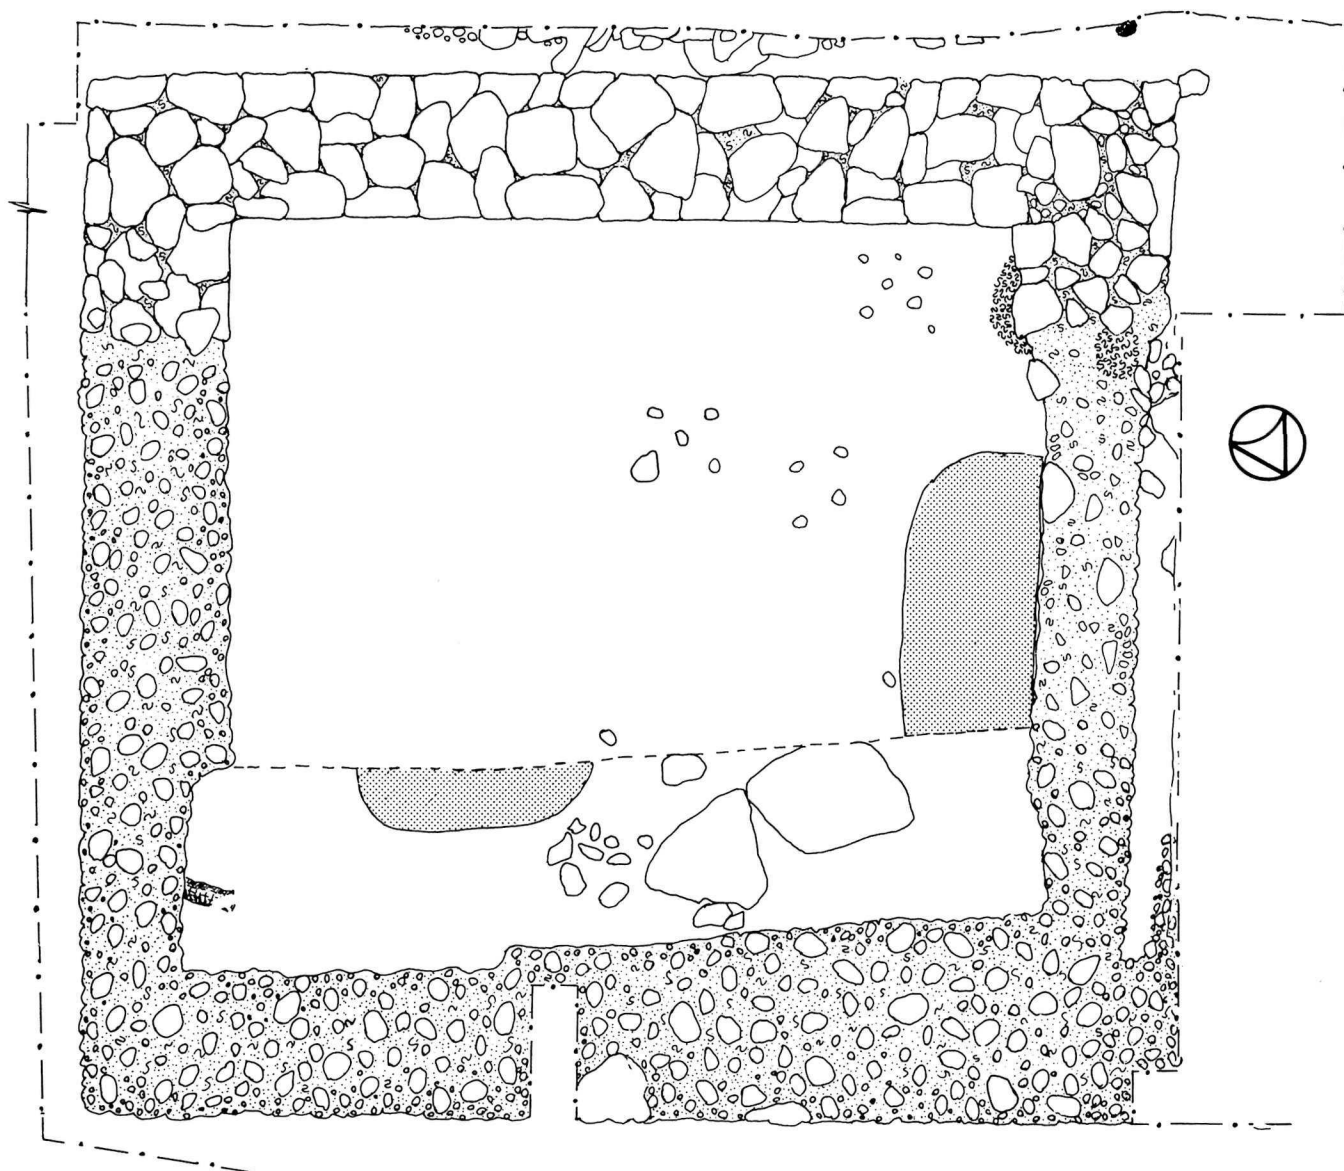
39 Plan of the malt kiln.

The westernmost 3 ft. of the feature stood above the rest of the platform. This might have been part of a balk to reduce

heat going to waste or simply a section of the platform that was not destroyed to the same degree as the remainder. The remainder was 0.5 ft. above the rubble paving and 1.0 ft. above the remnants of wooden flooring under the paving. The base of the platform was 0.5 ft. below the wood fragments.

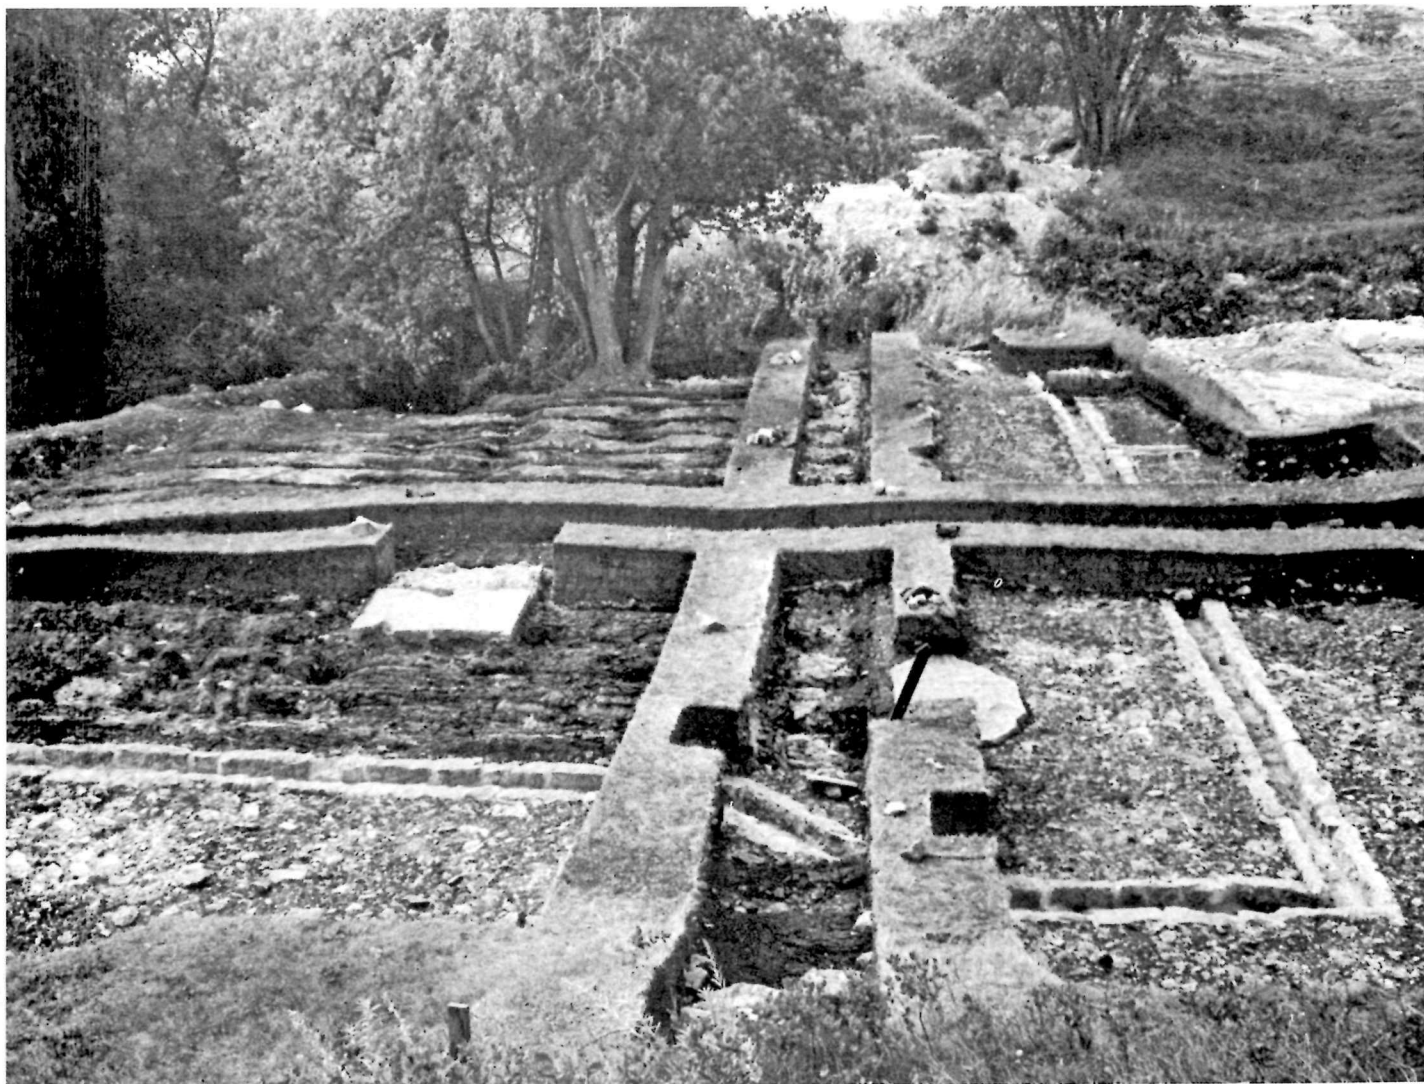
40 The distillery-brewery-storehouse looking south with the guttered paving in the foreground and to the right.

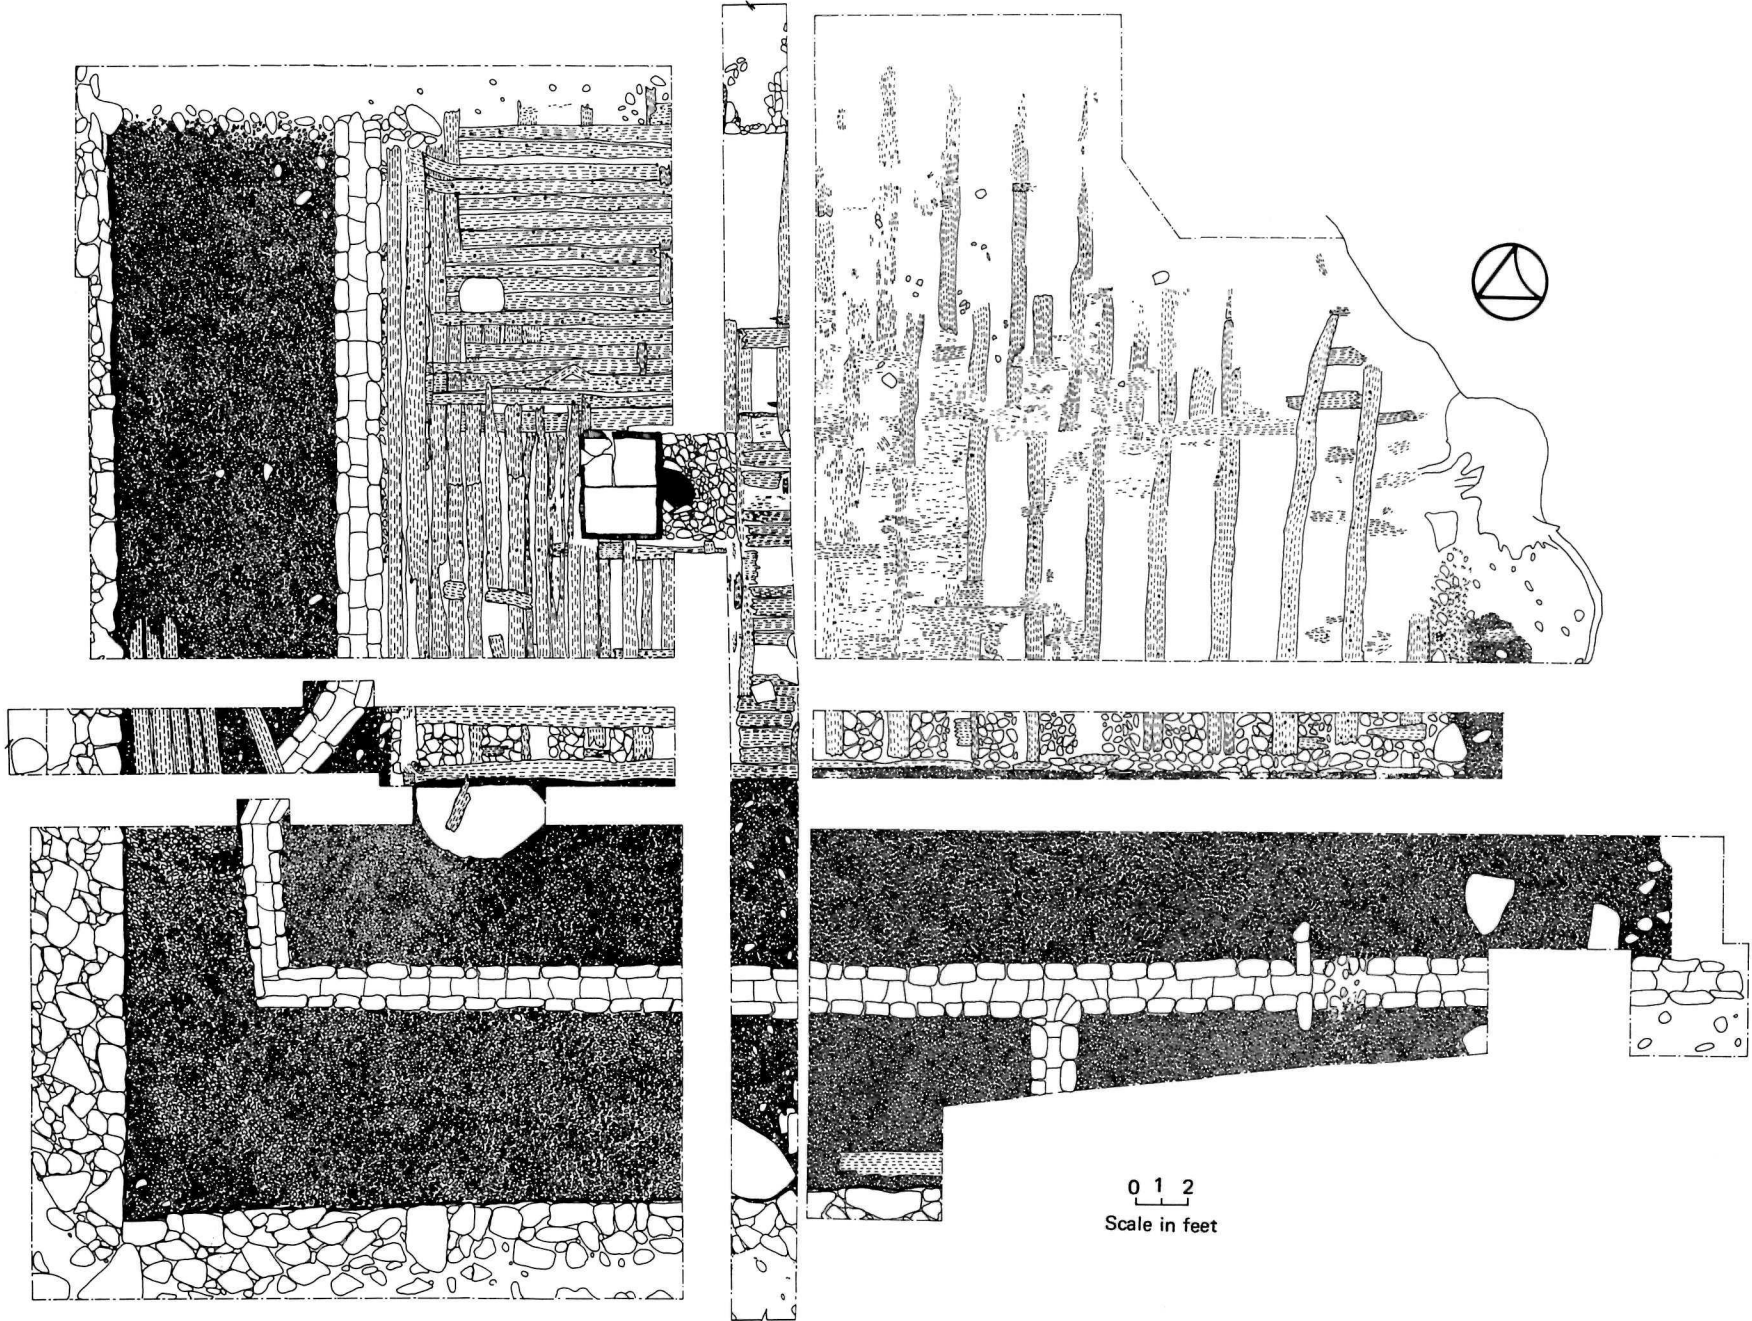
41 Plan of the distillery-brewery-storehouse.

In 1967, the project excavated the building constructed in 1845 to 1846 on the north bank of the creek near its mouth which according to Miquelon (1970) and Ingram (1970b) was probably a distillery (Fig. 4; item 16). For reasons discussed by Ingram, the building served several functions, none of which was evidently distilling or if so, not on a commercial scale. His evidence indicated that brewing and general storage were its primary uses. In 1928, Watson described it as a dwelling as well as a brewery (Fig. 2; item 133). Miquelon and Ingram both noted its use for the general company activities which were displaced by the arrival of the military in 1846.

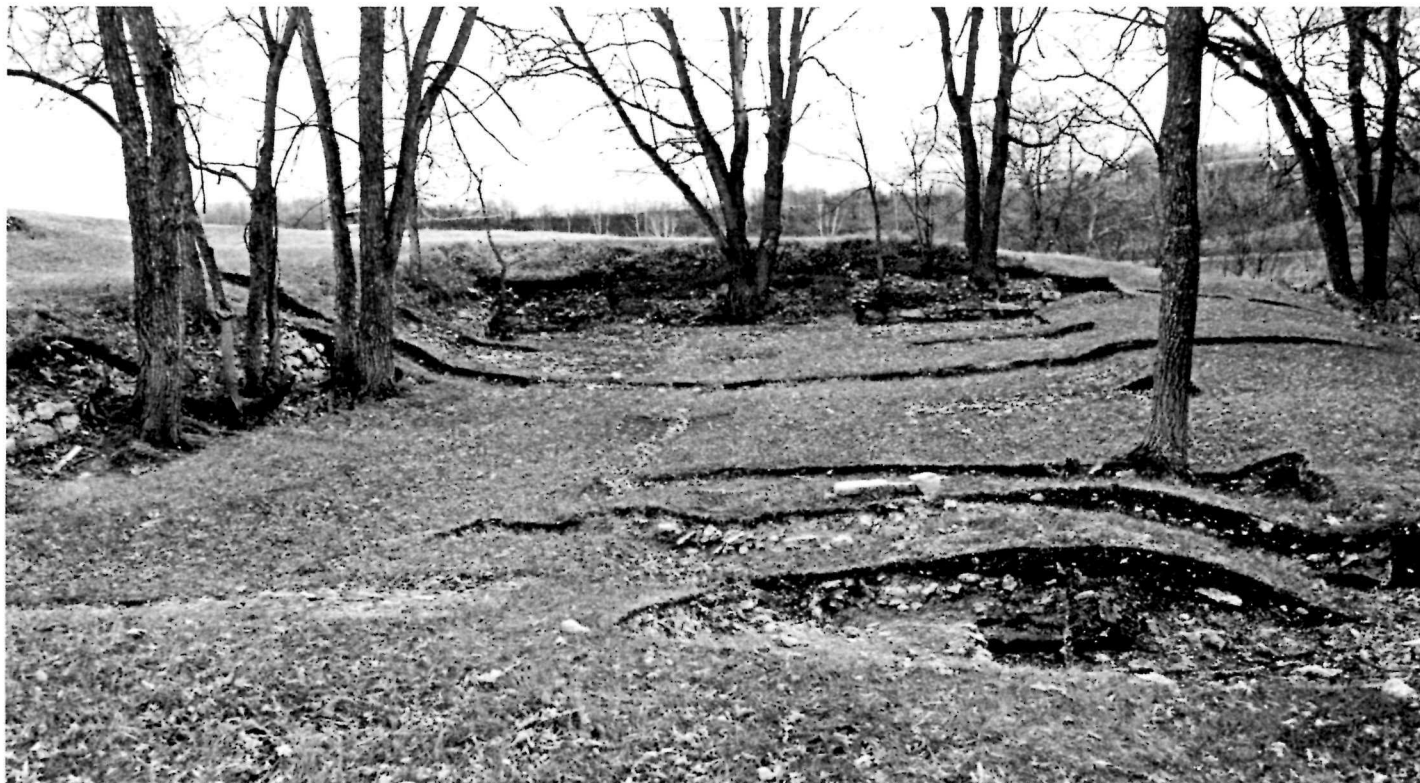
42 Looking east across the storehouse depression along the north bank of the creek.

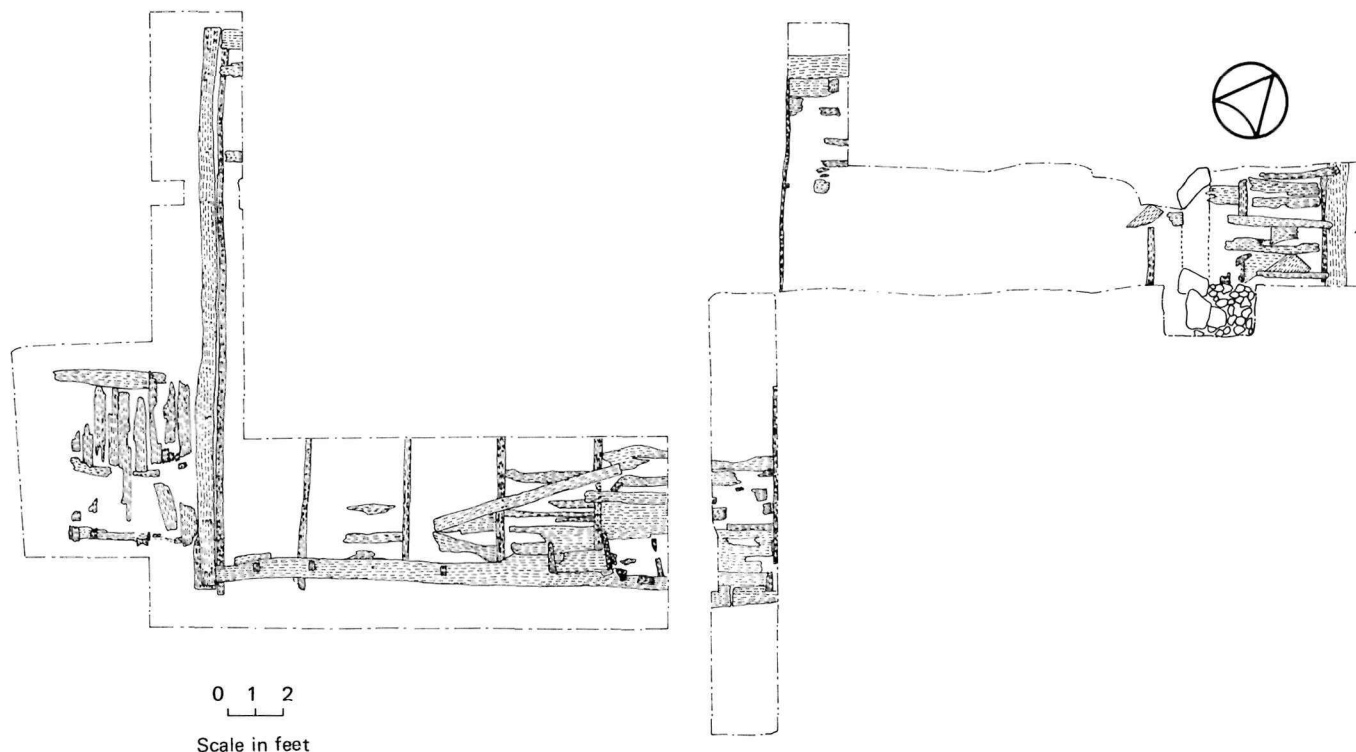
43 Plan of the beer cellar.

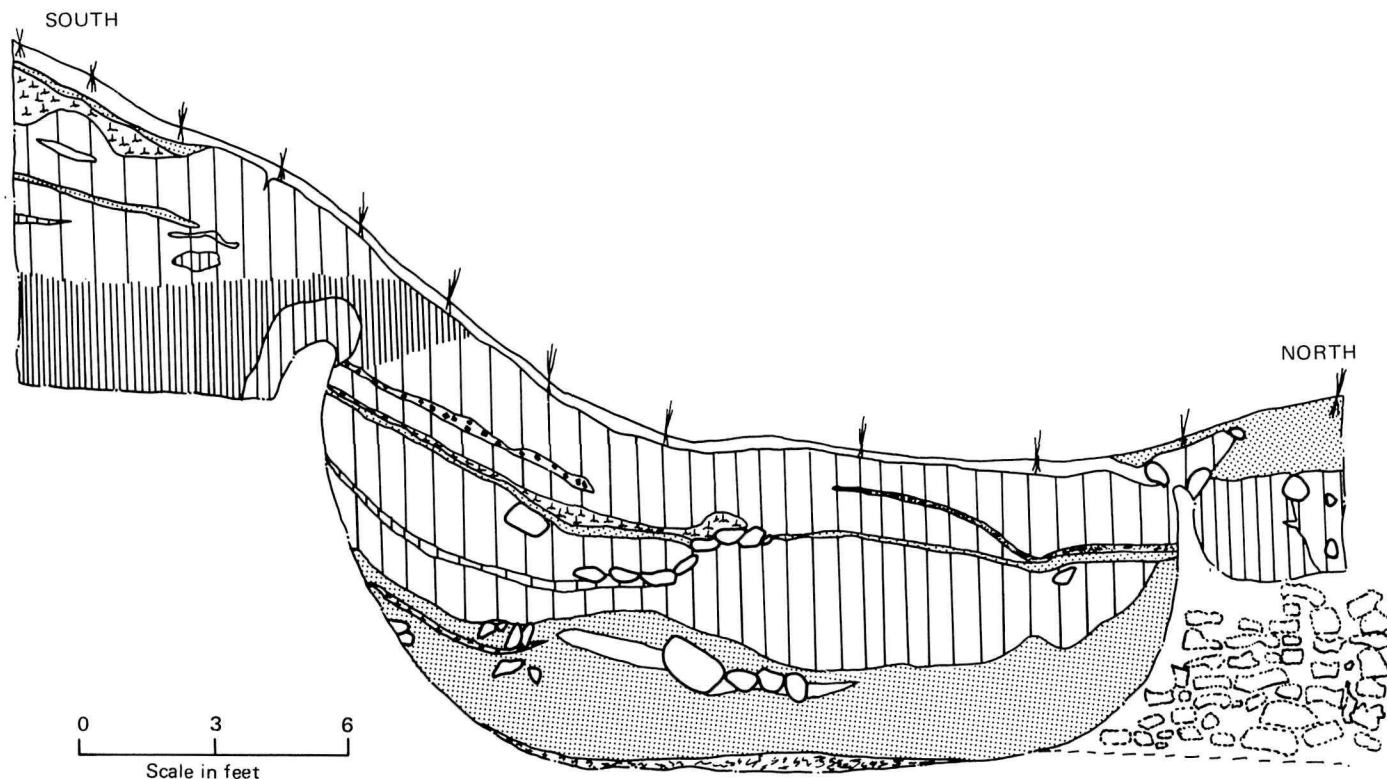
44 North-south profile of the west lime kiln.

The upper margins of the kiln were deteriorated, but from what was left one could determine that the kiln was 18 ft. in diameter and at least 8 ft. deep. Where measurable, the basin-shaped mortar and granitic boulder lining was 0.4 ft. to 0.7 ft. thick. The earth outside the lining was baked red. The fill consisted of pure lime on the bottom. Above this were slumped

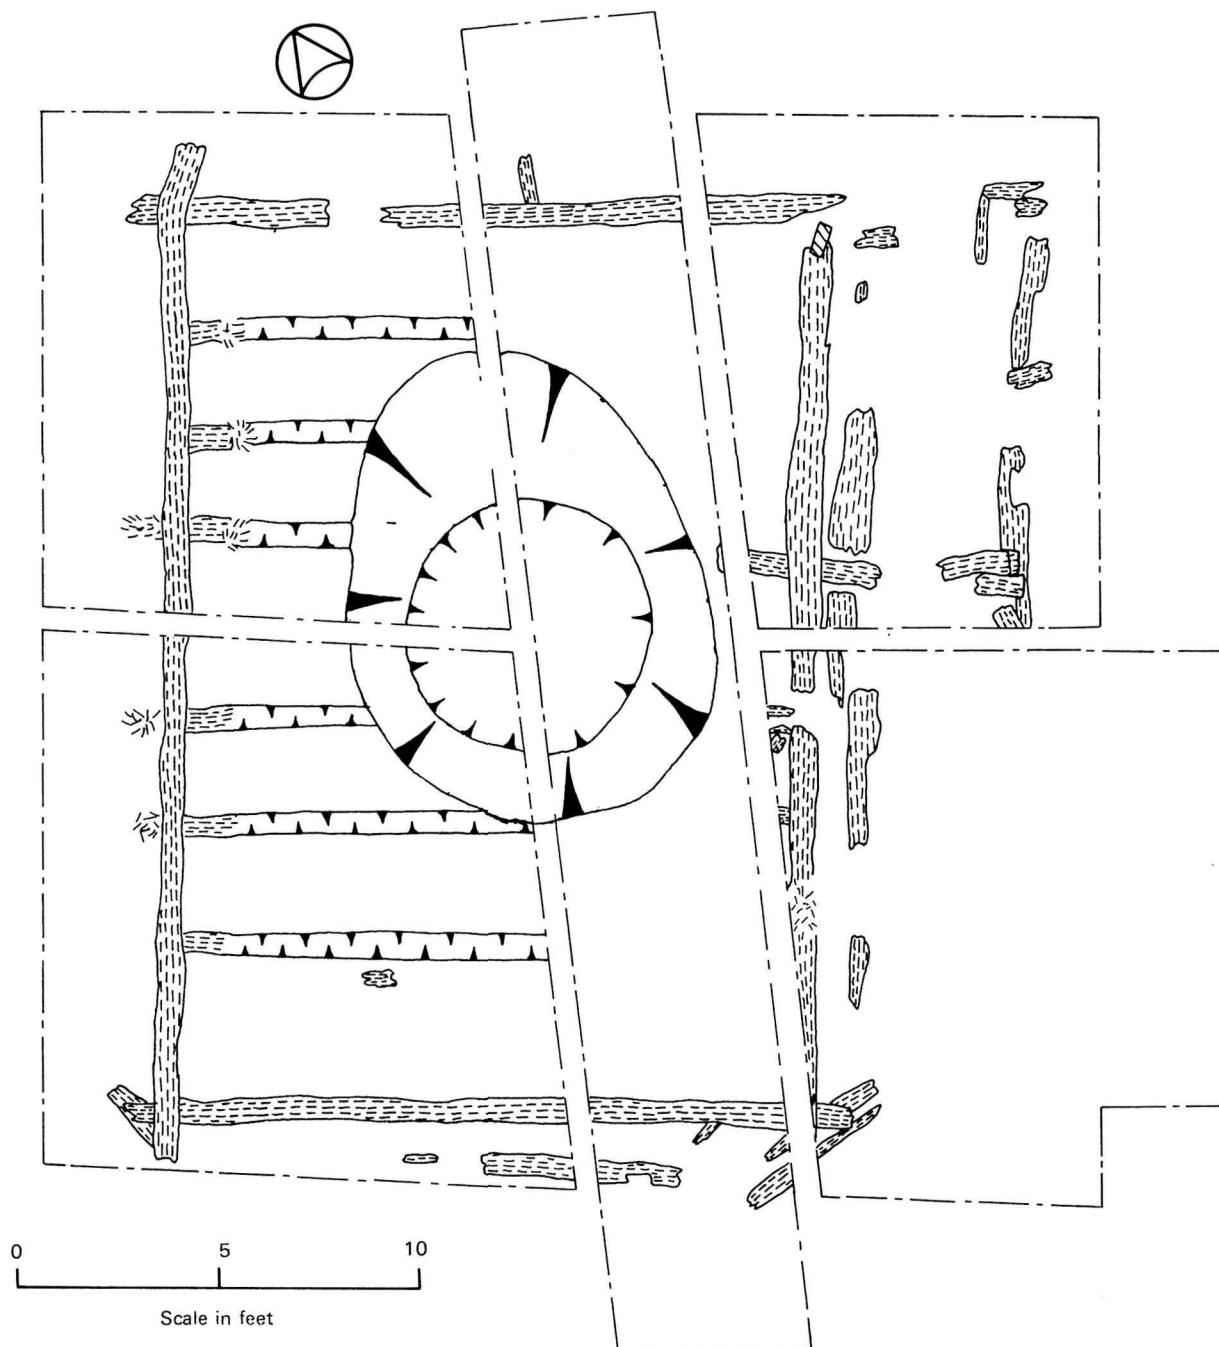
46 Plan of the miller's residence.

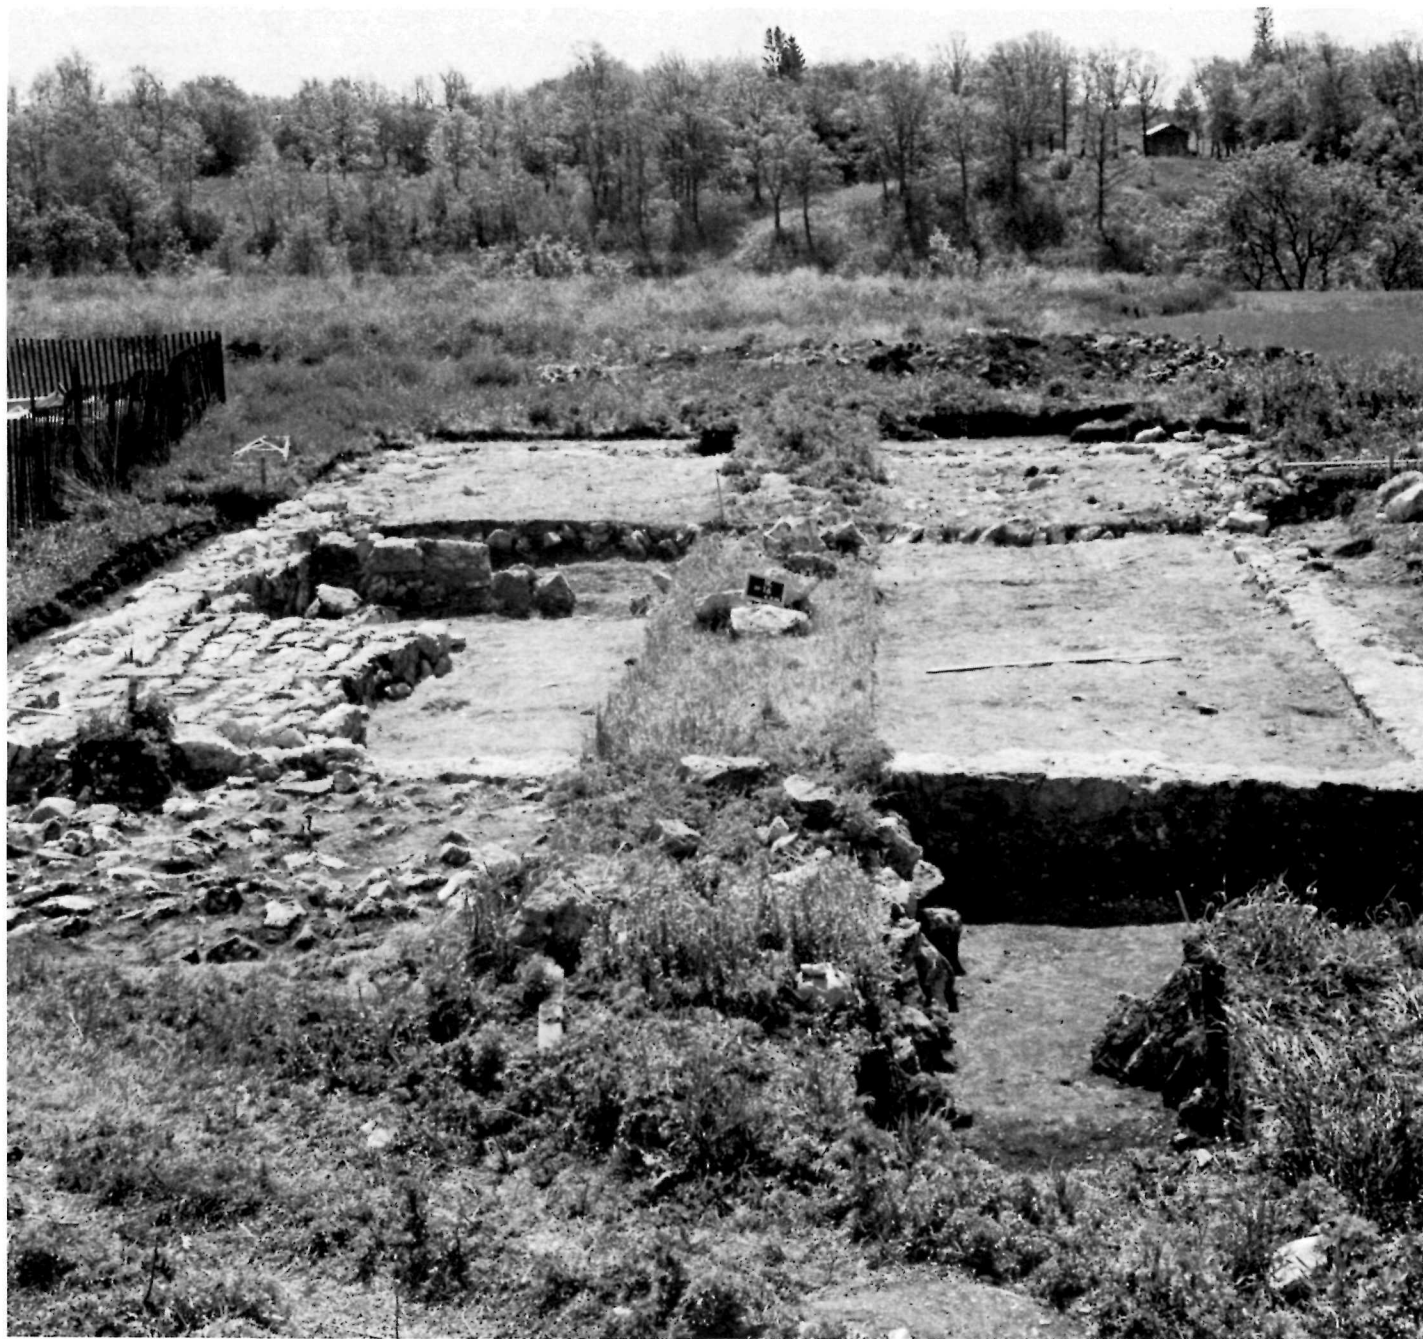
48 Horse stable looking east.

Excavations (Figs. 48, 49) revealed that the stable only approximated the dimensions described above. Outside measurements on each foundation were

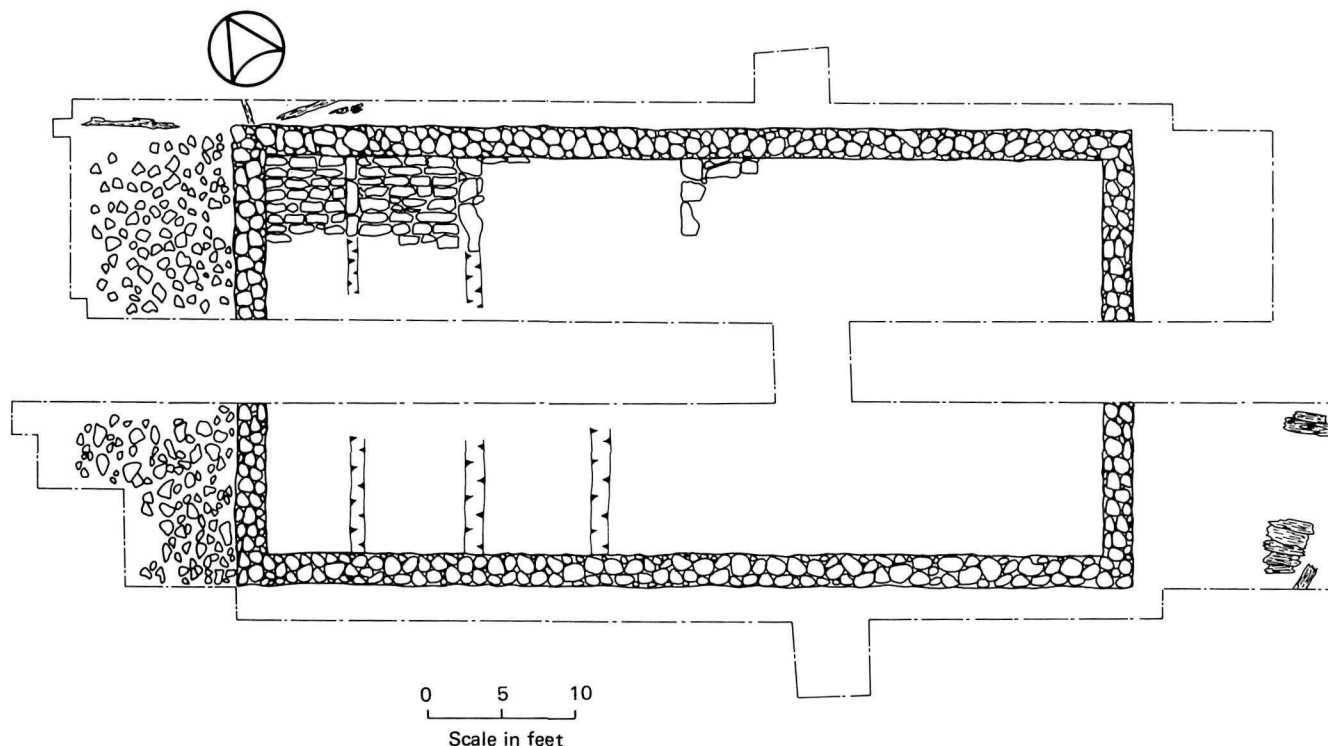
49 Plan of the horse stable.

as follows: south 60.7 ft.; north 61.5 ft.; east 31.2 ft., and west 31.0 ft. The structure thus did not have perfectly square corners. Width of the top of the foundation was consistent at 2.1 ft. It was 2.5 ft. to 3 ft. deep and there was an interior and an exterior shelf on the north foundation so the base was 3 ft. wide.

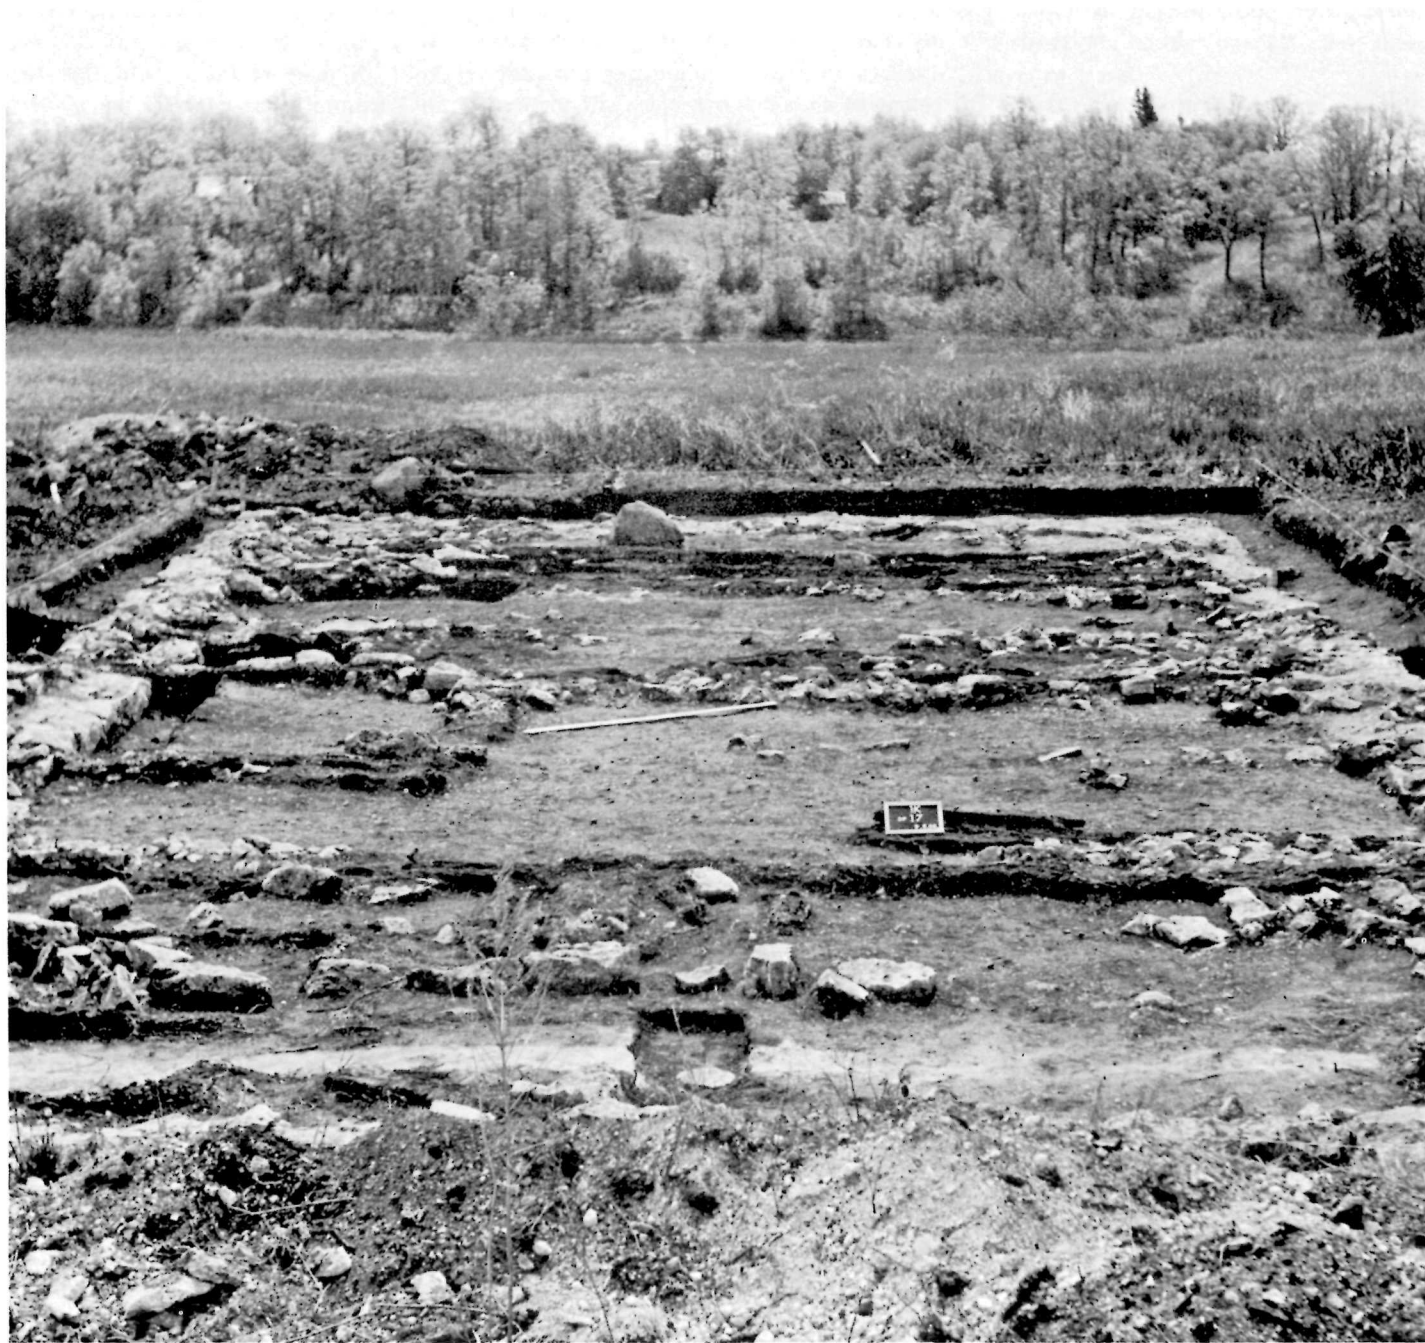
50 Ox stable looking east.

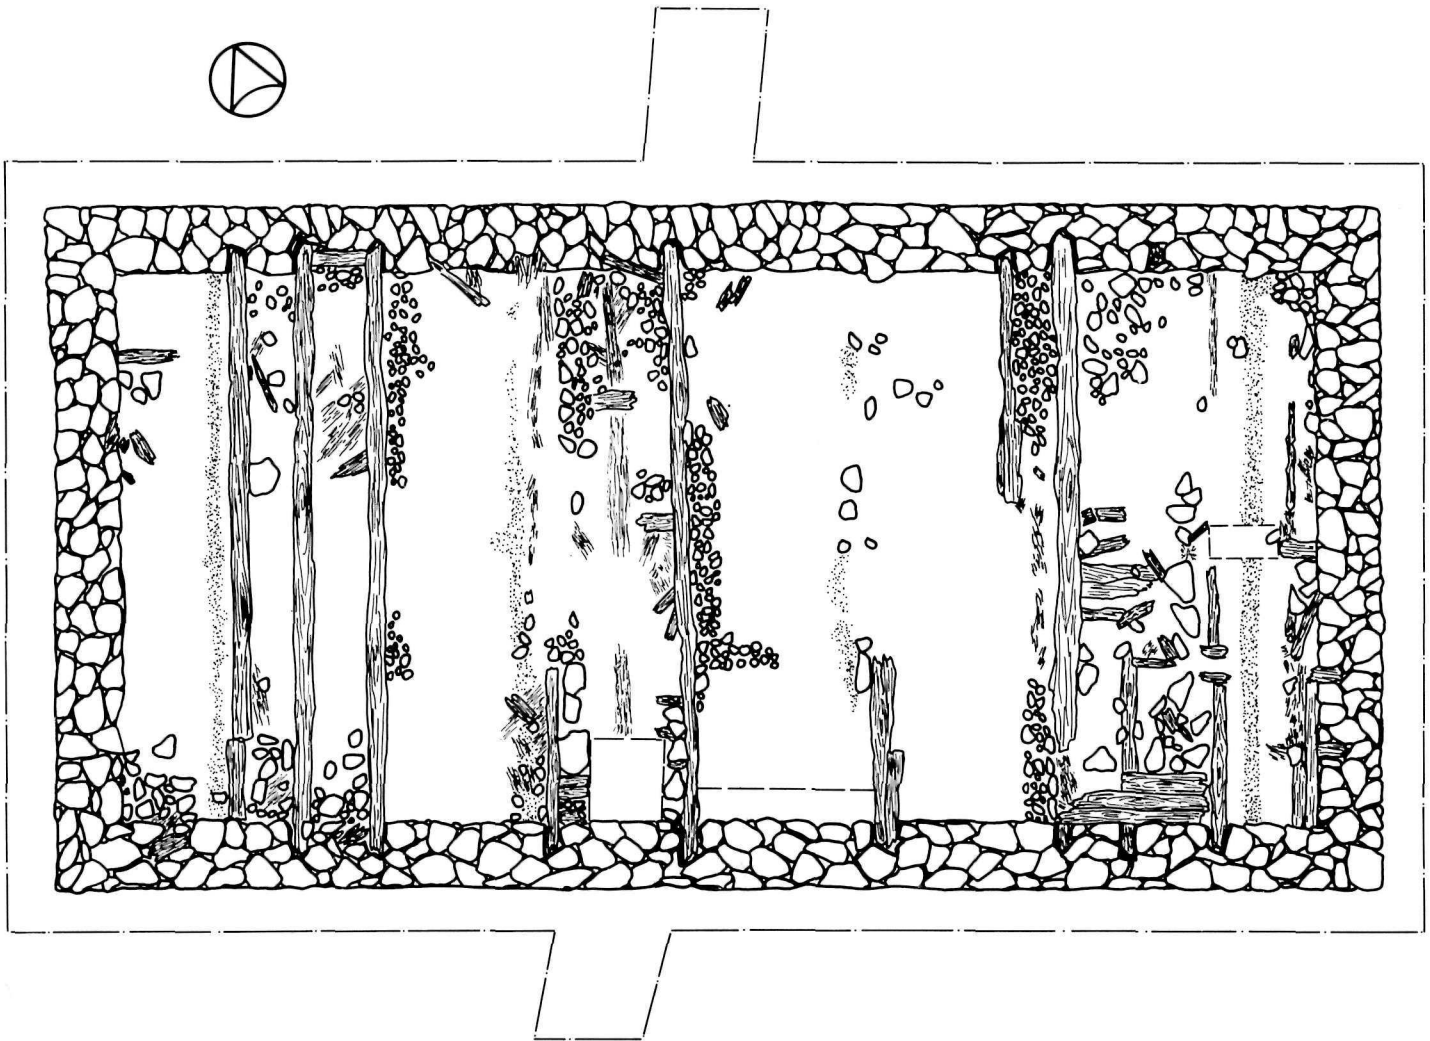
51 Plan of the ox stable.

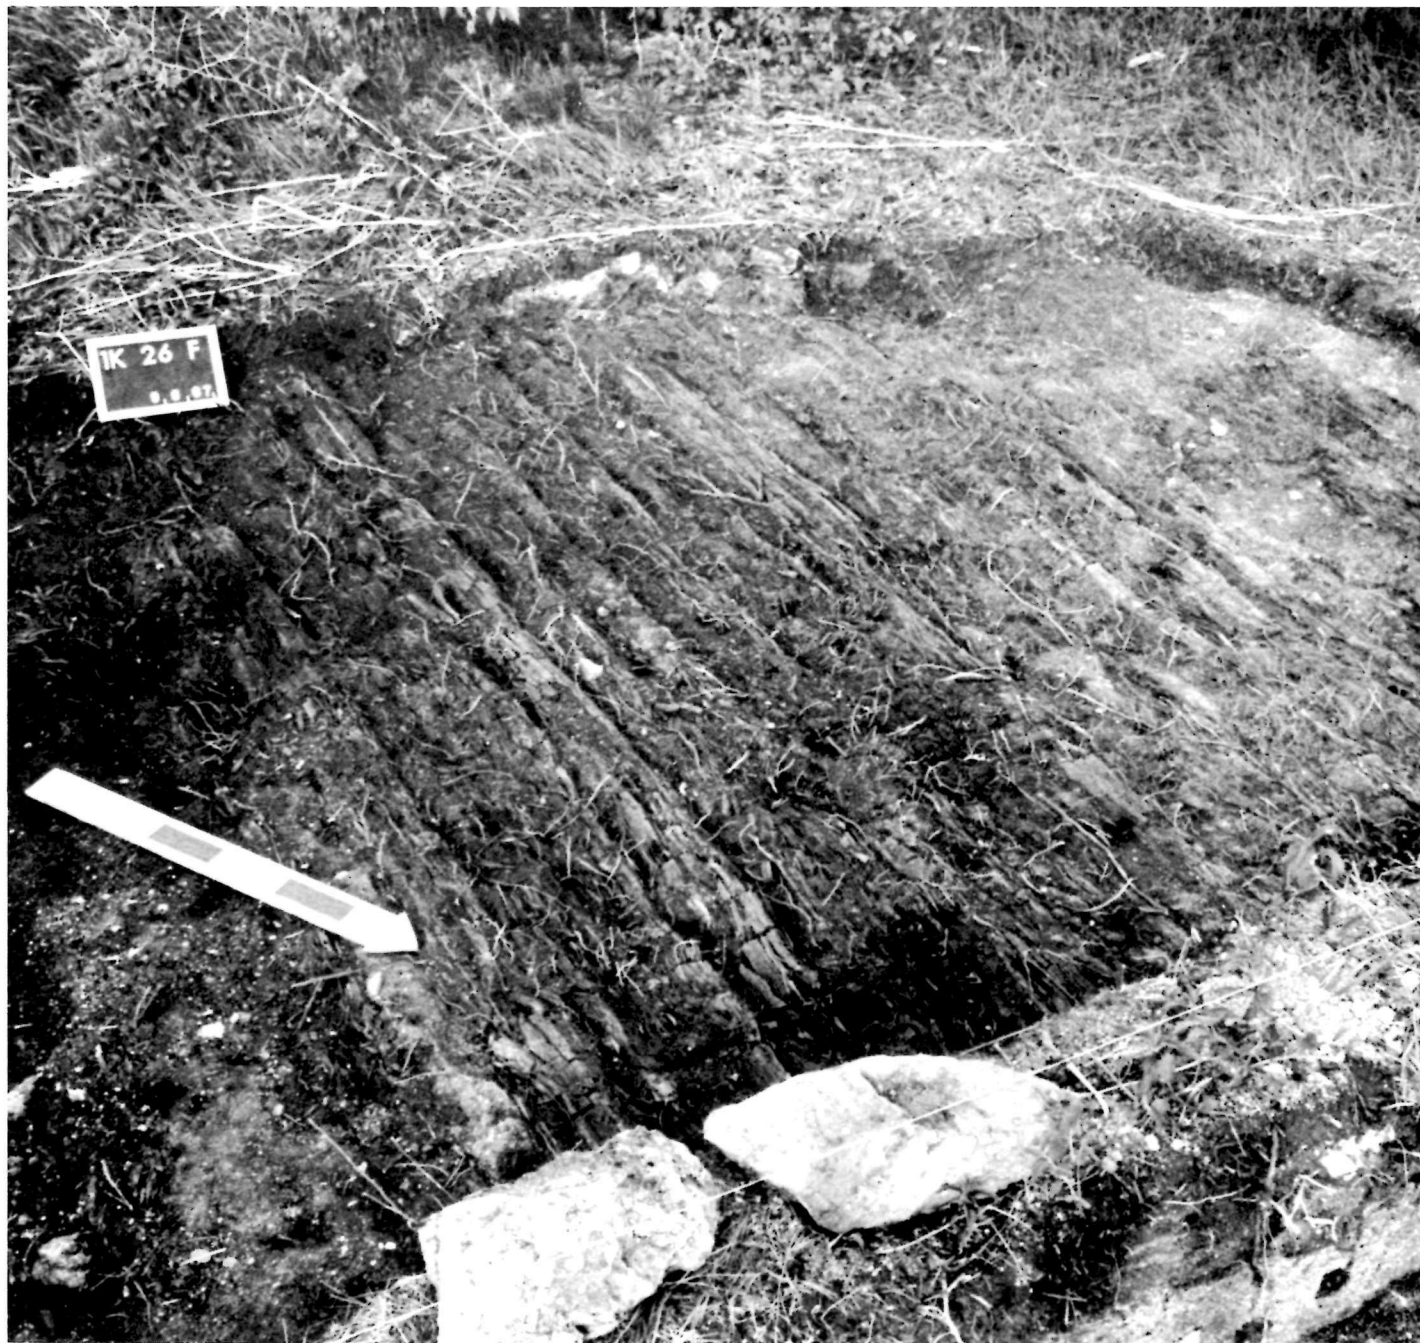
54 North cow barn showing the nature of the log flooring.

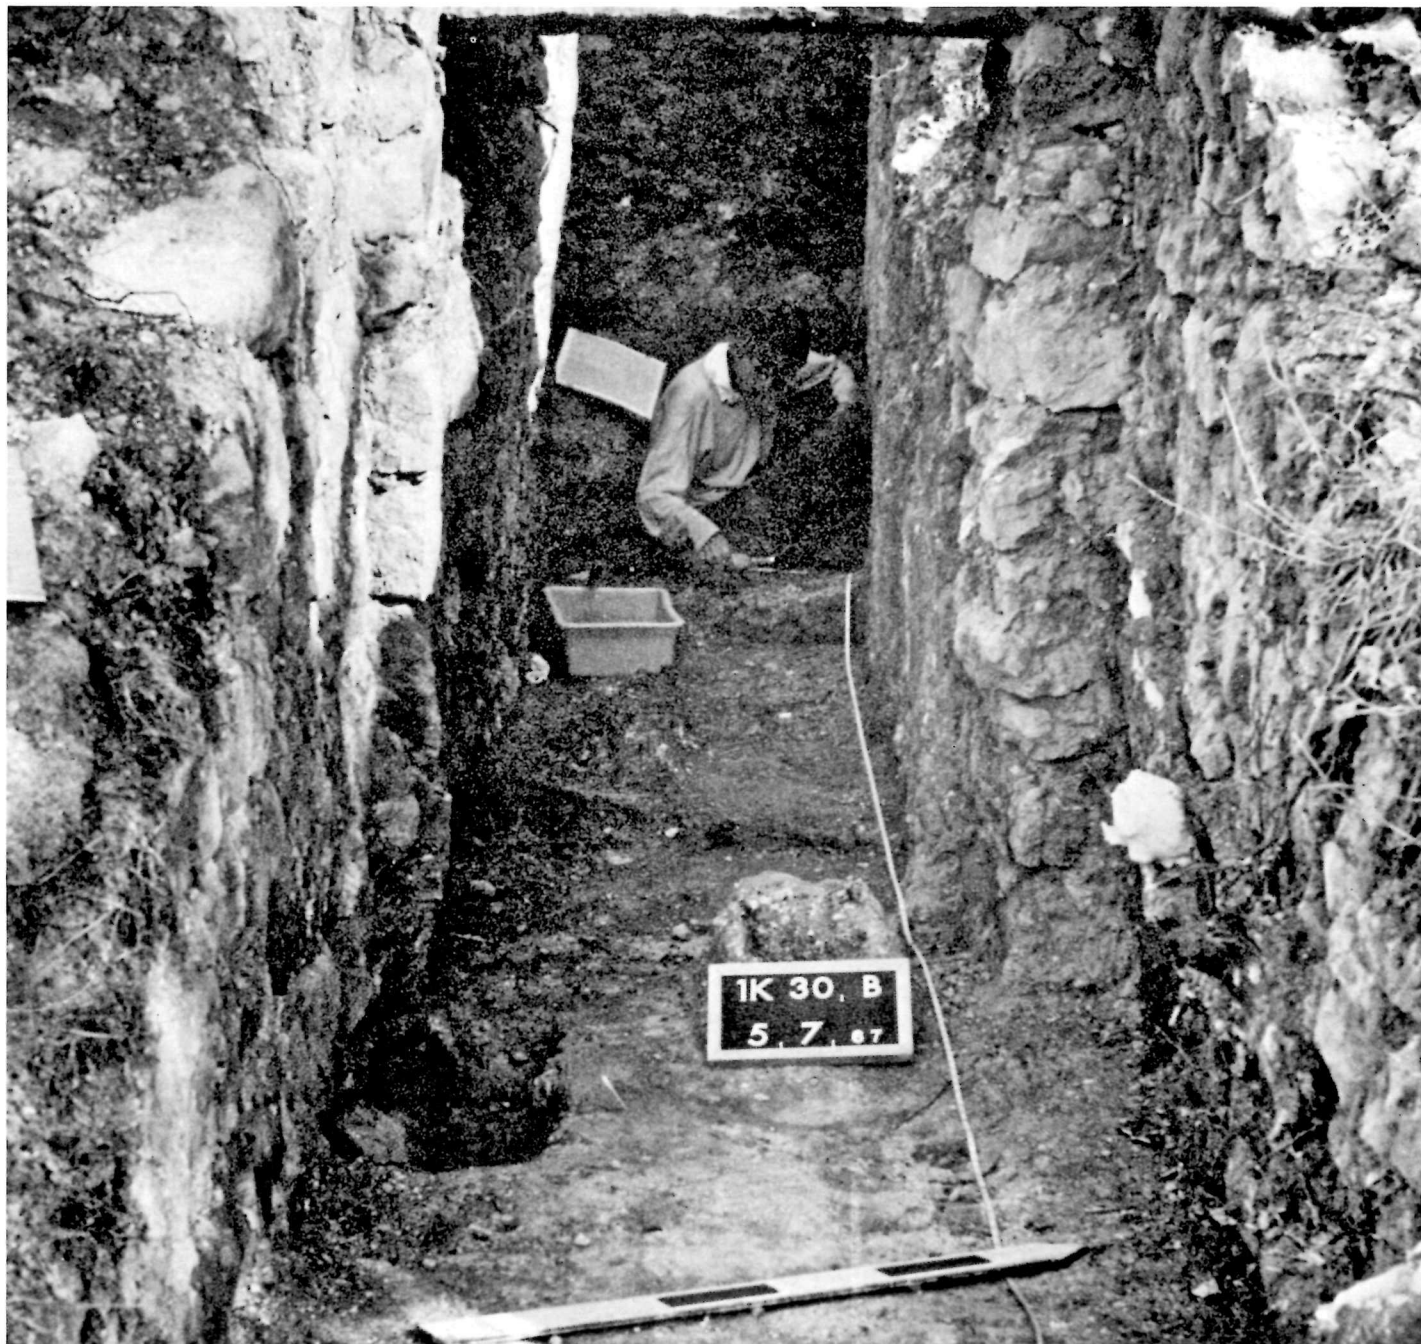
55 View into the entranceway of the prison  
root house.
