TP 185E
Issue 1/2018

AVIATION SAFETY LETTER

GENERAL AVIATION—SPECIAL EDITION

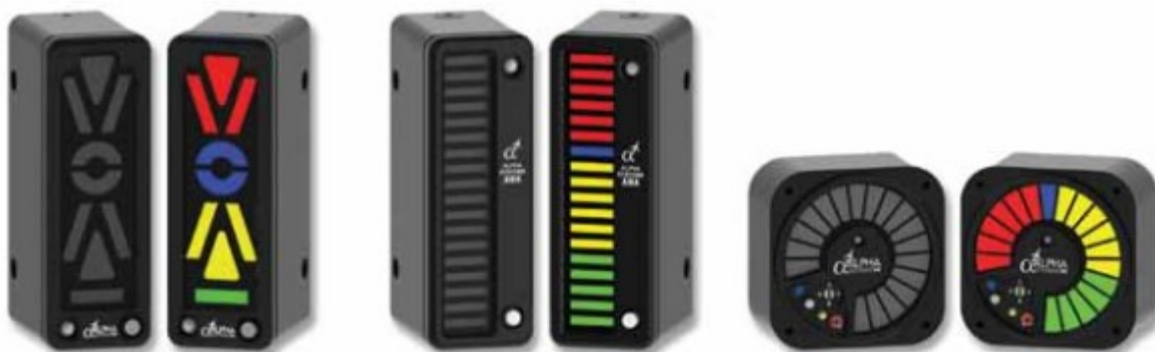
Example of some AOA indicators that could be viewed in a cockpit. The color ranges indicate the available lift reserve: green is normal, yellow indicates a gradual reduction in lift (the pilot is pulling too hard), and red indicates approaching the critical angle of attack (the wing is about to stall).

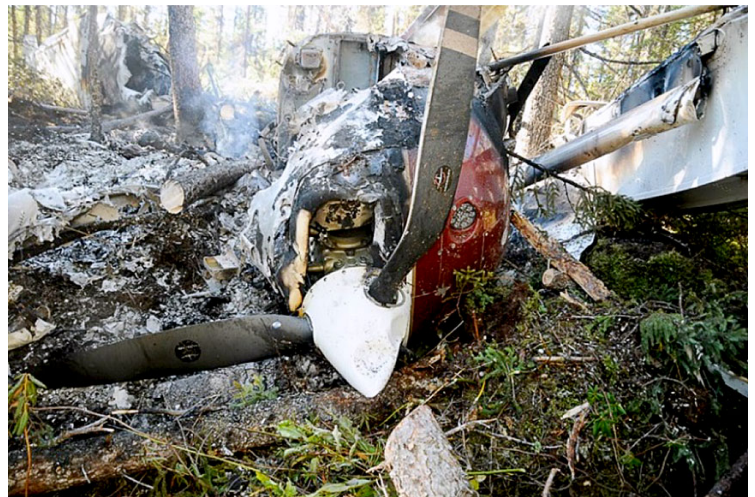
Figure 2: View of engine and propeller

The 3-blade propeller was coupled to the engine. An examination of the propeller at the accident site and at the TSB Engineering Laboratory did not reveal any signs of rotation at impact. The blade that was perpendicular to the top of the engine was not bent or twisted. The 2 other blades were bent backward and showed no sign of torsion (Figure 2). There were no further indications of propeller rotation observed on the trees or ground.

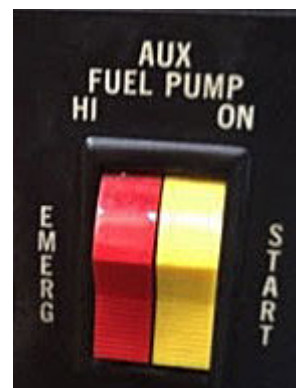
Figure 3. Auxiliary fuel pump switch

"In the event of an engine-driven fuel pump failure during take-off, immediately hold the left half of the auxiliary fuel pump switch in the HI position until the aircraft is well clear of obstacles. Upon reaching a safe altitude, and reducing the power to a cruise setting, release the HI side of the switch. The ON position will then provide sufficient fuel flow to maintain engine operation while maneuvering for a landing."

In this occurrence, to prevent the fuel-air mixture from becoming too rich, the auxiliary fuel pump was not running when the engine-driven fuel pump failed, because the use of the auxiliary fuel pump during takeoff was counter-indicated by Cessna.
