TP 185E
Issue 2/2018

AVIATION SAFETY LETTER

In this Issue...

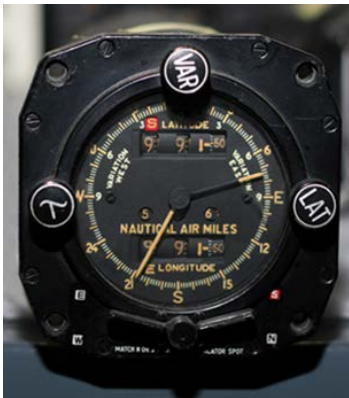
Air Position Indicator

Radium-painted gauges, dials, and switches, such as these, have been around since at least World War I when they were first employed in aircraft. △

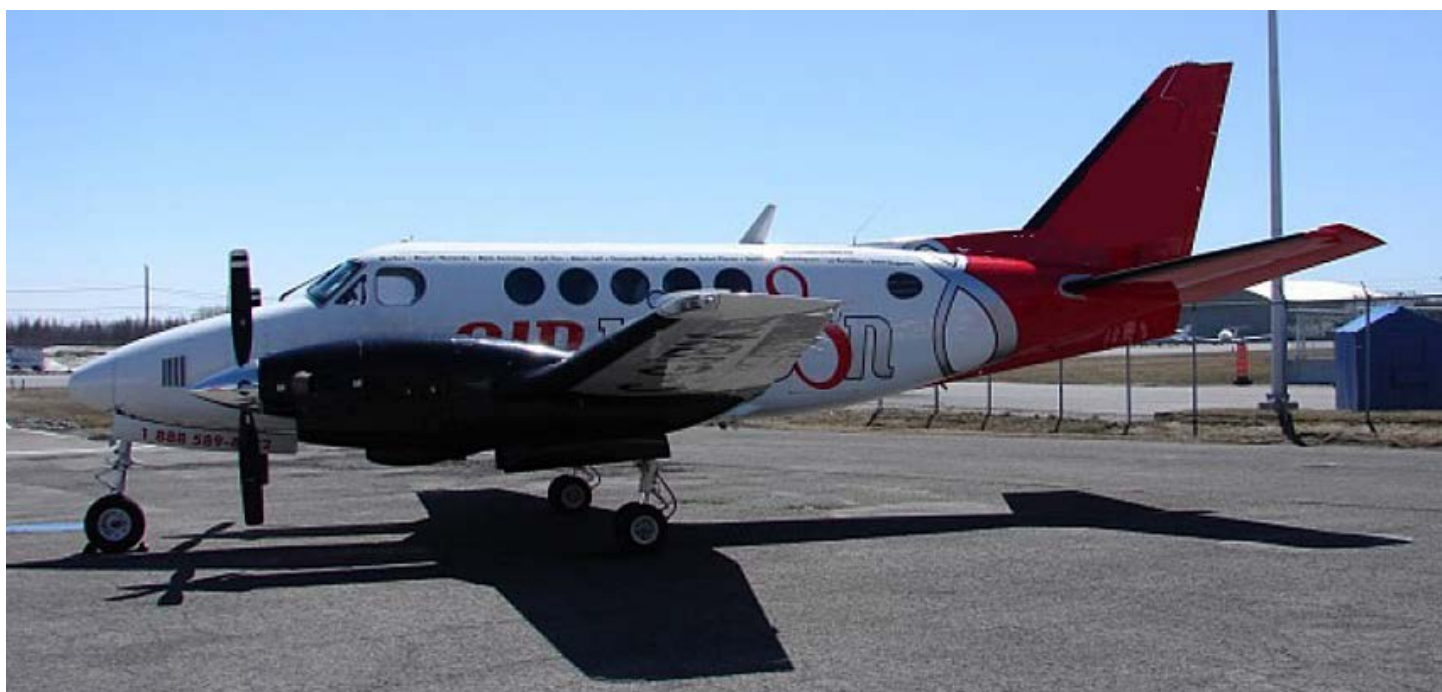
Figure 1. Source: Sky Jet M.G. Inc.

A Beechcraft King Air A100 (Figure 1) as Flight SJ512, was on an instrument flight rules flight from Rouyn-Noranda Airport (CYUY) (Quebec) to Quebec/Jean-Lesage International Airport (CYQB) (Quebec) with 2 pilots and 6 passengers on board.

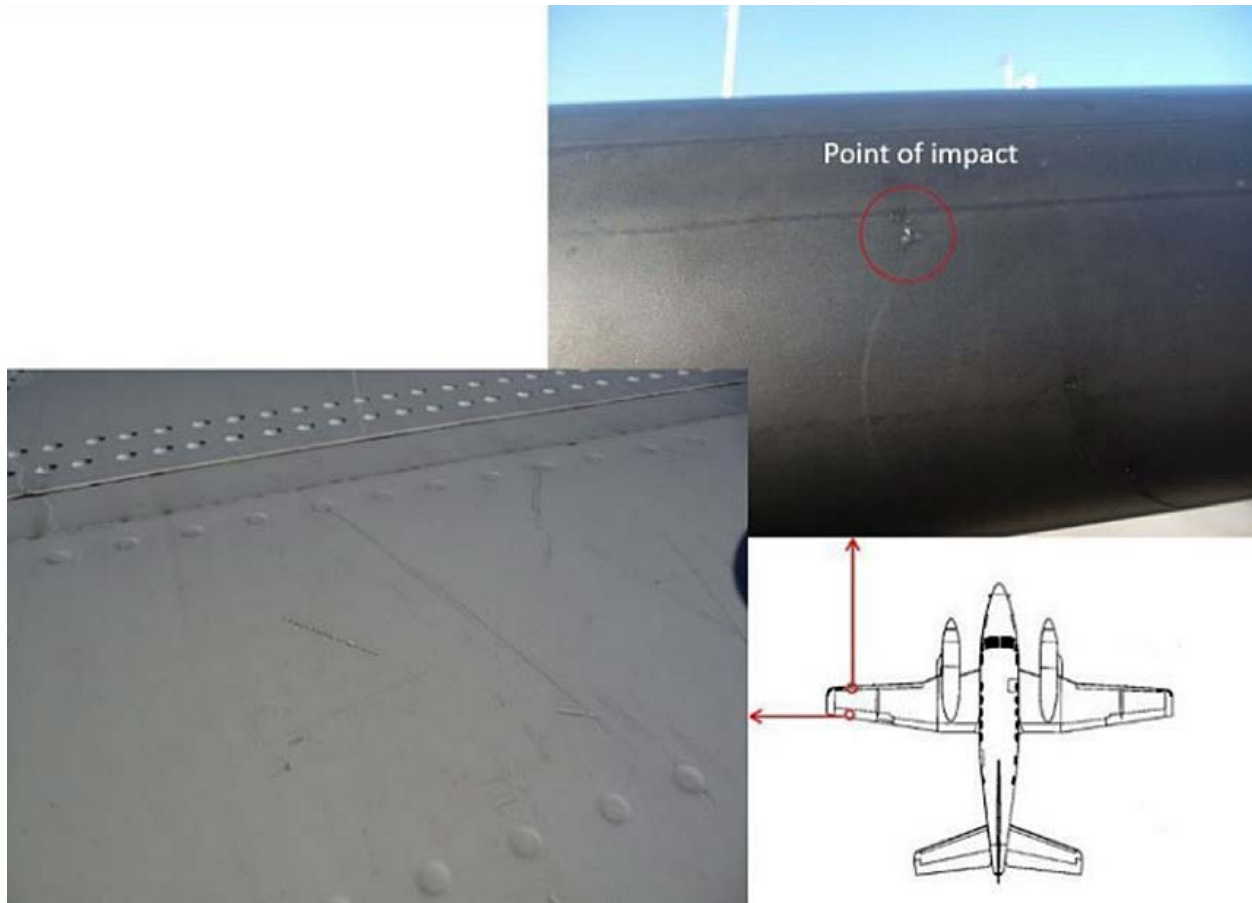
Figure 2. Damage to the aircraft (Source: Transport Canada, with photo montage by the TSB)

The damage was limited to a dent at the point of impact on the left wing de-icing boot, as well as scratches on the upper surface of the left wing (Figure 2). The damage was minor and had no effect on the airworthiness of the aircraft.

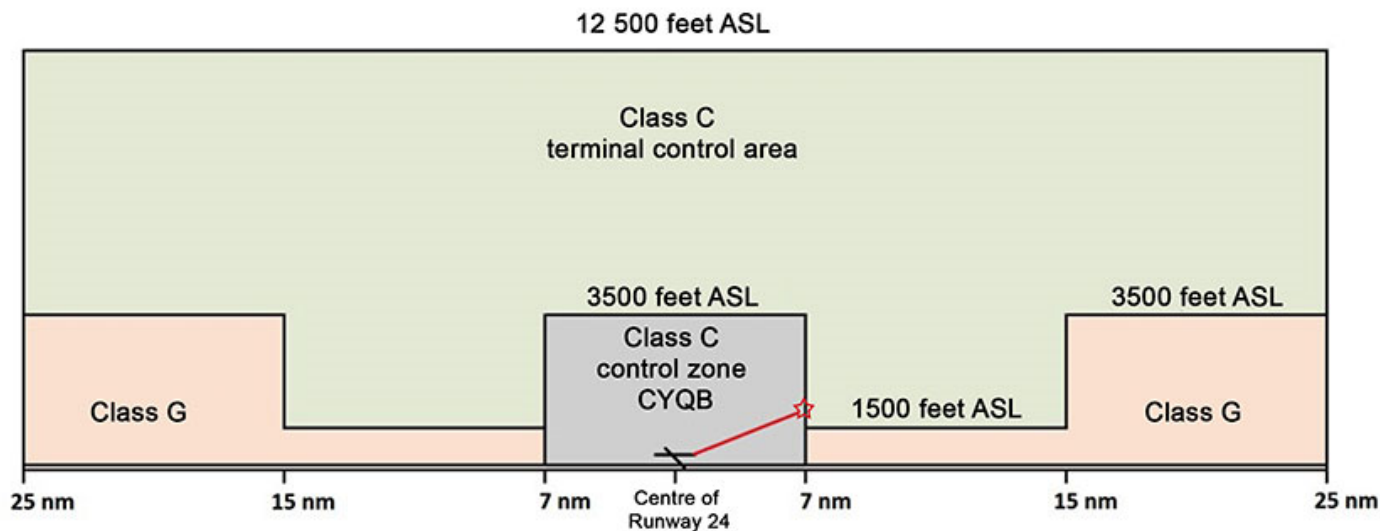
Figure 3. Airspace classification of Québec/Jean-Lesage International Airport.
The red star indicates the location of the collision.

CYQB is located within Class C controlled airspace, which means that all aircraft must obtain authorization from air traffic control (ATC) before entering this airspace. Class G airspace is an airspace within which ATC has neither the authority nor the responsibility to exercise control over air traffic. The collision took place within the Class C control zone (Figure 3).

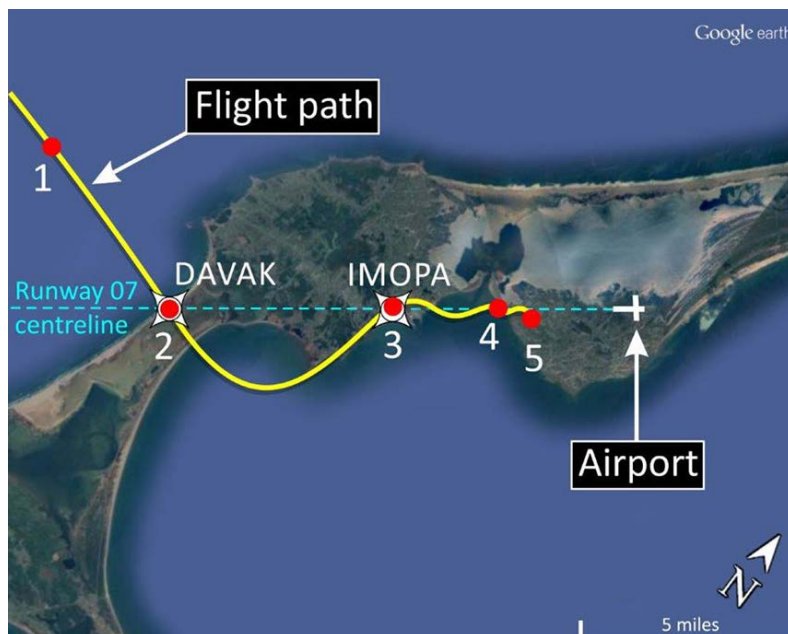
Figure 1. Flight path (Source: Google Earth, with TSB annotations)

1. 4.7 NM from DAVAK, 6 800 ft ASL, 240 kt, 2 500 ft per min descent
2. At DAVAK, 4 500 ft ASL, 238 kt, 1 600 ft per min descent (1 500 ft above the published crossing altitude, about 100 kt above the recommended approach speed)
3. At IMOPA, 2 200 ft ASL, 188 kt, 1 900 ft per min descent (790 ft above the published crossing altitude, about 50 kt above the recommended approach speed; gear and flaps should be set)
4. 2.7 NM from the runway, 1 440 ft ASL, 1 200 ft per min descent, 175 kt, gear and flaps selected (the aircraft should be levelling at 620 ft ASL and slowing to 125 KIAS)
5. Impact: 1.4 NM from the runway and about 1000 ft south of the centreline

At 12:27:14, the aircraft crossed DAVAK on a heading of 114°M at 4 500 ft ASL—1 500 ft higher than the published procedure crossing altitude. The aircraft was descending at 1 600 ft per min and at an airspeed of 238 kt—about 100 kt above the recommended approach speed of 140 KIAS. This resulted in the aircraft deviating significantly from the inbound course of 072° and subsequently proceeding on a meandering flight path.

Almost immediately afterwards, the aircraft crossed IMOPA—the final approach waypoint, 4.2 NM from the runway—at 2 200 ft ASL, which is 790 ft above the published crossing altitude of 1 410 ft ASL. The aircraft was descending at 1 900 ft per min, the speed was 188 kt—

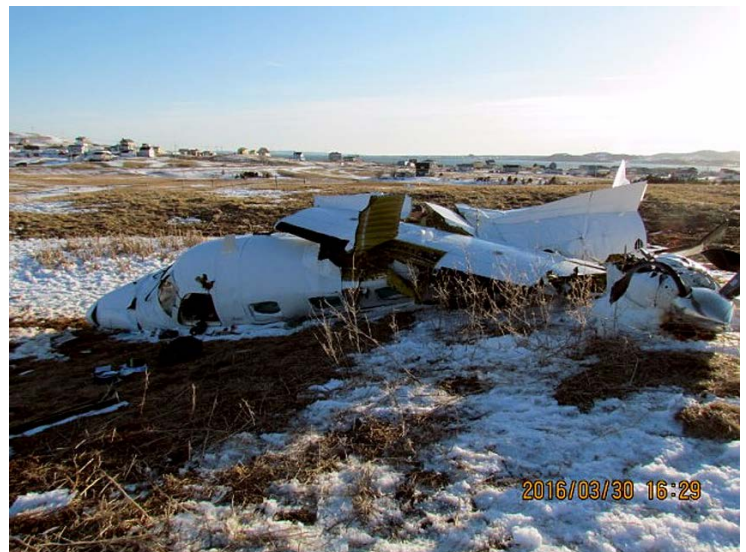
Figure 2. Accident site

During the approach to Runway 07, the aircraft struck the base of a hill in a left-wing-low, nose-high attitude, 1.4 NM west and 1 000 ft south of the runway centreline. The aircraft momentarily became airborne again, then struck the ground and slid for about 100 ft before coming to rest.

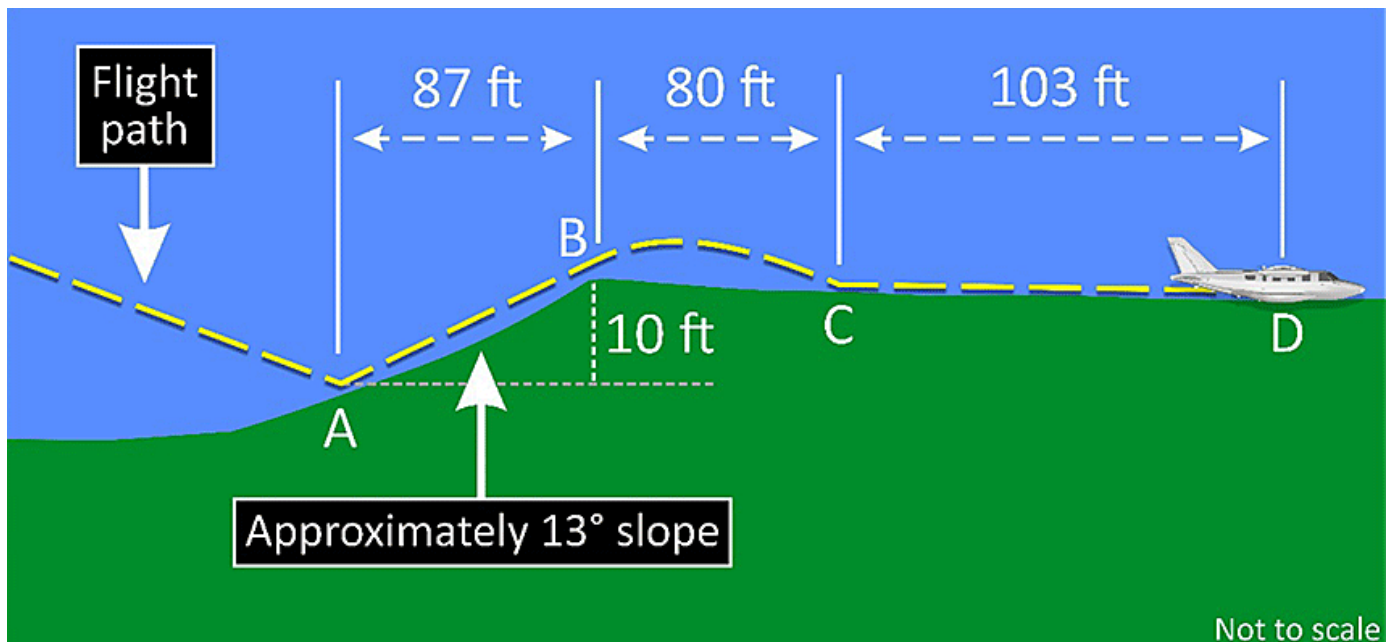
Figure 3. Impact sequence

- A. First point of impact
- B. Top of slope and end point of initial ground scars (aircraft airborne)
- C. Second point of impact
- D. Final resting position of main aircraft wreckage

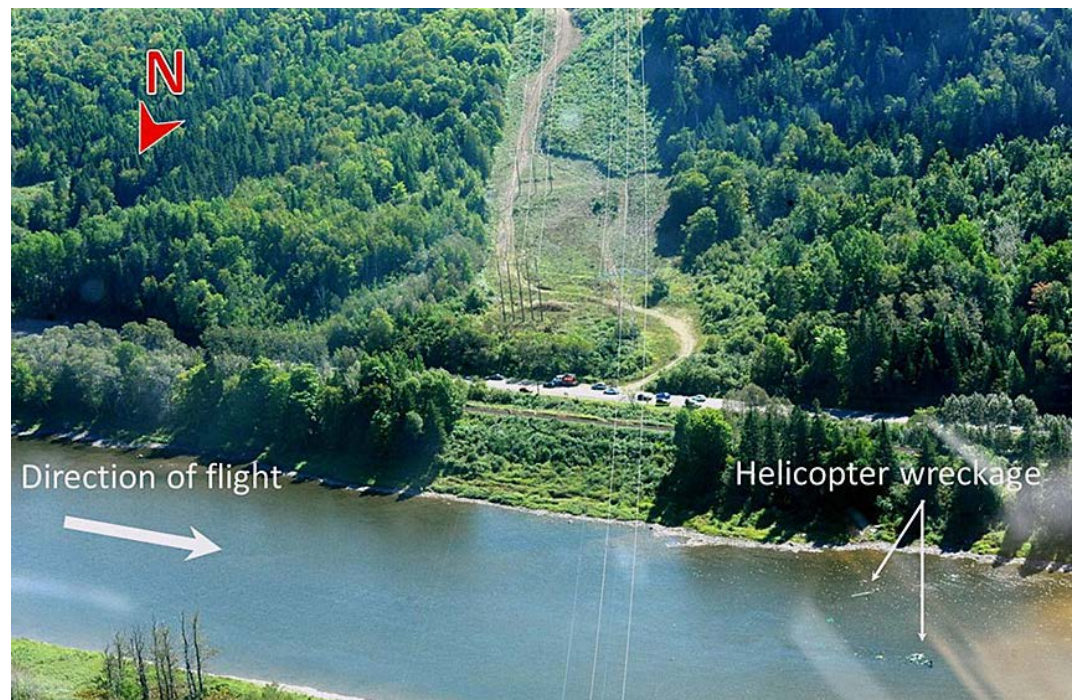
Figure 1. Aerial photo of occurrence site (Source: NB Power, with TSB annotations)

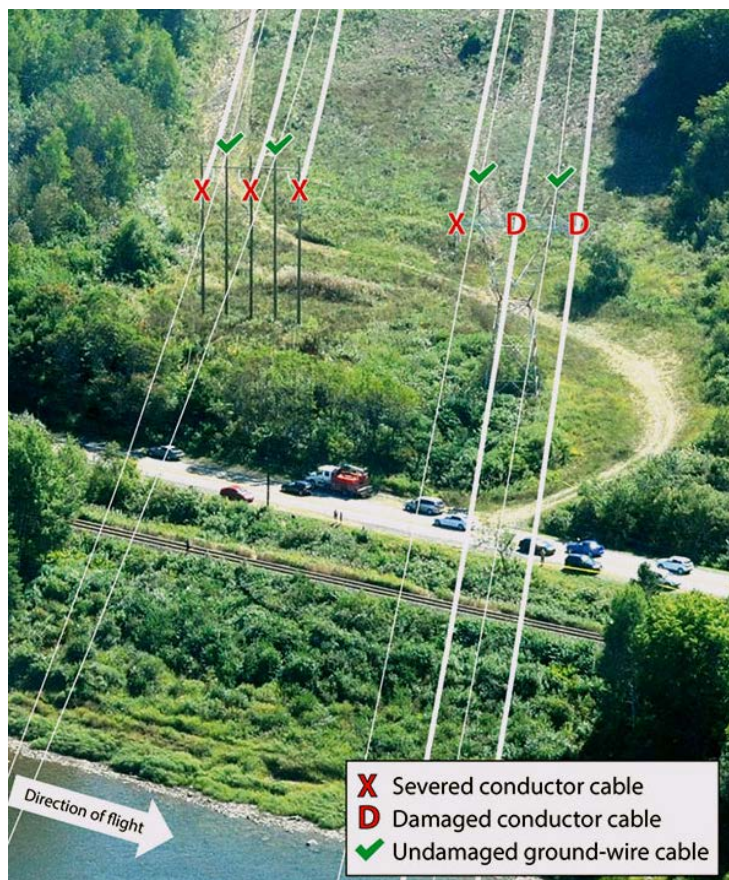
Figure 2. The Flatlands-Long Island power transmission lines, indicating damaged wires. The conductor cables are represented by thick white lines, and the ground-wire cables by thin white lines. (Source: NB Power, with TSB annotations)

The helicopter severed 4 of the conductor cables and damaged the remaining 2 conductor cables.

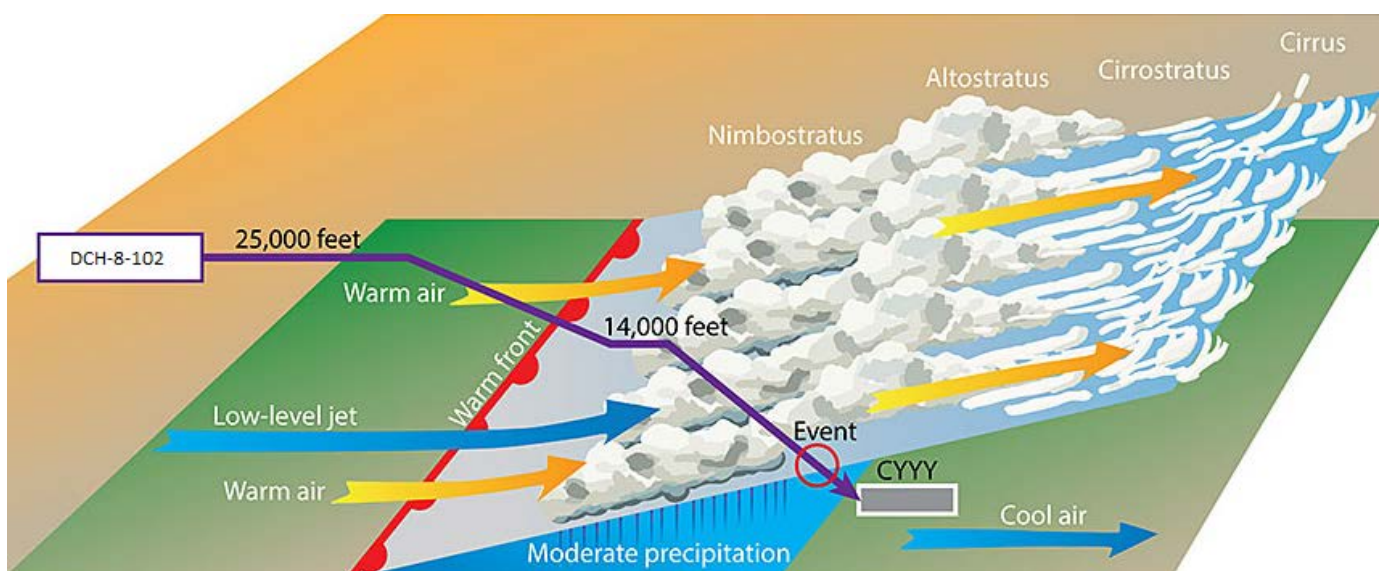
Figure 1 Cross-section of warm front and descent trajectory

Throughout the approach and landing, forecasted meteorological conditions were conducive to moderate turbulence and severe icing below freezing temperatures, as the aircraft was descending through a warm front with embedded altocumulus castellanus (ACC) and a low-level jet stream.
