National  
Defence

ISSUE 2, 2018

# Flight Comment

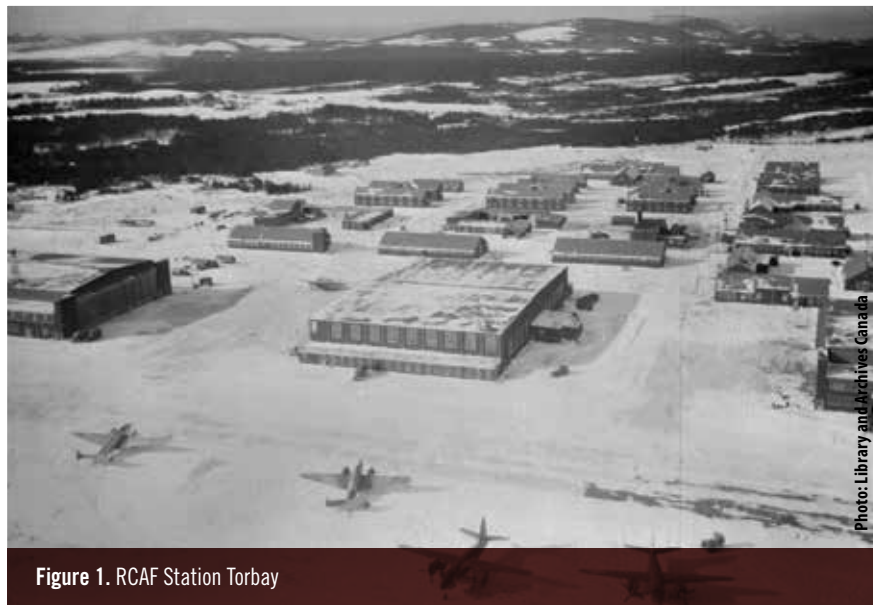
Figure 1. RCAF Station Torbay

Therefore, it was “operations normal” for Eastern Air Command to task 145 Bomber Reconnaissance Squadron of RCAF Station Torbay, Newfoundland (Fig. 1), to carry out four convoy escort missions on 5 August 1943 using its Ventura General Reconnaissance Mark V (GR-V) aircraft (Fig. 2). The twin-engine Lockheed Ventura GR-V was a recent addition to the RCAF’s fleet. Bigger, faster, better armed and better equipped than the Lockheed Hudson it had replaced, the Venturas of 145 Squadron were used for convoy escorts and anti-submarine sweeps. The standard crew was one pilot, one navigator/radar operator and two wireless operators/air gunners. Fitted with two extra fuselage tanks,

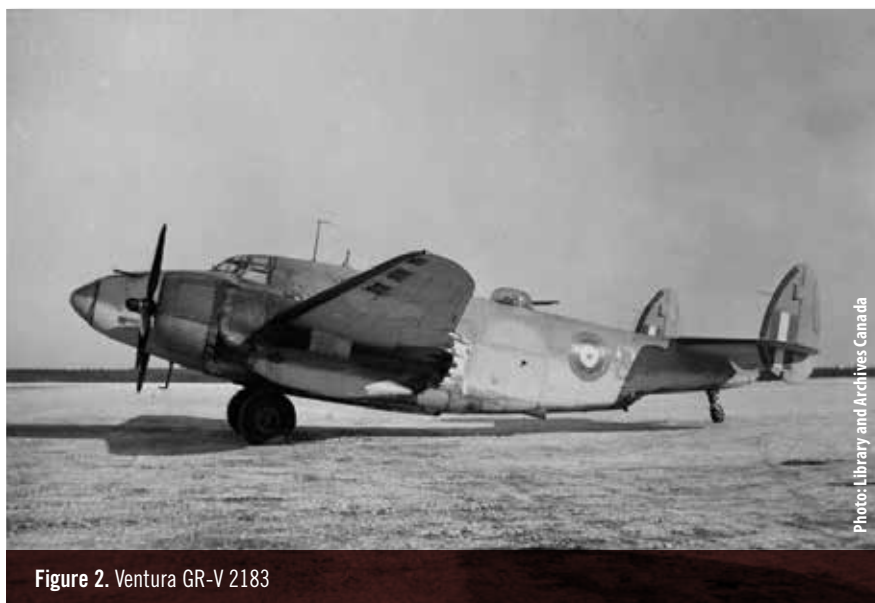
Figure 2. Ventura GR-V 2183

two wing tanks, six depth charges (Fig. 3) and a full internal fuel load (a maximum war load of 31,000 pounds), the Ventura had to be handled carefully to get airborne safely in even the best conditions. When dealing with poor weather, as was often the case, the crew faced even greater challenges.
