TP 185E
Issue 4/2018

AVIATION SAFETY LETTER

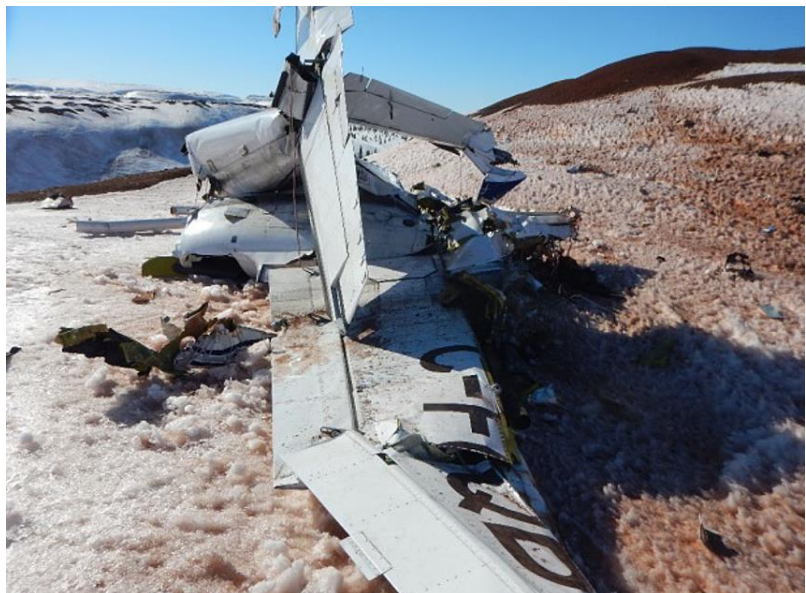
Figure 3. Wreckage

The aircraft wreckage was found at the top of the plateau, about 134 ft east of the initial point of impact with the ground (Figure 3). The left engine was separated from the wreckage (Figure 4) and was found slightly farther away, with the propeller. Sections of the conductor cables were wrapped around the left engine propeller drive shaft.

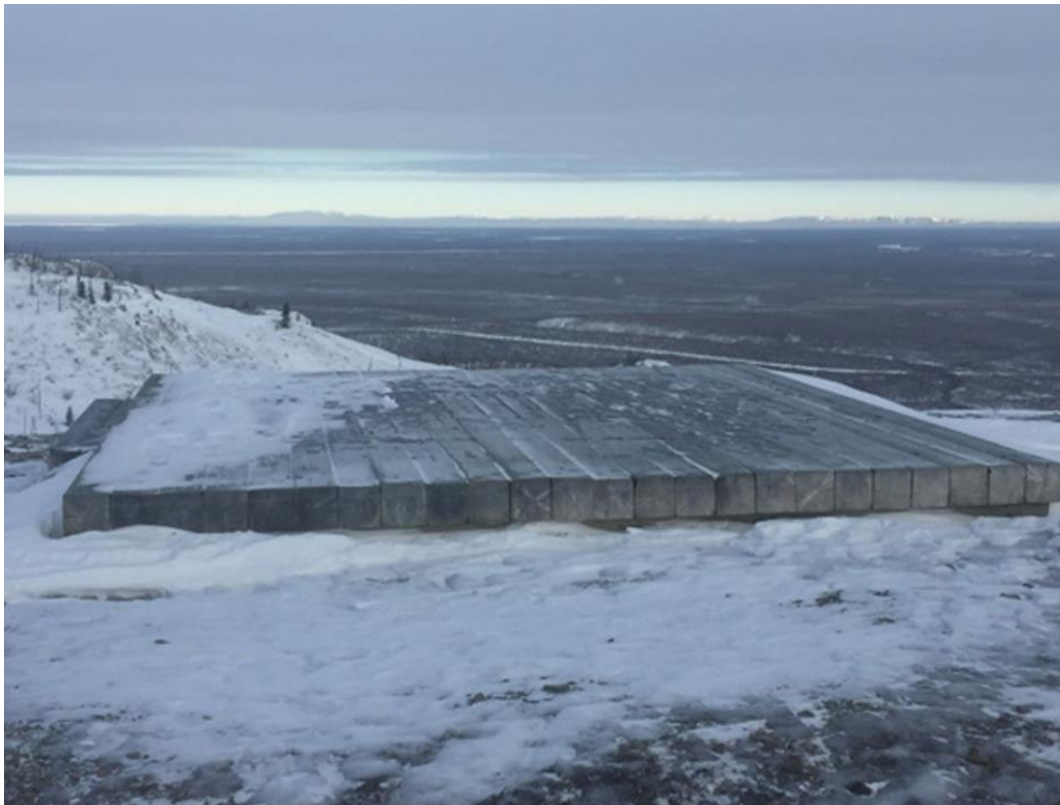
Figure 1. Helipad on Bear Rock

At 09:58, the helicopter landed on a helipad near the telecommunications tower and was shut down. The helipad, measuring 16 feet (ft) by 16 ft, is made of treated timber. At the time of the occurrence, the helipad was mostly bare wood; however, there were several patches of ice (Figure 1).

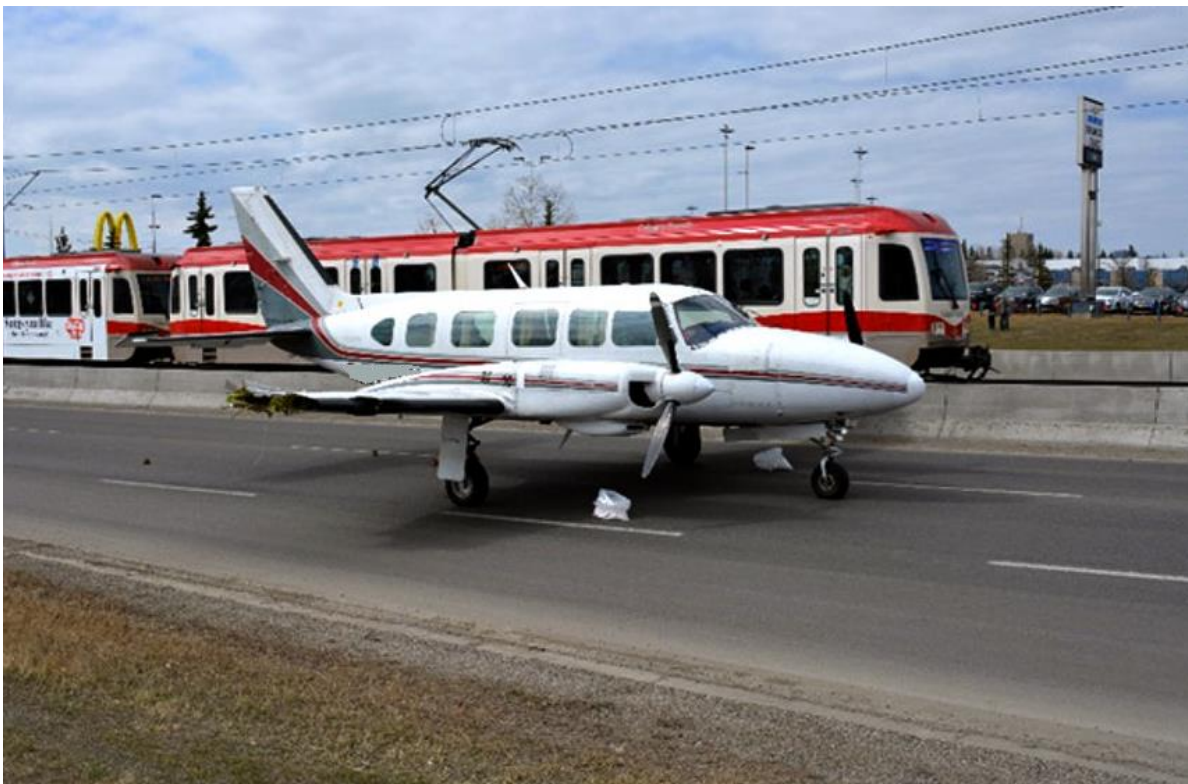
Figure 1. The occurrence aircraft after coming to a stop on 36 Street N.E., Calgary, Alta.

The aircraft touched down in the northbound lanes of 36 Street N.E., just north of the intersection with Marlborough Drive N.E. Shortly after the aircraft touched down, its right wing contacted a light standard on the right side of the road, shearing off the outer 4 ft of the wing. The aircraft continued north, through the intersection with Marbank Drive N.E., and came to a stop just south of the on-ramp for eastbound 16 Avenue N.E., which is part of the Trans-Canada Highway (Figure 1).
