Mechanically Fastened Air Barrier
System

Canada Mortgage and Housing Corporation
Project Implementation Division
682 Montreal Road
Ottawa, Ontario
K1A 0P7

Mr. B. Shorney and Mr. G. Kappeler

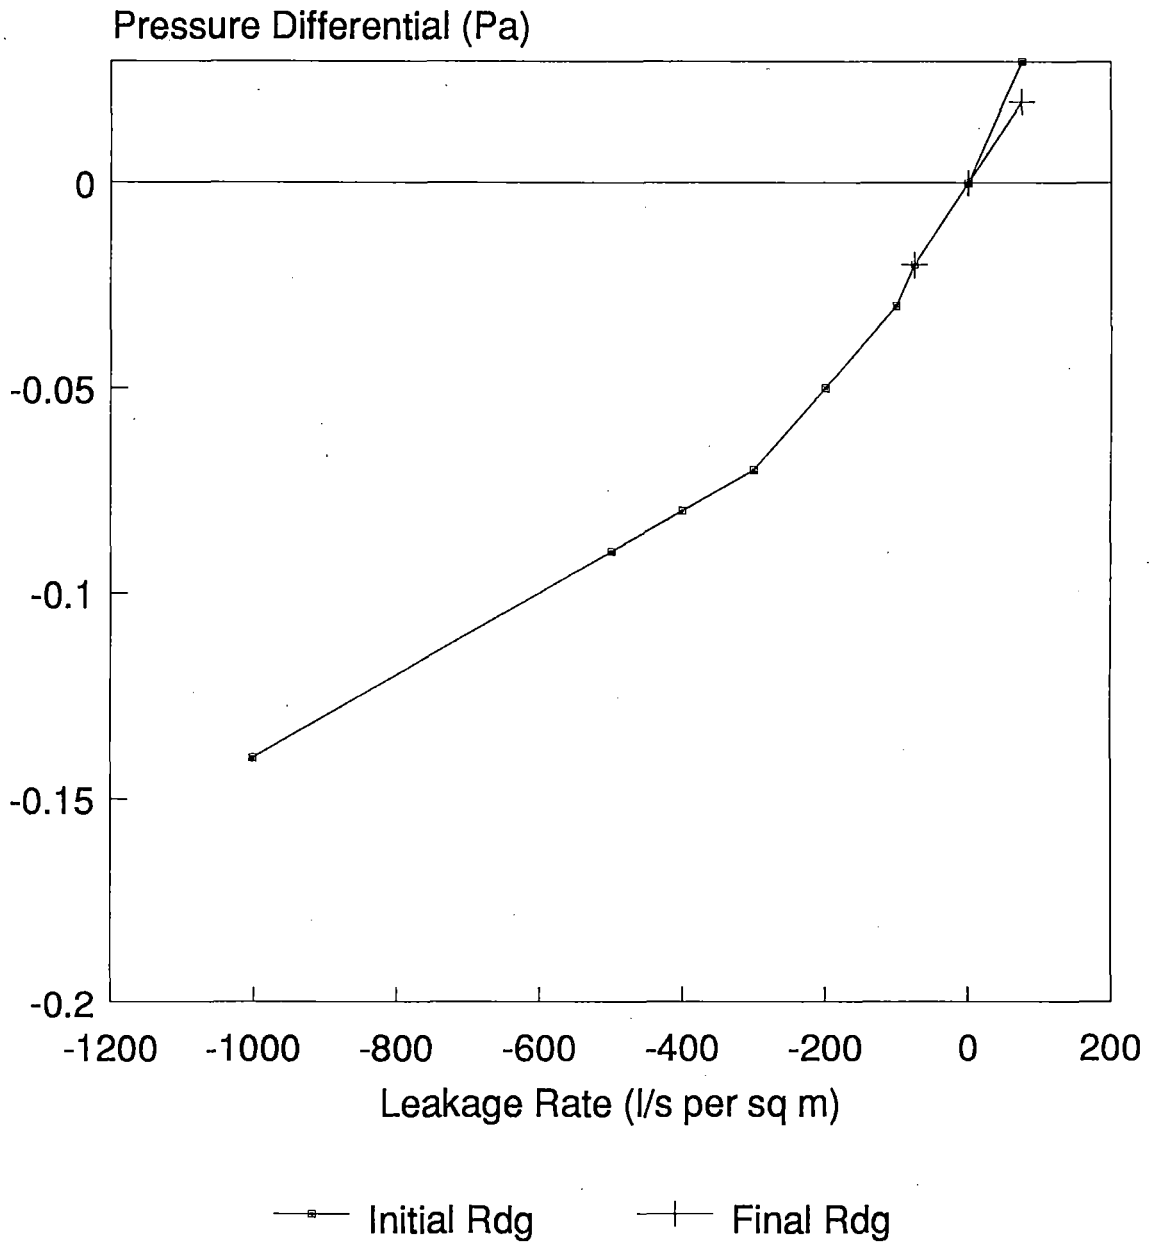
FIGURE 2: Air Barrier Test *
Air Pressure / Leakage Rate Results

* Tests conducted at Morrison Hershfield
Construction Laboratory, Ottawa
Oct. 3, 1988

The results of the air leakage tests conducted are included in Table 1 and in Figure 2. The air temperature throughout the tests was 21°C.

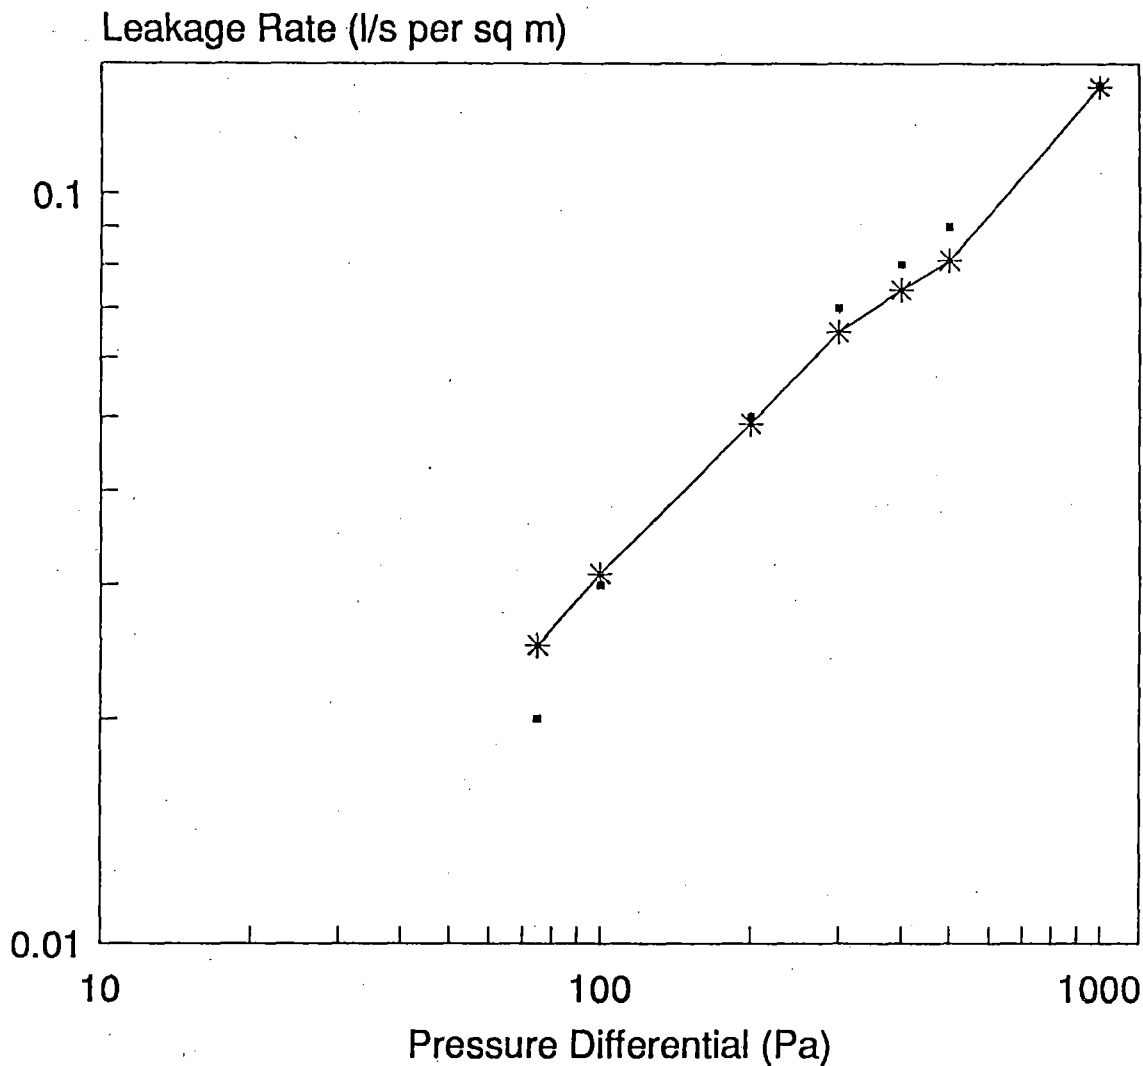
FIGURE 4: Kappeler Air Barrier Test *
Air Pressure / Leakage Rate Results
(Logarithmic axis)

▪ Oct 3/88 —*— Nov 1/88, Chamber

* Tests conducted by Morrison Hershfield
-Oct 3/88 test, Ottawa, Area=1.0 sq m
-Nov 1/88 test, Kitchener, Area=7.12 sq

The results of the tests conducted are included in Table 1 and in Figure 4. Figure 4 includes the results of previous tests conducted in our Ottawa laboratory plotted in a
