**ISSUE 2/2021**

# **AVIATION SAFETY LETTER**

TP 185E

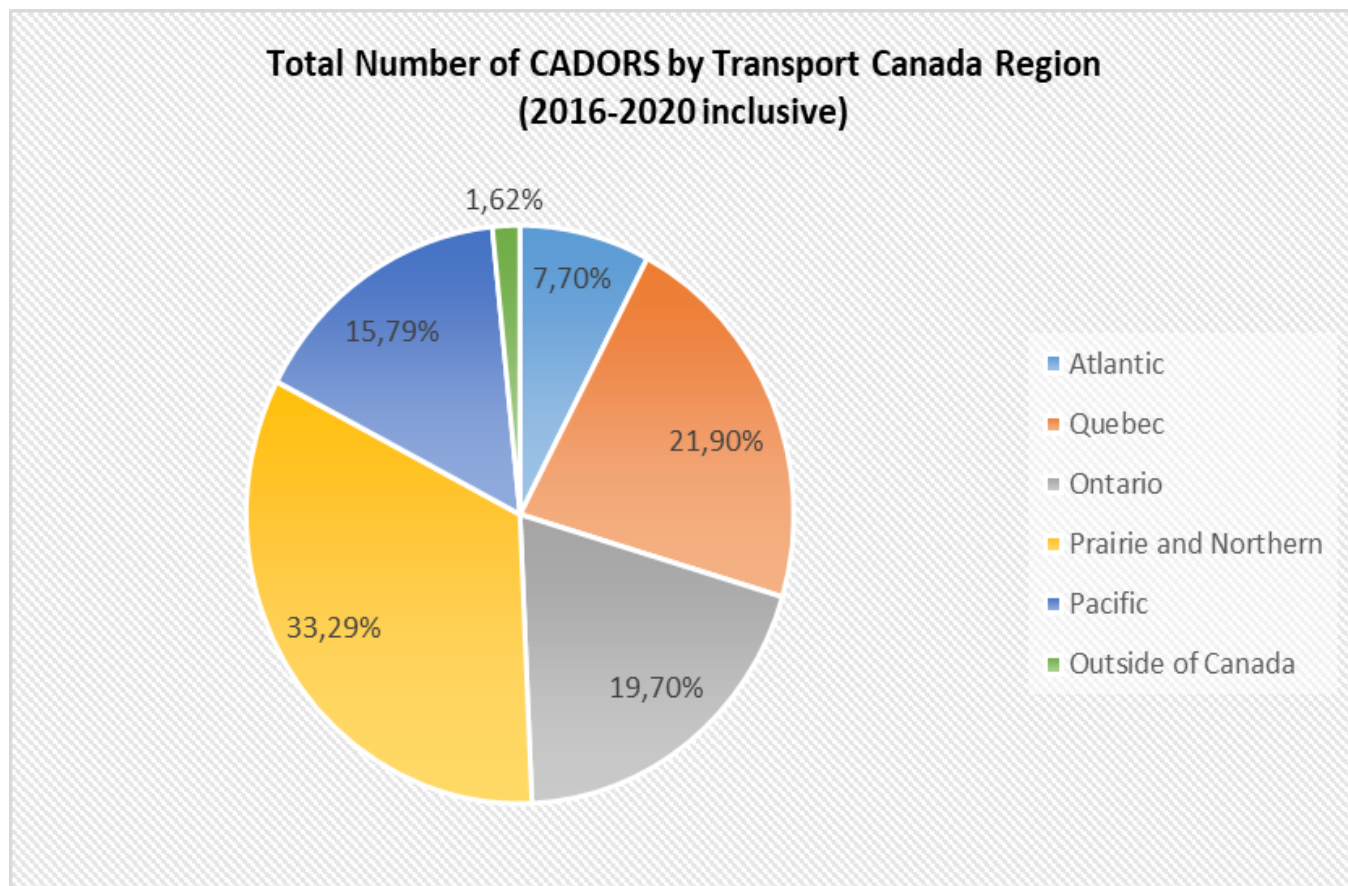
Figure 2: Total number of CADORS by Transport Canada region

Between 2016 and 2020, approximately one-third of aviation incidents and accidents reported in CADORS occurred in the Prairie and Northern Region (comprising Manitoba, Saskatchewan, Alberta, Nunavut, Northwest Territories and Yukon), while Quebec and Ontario Regions accounted for almost 55% of occurrences.

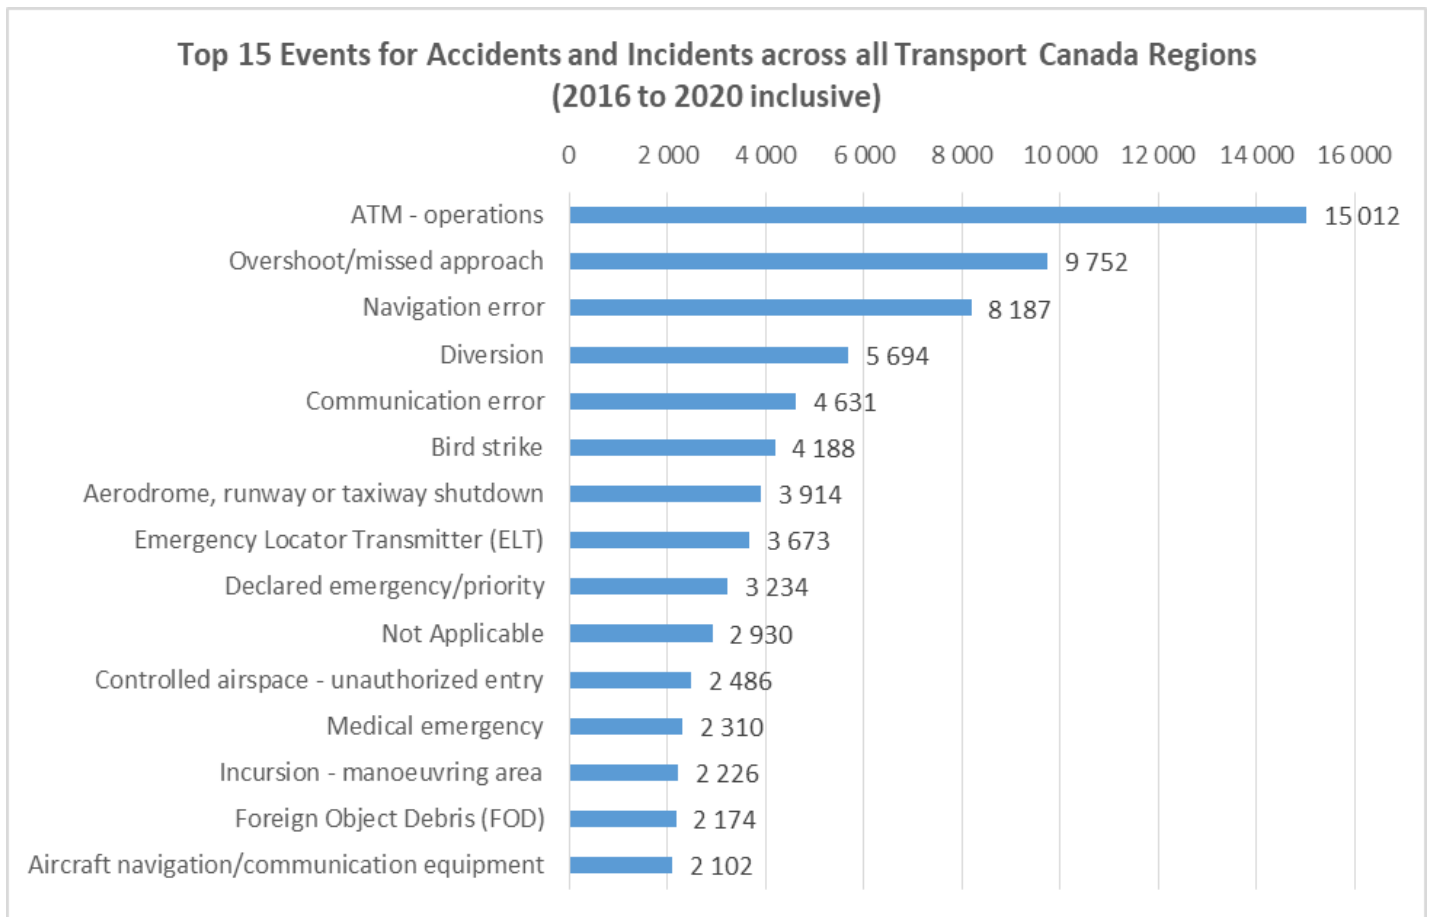
*Figure 3: Top 15 events for accidents and incidents across all Transport Canada regions*

The 15 most frequent events assigned to CADORS records over the last five years (2016 to 2020) accounted for 62% of all occurrences. Over that five-year period, “ATM—operations”<sup>1</sup> events accounted for 13% of occurrences, while 8% involved an overshoot or missed approach, 7% involved a navigation error, and 5% involved a diversion. The remaining events were each involved in less than 5% of occurrences.

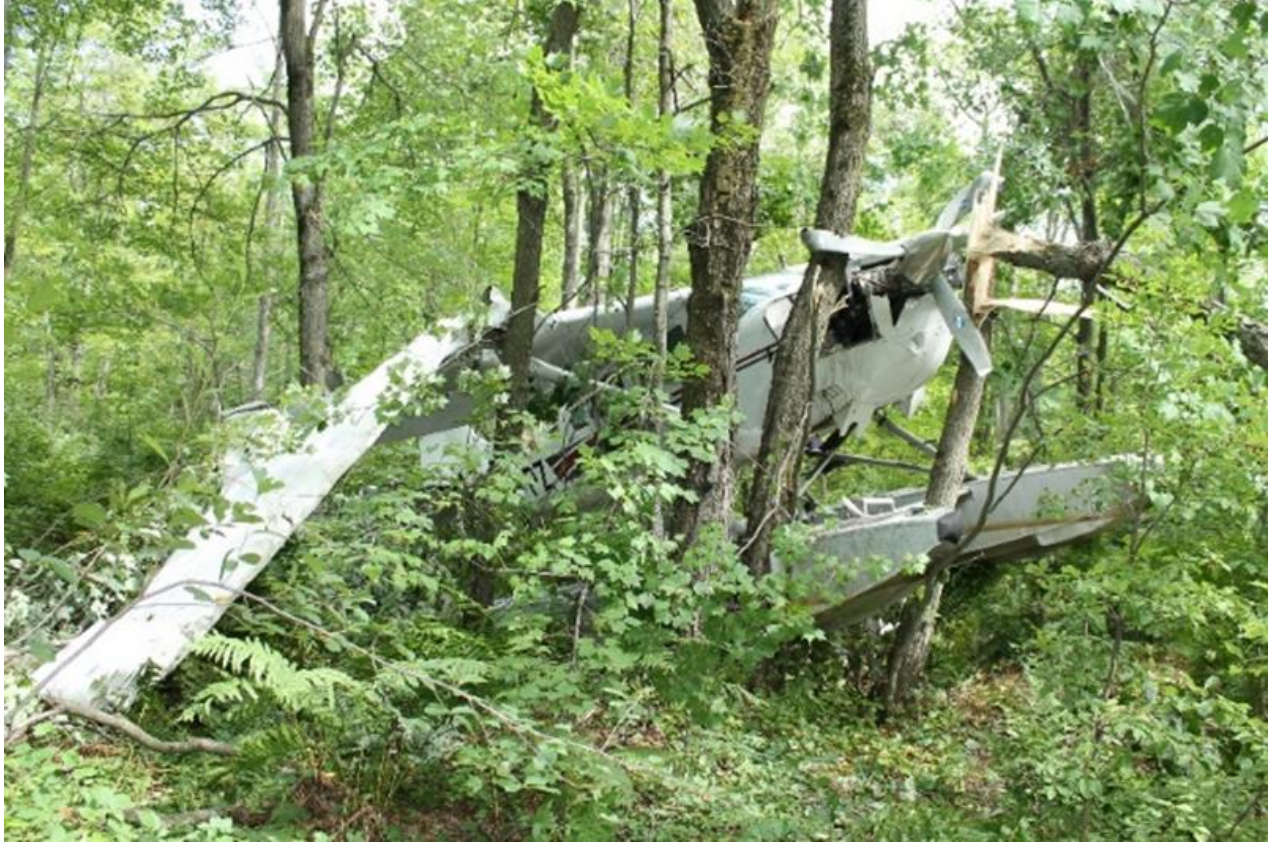
*Figure 2. Occurrence aircraft wreckage (Source: TSB)*

The area surrounding the wreckage, approximately 1 000 ft southeast of the lake, was a woodland with large, deciduous trees. The first signs of an impact with trees could be found approximately 250 ft southeast of the wreckage (Figure 2).

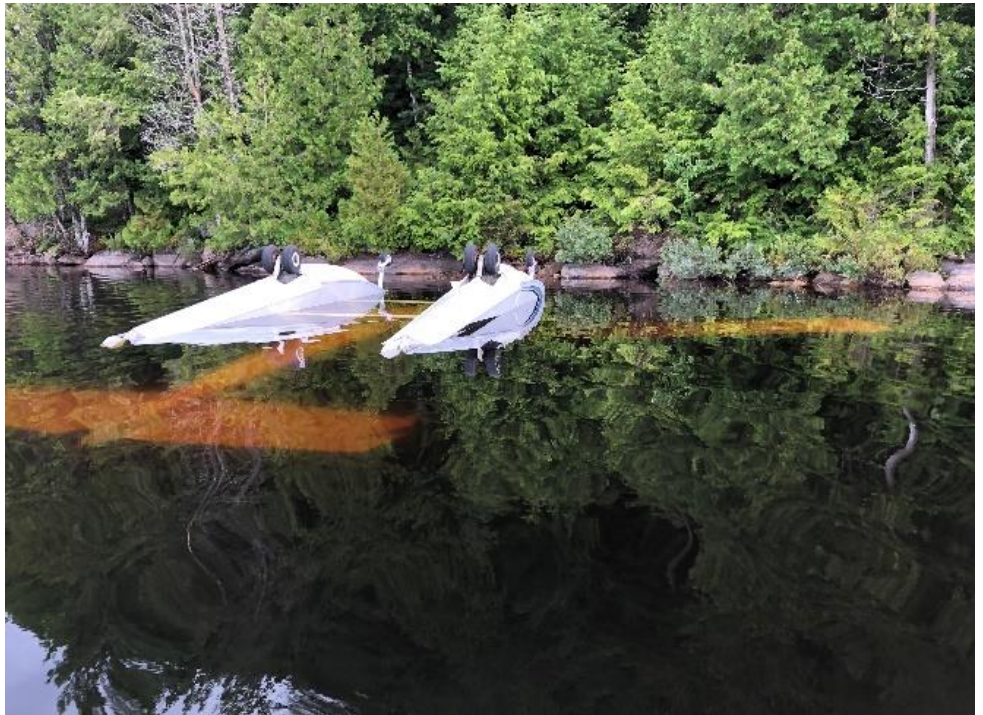
*Figure 1. The occurrence aircraft found the day after the occurrence, tied to the shore (Source: friend of the pilot)*

The aircraft touched down on the surface of the water with the wheels down, causing it to flip over; the aircraft came to rest inverted, the floats above the water keeping it afloat (Figure 1).
