ATLANTIC CANADA
WOOD FRAMING
MOISTURE SURVEY

MAY 1989

PROJECT IMPLEMENTATION DIVISION
CANADA MORTGAGE AND HOUSING CORPORATION

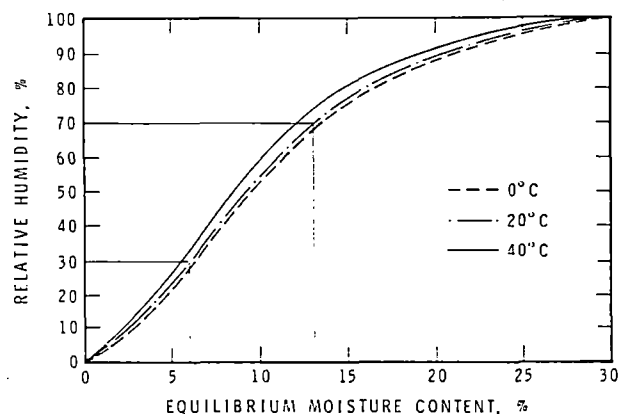
Fig. 1 Moisture content of wood at various relative humidities

The moisture level of the wood will eventually reach equilibrium with that of the surrounding air. This equilibrium moisture level depends principally on the relative humidity of the air. Air temperature has little effect on the equilibrium moisture level over its normal indoor range. Figure 1 shows the equilibrium moisture content of wood at various humidity levels and temperatures.
