**ISSUE 4/2021**

# **AVIATION SAFETY LETTER**

TP 185E

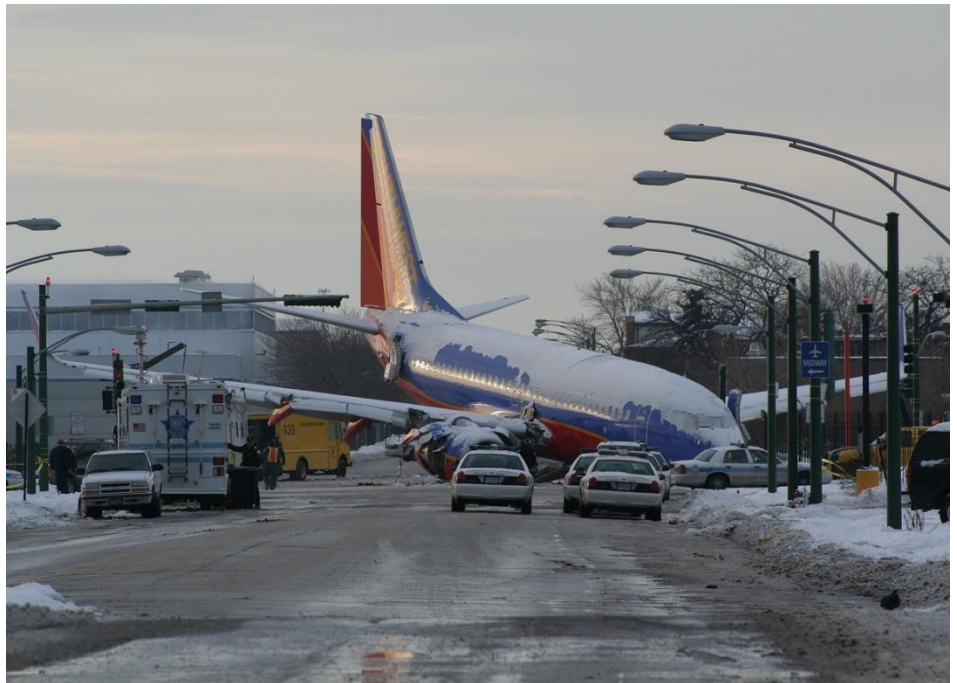
Figure 1. The December 8, 2005 B737-700 accident at Chicago Midway airport resulted in the TALPA ARC, an important safety initiative to address operations on wet and contaminated runways that ultimately led to the GRF.

The origins of GRF can be found in the work of the *Takeoff and Landing Performance Assessment Aviation Rulemaking Committee* (TALPA ARC). After a Boeing 737-700 runway overrun accident at Chicago Midway Airport, which occurred on December 8, 2005 (Figure 1), the United States Federal Aviation Administration (FAA) convened the TALPA ARC. The goal of this committee was to consider safety issues associated with takeoff and landing on wet and contaminated runways. Participants included aircraft manufacturers, air operators, airport

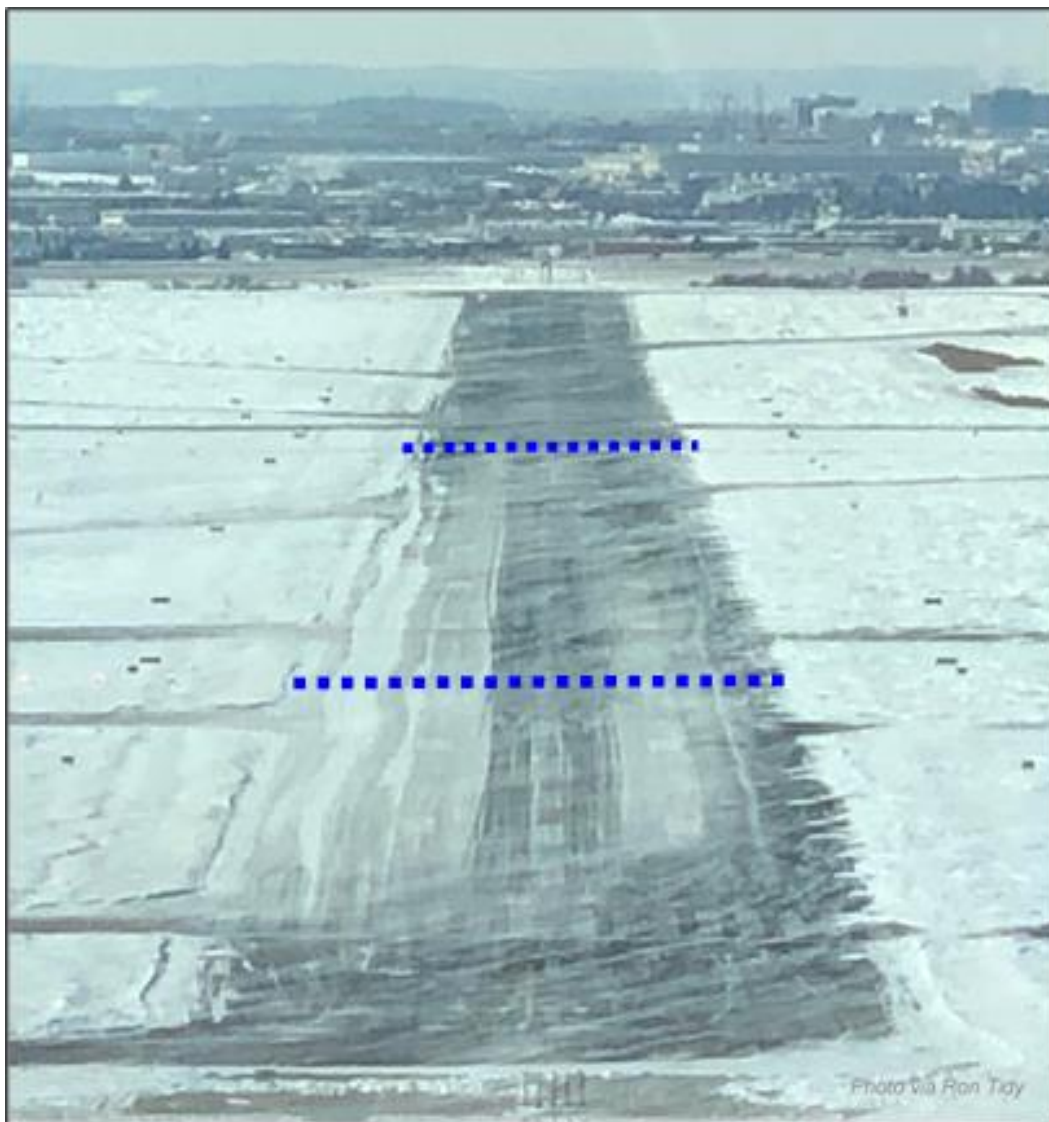
*Figure 1. The two dashed blue lines overlaid on the photo help to show benefits of reporting runway surface conditions by thirds with associated RWYCCs. For landings in this direction, the RWYCCs would be 3/3/5. This “shorthand” description of runway friction makes it easy for pilots to understand that the contaminants are primarily located in the first two thirds of the runway. For landings in the opposite direction, the RWYCCs would be 5/3/3.*

The photograph below illustrates how reporting in thirds helps to improve pilot situational awareness.

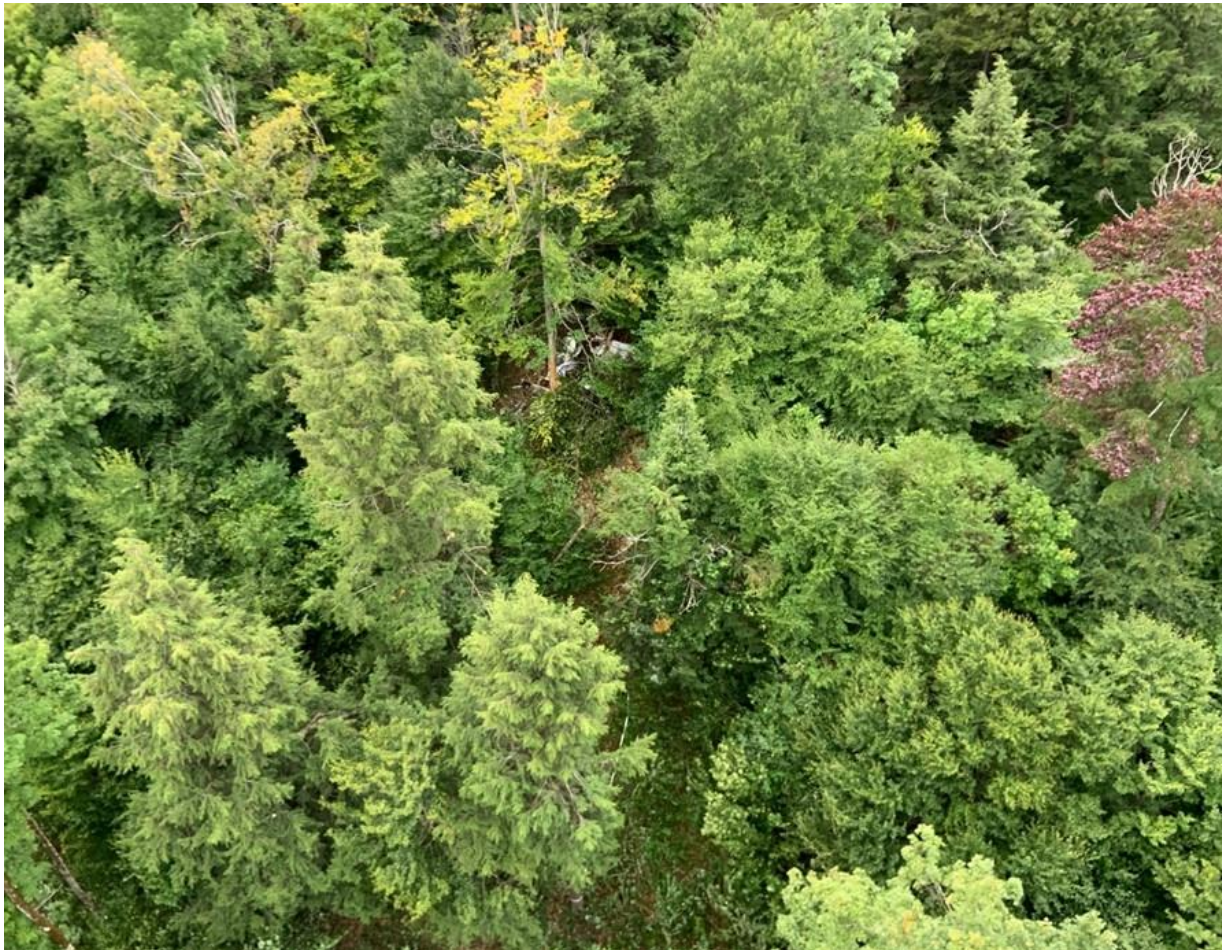
*Figure 1. Aerial view of the wreckage site (Source: Sûreté du Québec)*

The wreckage of the occurrence aircraft was located three days later, on 7 September 2019, in a heavily wooded area near Racine, Quebec (Figure 1), at an elevation of 887 ft ASL. The aircraft had struck trees and been destroyed by impact forces. The pilot received fatal injuries on impact.

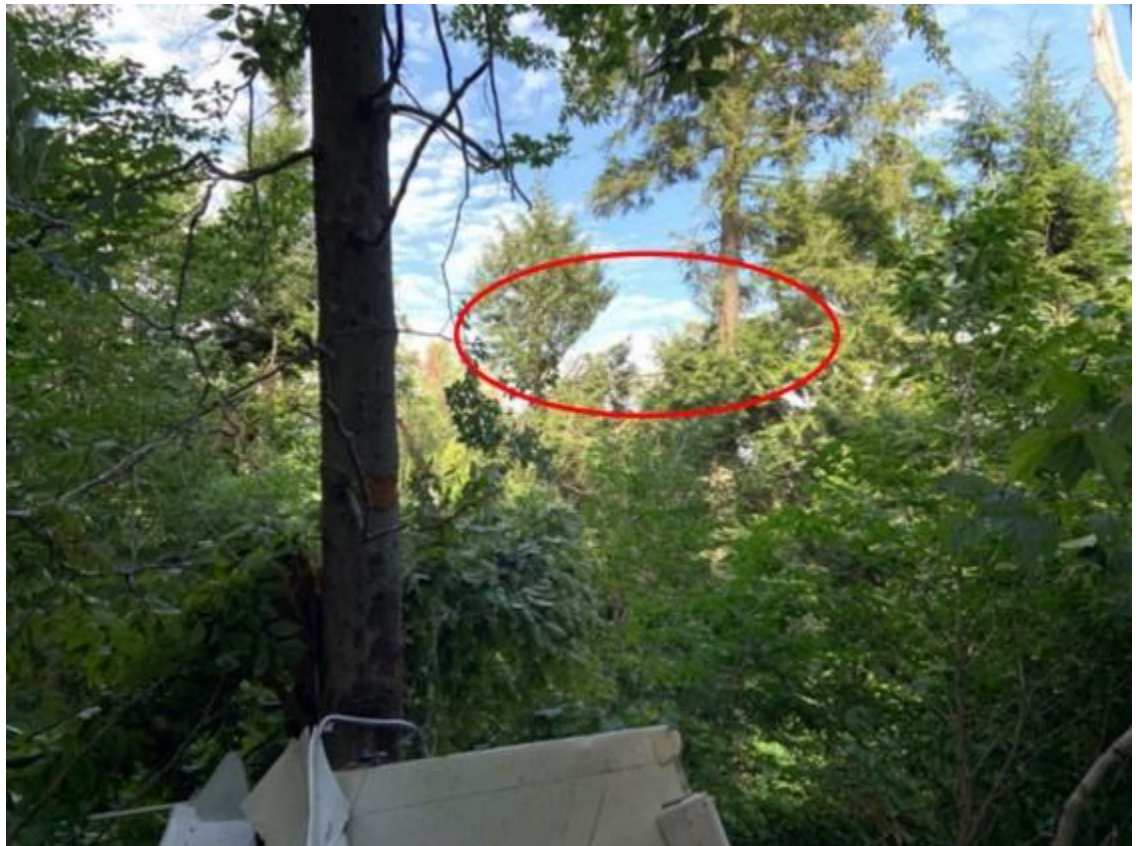
*Figure 3. Damage to trees caused by the occurrence aircraft looking back towards the direction of flight (Source: Sûreté du Québec, with TSB annotation)*

The accident site was in a heavily wooded area near Racine, Quebec. The aircraft's wings first struck two tall evergreen trees. Damage to the trees indicate that the aircraft was travelling at high velocity in a nose-down, banked attitude before it struck them (Figure 3).

After the first strike, the aircraft collided head on with a hardwood tree. The aircraft's fuselage wrapped around the tree's trunk before striking the ground, inverted, on the opposite side. All flight control surfaces

were accounted for and came to rest scattered within a restricted perimeter from the point of impact, indicating that the aircraft broke up on impact and not in flight. There were no signs of pre-impact failures of material or component malfunctions.

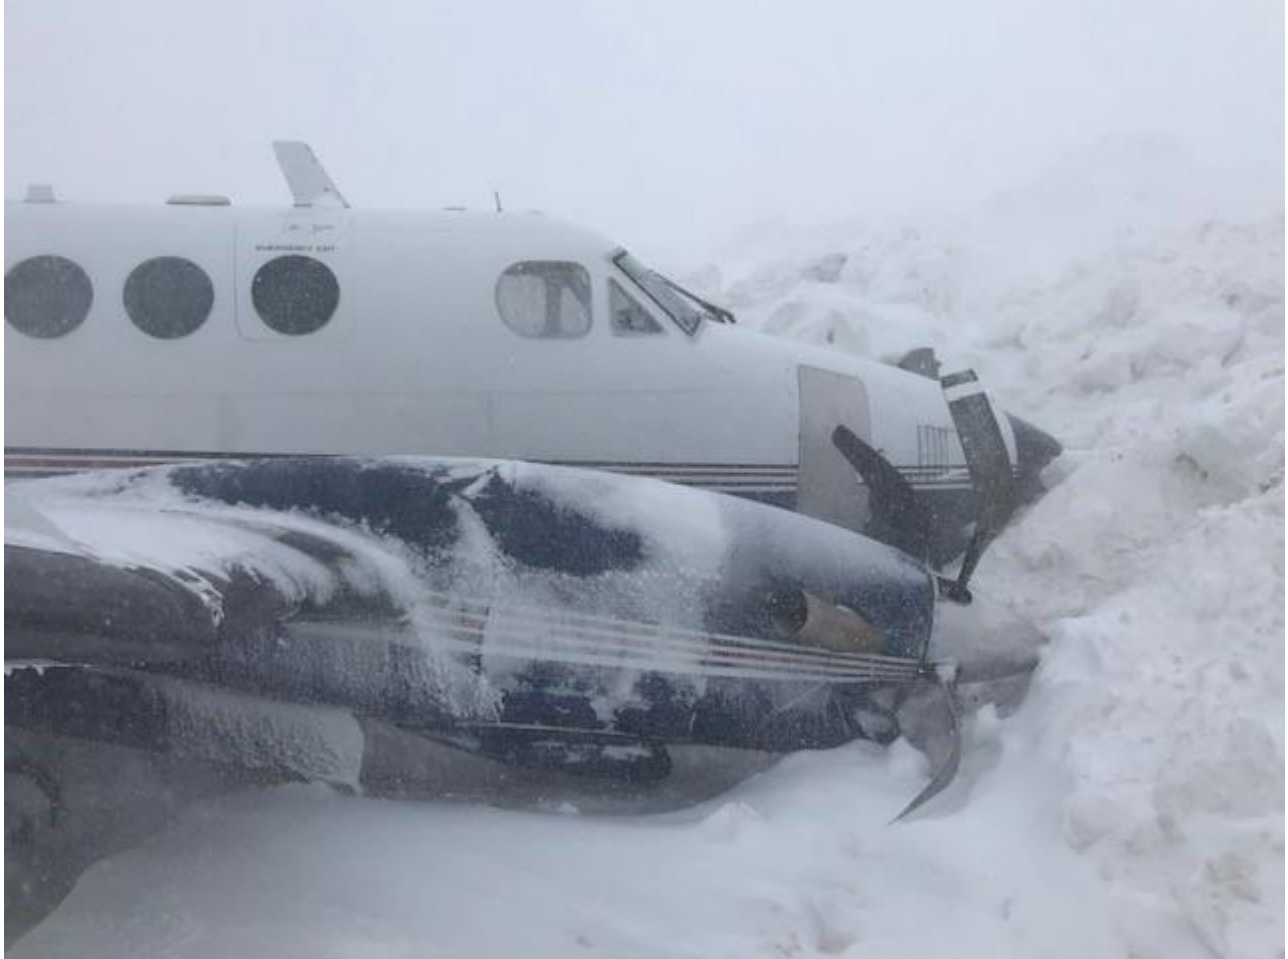
*Figure 2. Wreckage of the occurrence aircraft (Source: Third party, with permission)*

The aircraft's fuselage, nose, engines, propellers, nacelles, flaps, wing centre section, and right wing spar were damaged (Figure 2).

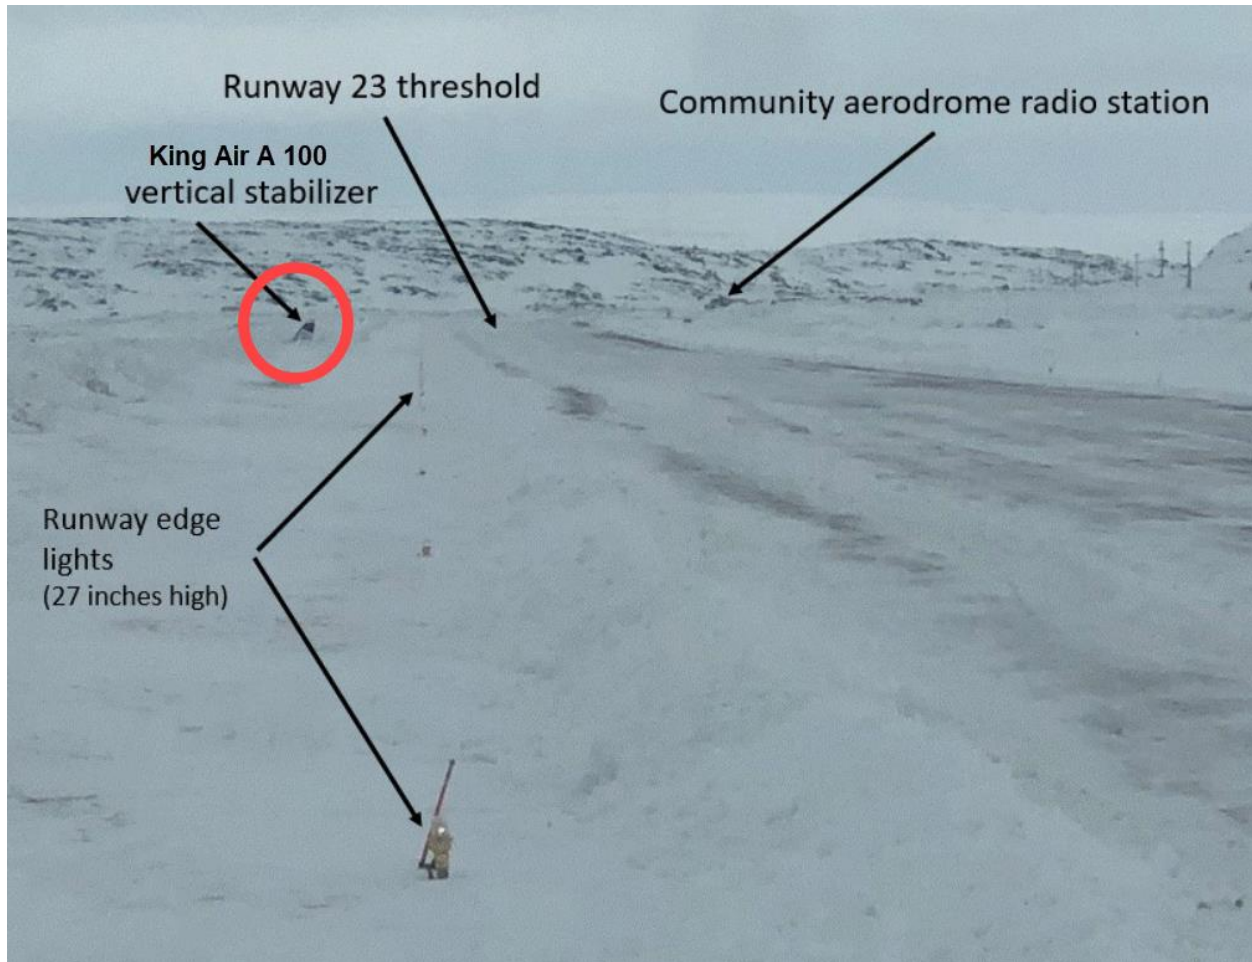
Figure 4. View toward the threshold of Runway 23  
(Source: Third party, with permission and TSB annotations)

A photo of the runway was taken the day following the occurrence, after snow clearing had begun (Figure 4). Due to the presence of snowbanks along the runway, the only portion of the aircraft that is visible in the photo is the vertical stabilizer. The photo also shows that the snow accumulation along the runway is almost as high as runway edge lights, which are 27 in. high.
