AVIATION **S**AFETY **L**ETTER

Very High Frequency Omnidirectional Range (VOR)

TP 185E

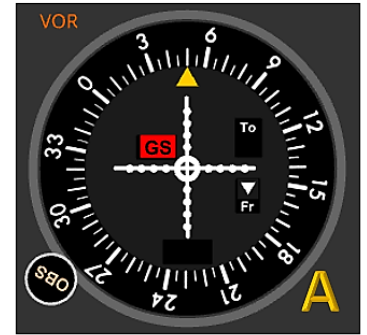
Photo A

Here's where it gets tricky. The VOR instrument in your plane not only has an omnibearing selector (OBS) that allows you to choose one of the 360 signals, but it also has a sense indicator which shows "TO" or "FROM." Well, the FROM is pretty straightforward: if my CDI is centred and there's a FROM indication, then I'm on that radial—the radial that is radiating FROM the station. My VOR would look like A, (Photo A). I'm on the 50° radial.

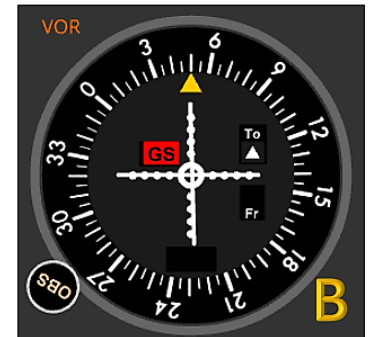
Photo B

But, what about the TO indication? What if I have 50° at the top (50° radial), my CDI is centered, but I have a TO indication, as in Photo B. What does that mean? Where am I relative to the VOR station? I certainly can't be in the same spot as with a FROM indication. Well, if your OBS has the number 50 at the top, your VOR instrument will pick up that 50° radial from anywhere within range. Now, the 50° radial doesn't radiate backwards. But on the southwest side of the station (blue airplane in Figure 2), because your VOR instrument is sort of *behind* the radial (that's why the purple line is broken), the sense indicator points TO the station (as you can see in VOR B), instead of FROM the station. And that's why you get a TO indication. So, Rudolph Red is on the 50° radial FROM the station; his VOR looks like A (Photo A). Brenda Blue, however, is on the 50° radial TO the station and her VOR looks like B (Photo B).

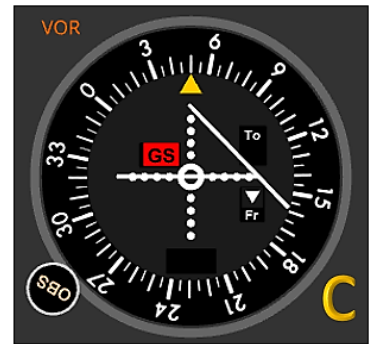
Photo C

Study Figure 4 below: It looks like Rudolph Red, with OBS set to 50°, is on the FROM side of the station and he is left of the radial. So, his VOR would look like VOR C: CDI deflected to the right because the radial is right of the balloon.

Carefully consider the situation for Rudolph and Brenda as depicted in Figure 6. Although their heading has changed, their *position relative to the VOR signal has not*. So, their VORs look the same as **C** and **D** (on page 8).

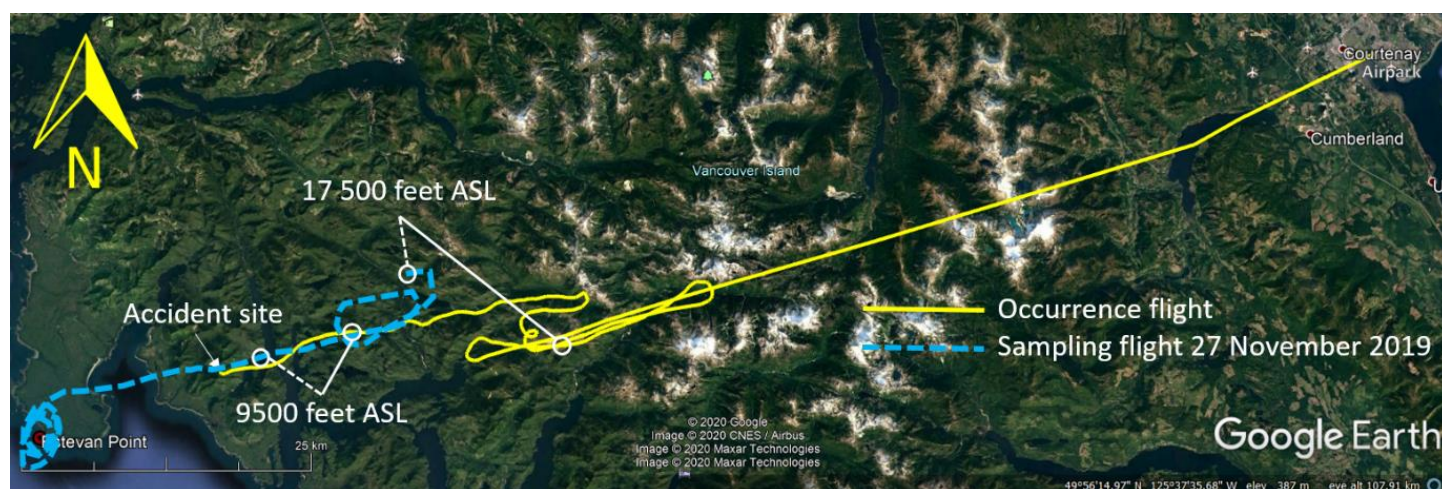
Figure 1. Flight paths of the occurrence flight and the previous sampling flight, based on NAV CANADA radar and National Oceanic and Atmospheric Administration GPS data (Source: Google Earth, with TSB annotations)

The on-board National Oceanic and Atmospheric Administration (NOAA) sampling equipment's global positioning system (GPS) indicated that the aircraft came to rest at 1222 (Figure 1). It had struck trees and collided with the ground near Stewardson Inlet, B.C. The pilot was fatally injured. The aircraft was destroyed. There was no post-impact fire.

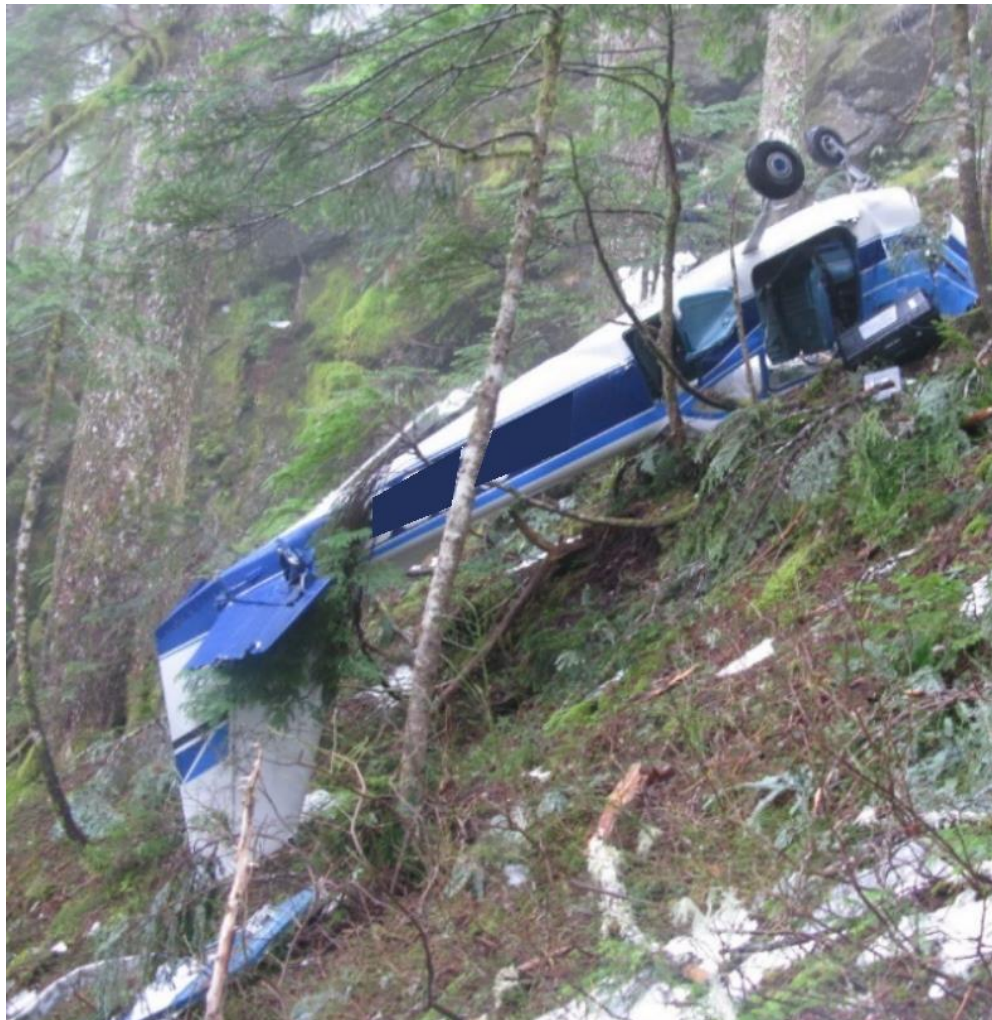
Figure 2. Occurrence site on 12 February 2020, looking west (Source: TSB)

The wreckage was found at approximately 2 600 ft ASL on a steep, densely wooded mountainside, 31 nautical miles (NM) northwest of Tofino/Long Beach Airport (CYAZ), B.C. The damage was consistent with a low-energy impact (Figure 2).
