Transport
Canada

ISSUE 1/2023

AVIATION **S**AFETY **L**ETTER

TP 185E

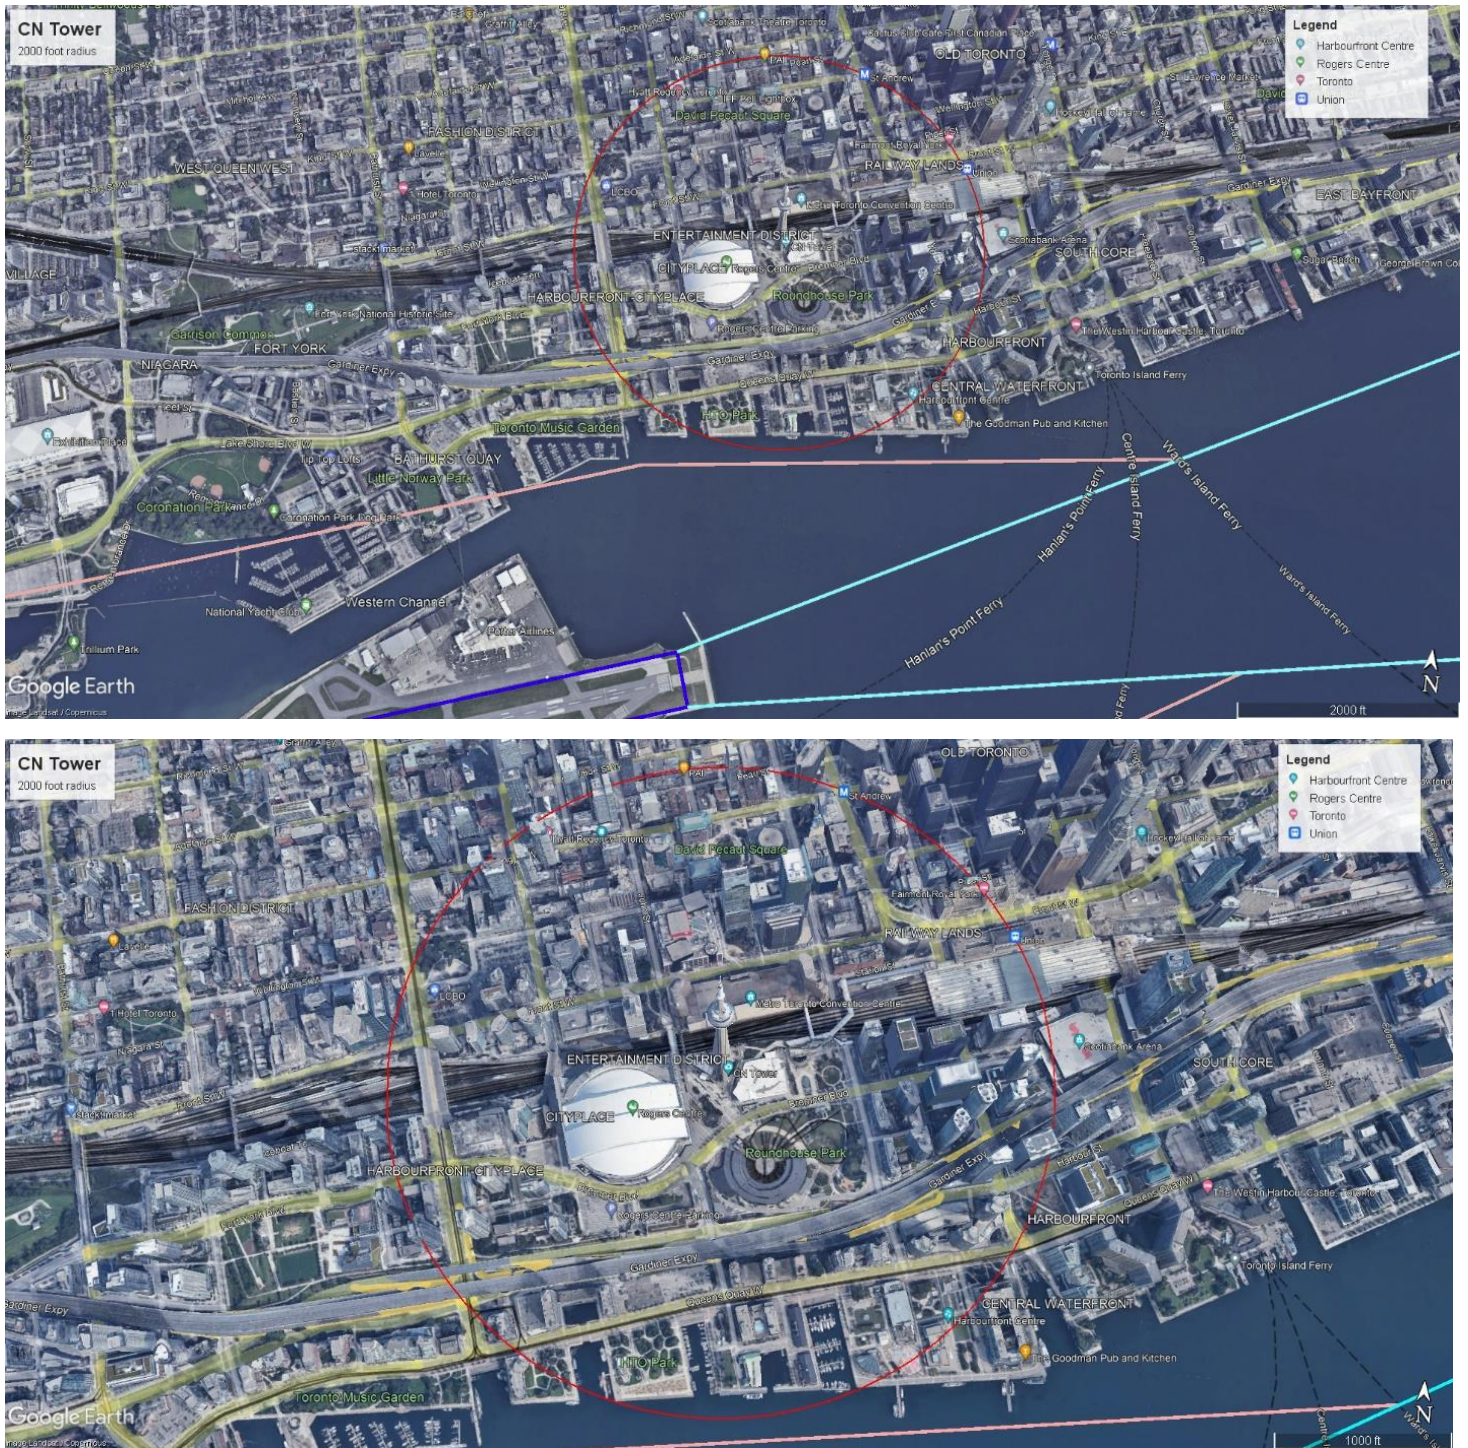
Figure 1: 2 000 ft radius circle around the CN tower

- (a) over a built-up area or over an open-air assembly of persons unless the aircraft is operated at an altitude from which, in the event of an emergency necessitating an immediate landing, it would be possible to land the aircraft without creating a hazard to persons or property on the surface, and, in any case, at an altitude that is not lower than
 - (i) for aeroplanes, 1,000 ft above the highest obstacle located within a horizontal distance of 2,000 ft from the aeroplane,
 - (ii) for balloons, 500 ft above the highest obstacle located within a horizontal distance of 500 ft from the balloon, or
 - (iii) for an aircraft other than an aeroplane or a balloon, 1,000 ft above the highest obstacle located within a horizontal distance of 500 ft from the aircraft

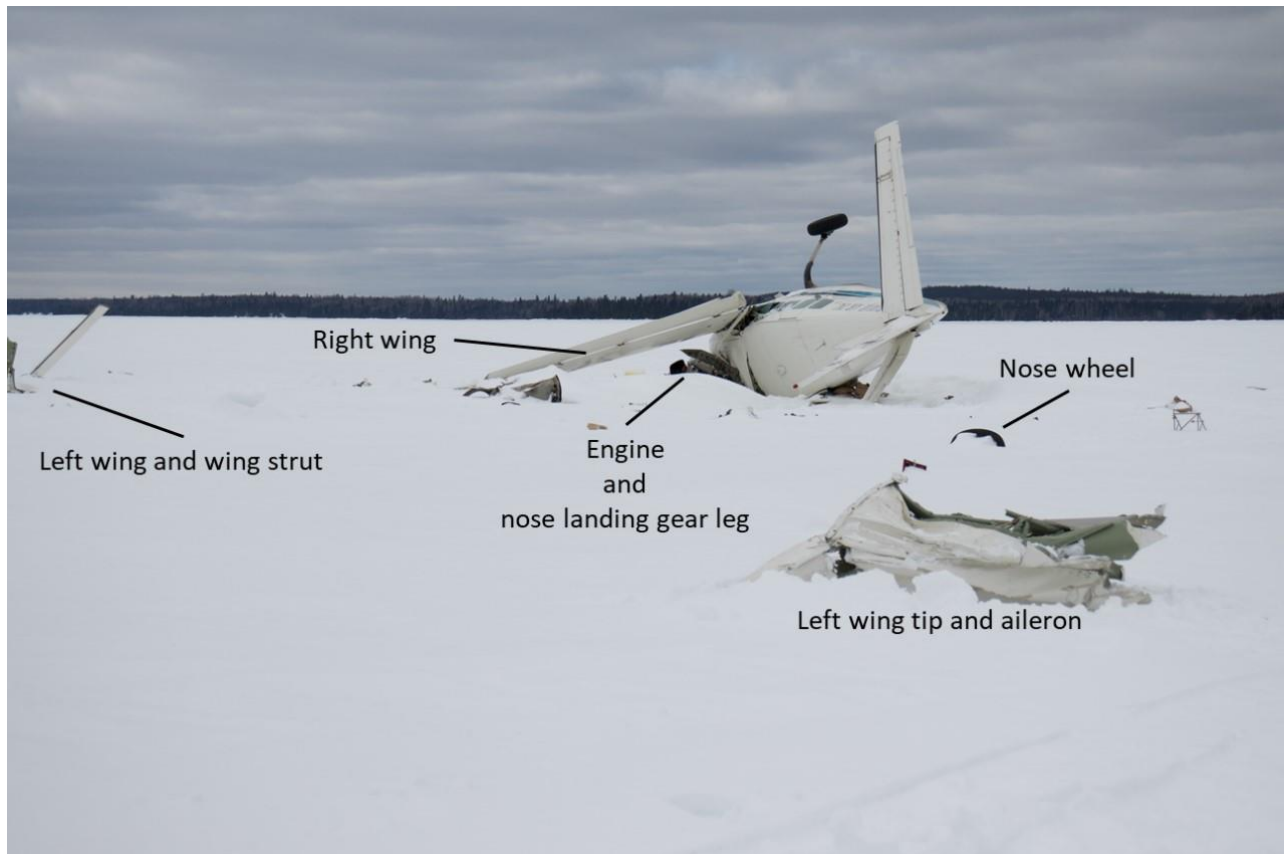
Figure 1: View along the wreckage trail (Source: TSB)

The pilot turned his head to inspect the left wing and saw that ice appeared to be accumulating on the leading edge. He turned his attention back to the flight instruments and saw that the altimeter was descending rapidly. He then pulled back on the control column to stop the descent; however, within a few seconds, the aircraft struck the frozen surface of Lac Seul, approximately 17 NM north-northwest of CYXL (Figure 1).

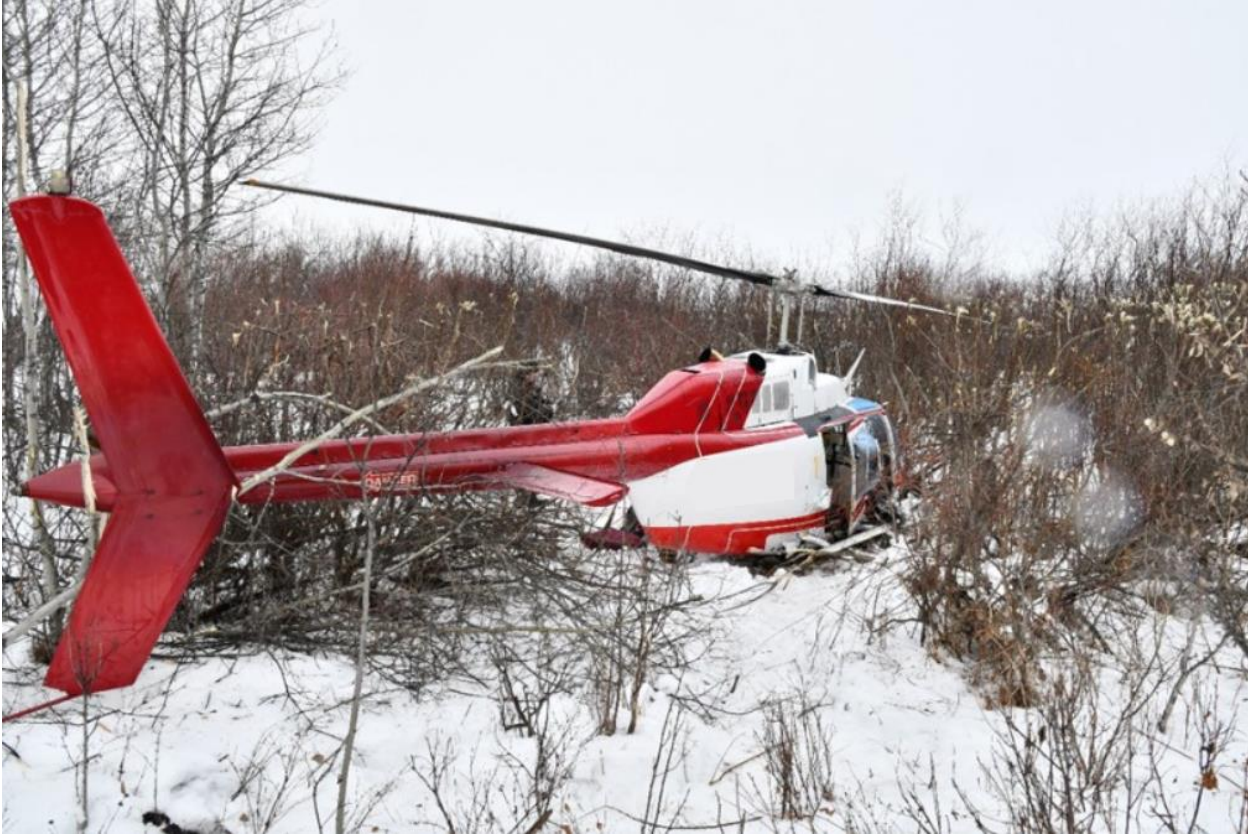
Figure 2: Accident site (Source: TSB)

Examination of the helicopter at the accident site indicated that the tail rotor blades were significantly damaged, and the steel tail rotor drive shaft located under the engine, between the engine reduction gearbox and the oil cooler blower assembly, was sheared in torsional overload. Transportation Safety Board (TSB) investigators confirmed drive shaft continuity forward and aft of the failed driveshaft. Flight control continuity was also confirmed for all four axes. There were no signs of a pre-existing mechanical problem with the helicopter before the impact with terrain.
