ISSUE 3/2023

AVIATION SAFETY LETTER

TP 185E

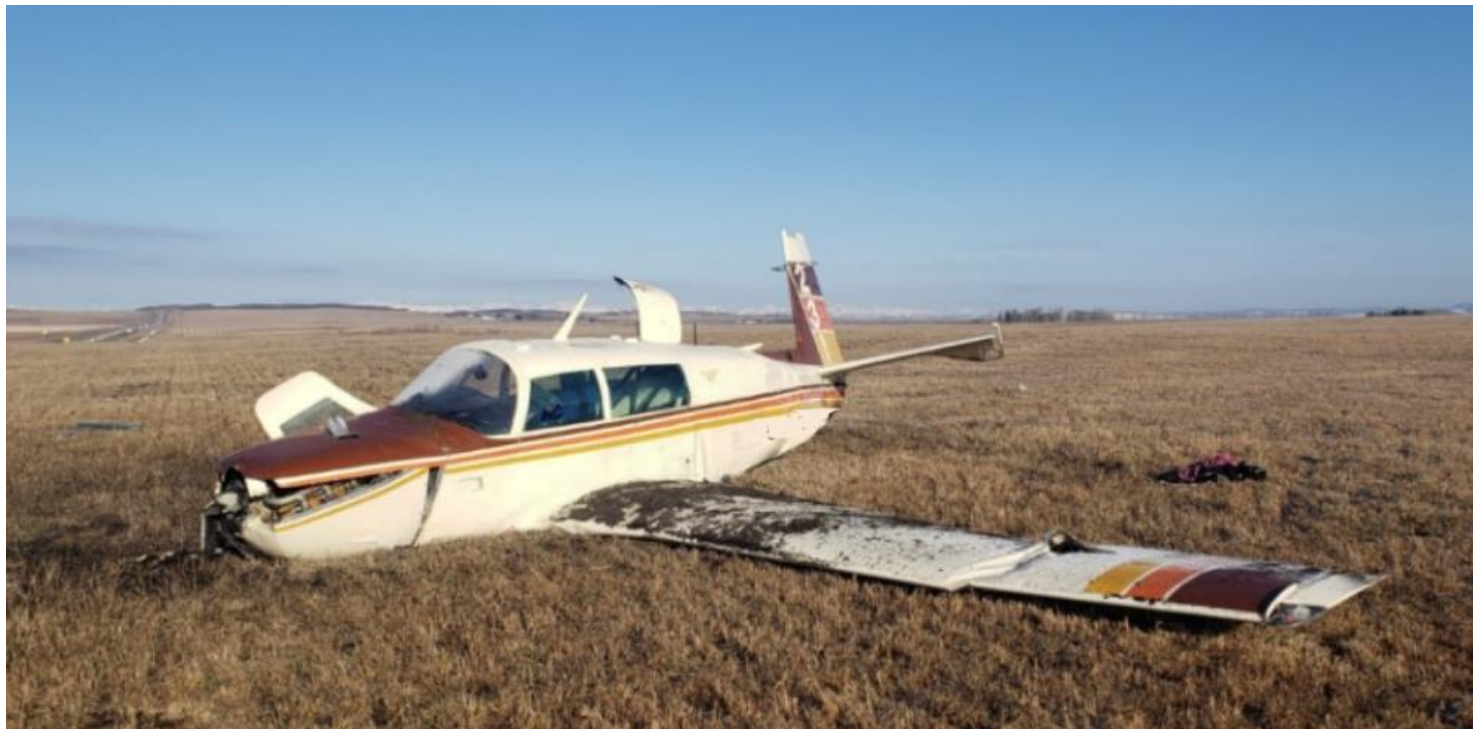
Figure 2: Accident site looking northwest (Source: TSB)

The aircraft collided with the bank of a ditch on the north side of the westbound lanes of the Trans-Canada Highway. The aircraft hit the ground in right-wing-low, nose-down attitude, went through a barbed wire fence and came to rest 68 ft north of the ditch, facing a southerly direction (Figure 2).

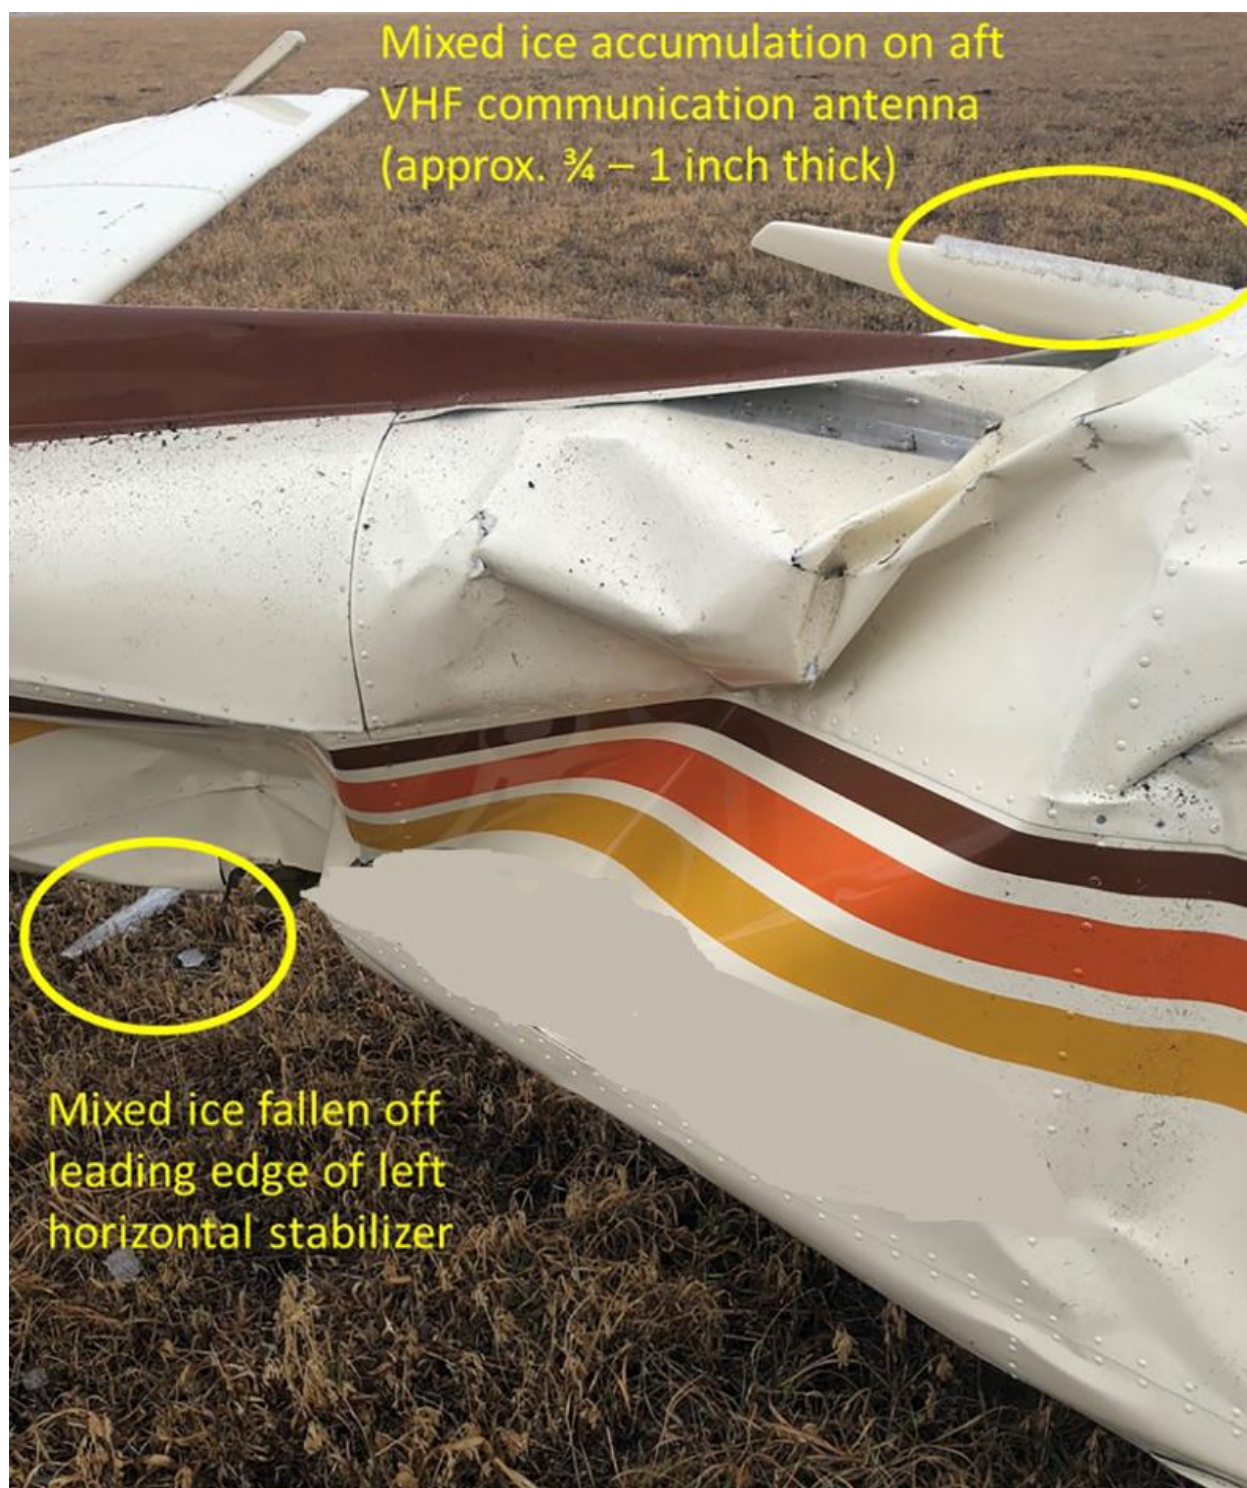
*Figure 3: Mixed ice accumulation on aft VHF (very high frequency) communication antenna
(Source: Royal Canadian Mounted Police, with TSB annotations)*

Royal Canadian Mounted Police (RCMP) officers from the Cochrane detachment responded shortly after the accident. Several photos were taken of the exterior of the aircraft and shared with the Transportation Safety Board (TSB). The photos revealed a build-up of mixed ice on the aft very high frequency (VHF) communication antenna, the leading edges of the horizontal stabilizer and the leading edge of the left wing (figures 3 and 4). The investigation estimated the build-up of the mixed ice on the VHF communication antenna to be between $\frac{3}{4}$ and 1 in. thick.

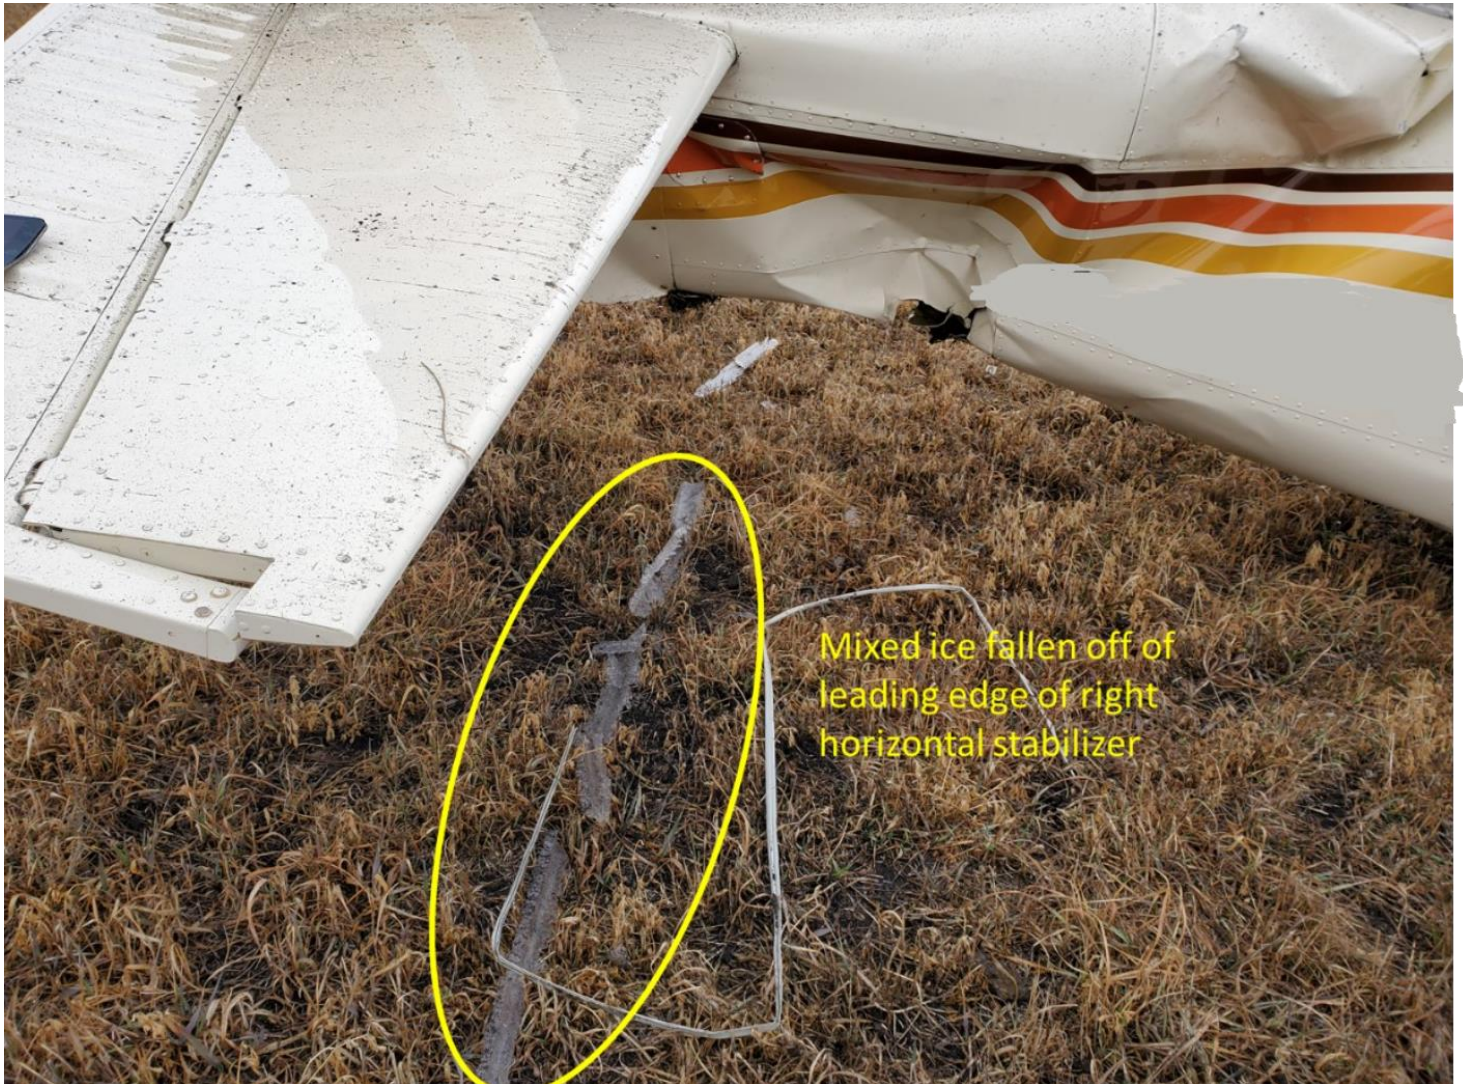
Figure 4: Horizontal stabilizer mixed ice (Source: Royal Canadian Mounted Police, with TSB annotations)

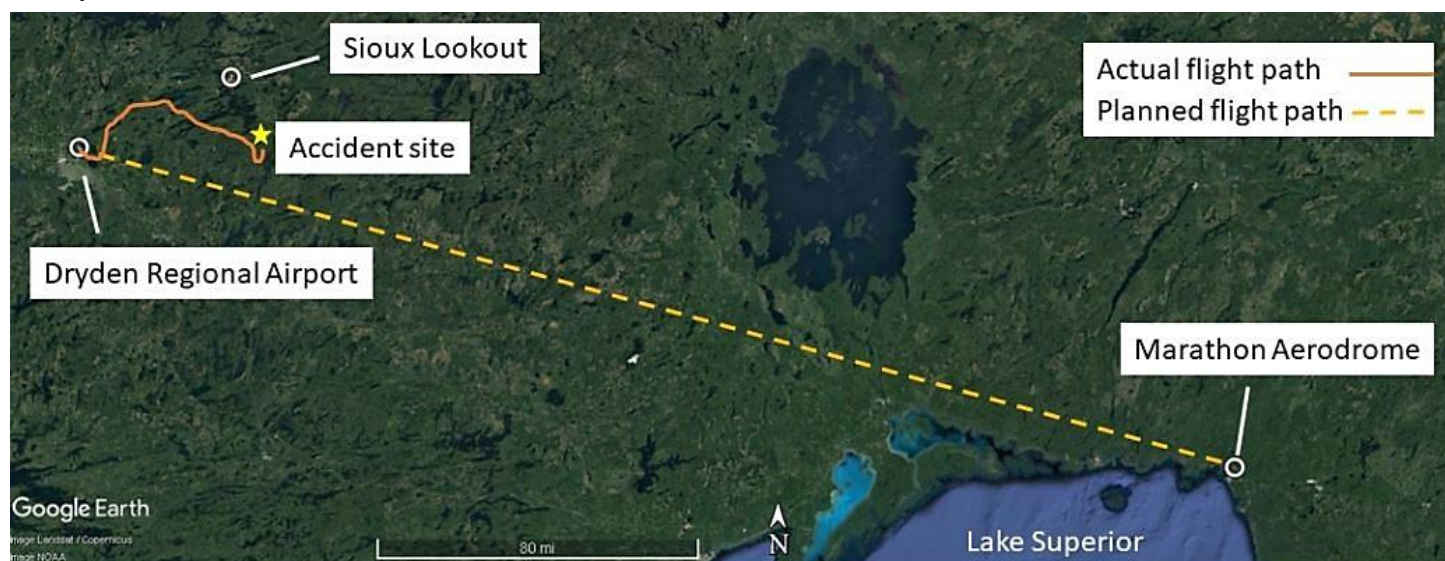
Figure 1: Map showing the flight path and accident location (Source: Google Earth, with TSB annotations)

At 2102Z on 29 April 2022, a Piper Cherokee PA-28-140 departed Dryden Regional, Ont. (CYHD), bound for Marathon Aerodrome, Ont. (CYSP), with one pilot and three passengers on board. The aircraft was reported overdue at 0139Z on 30 April 2022. The aircraft had last been observed on radar at 2145Z,¹ flying a zig-zag route over an area with limited cultural lighting (Figure 1). A search was initiated, and the wreckage was found approximately 19 nautical miles south-southeast of Sioux Lookout, Ont. (CYXL). The aircraft had impacted terrain in a wooded area during the hours of darkness. The pilot and three passengers were fatally injured. The aircraft was destroyed.
