AVIATION SAFETY LETTER

Ensuring Safe Winter Operations:
Best Practices for De/Anti-Icing in Aviation

In-flight Icing

TP 185E

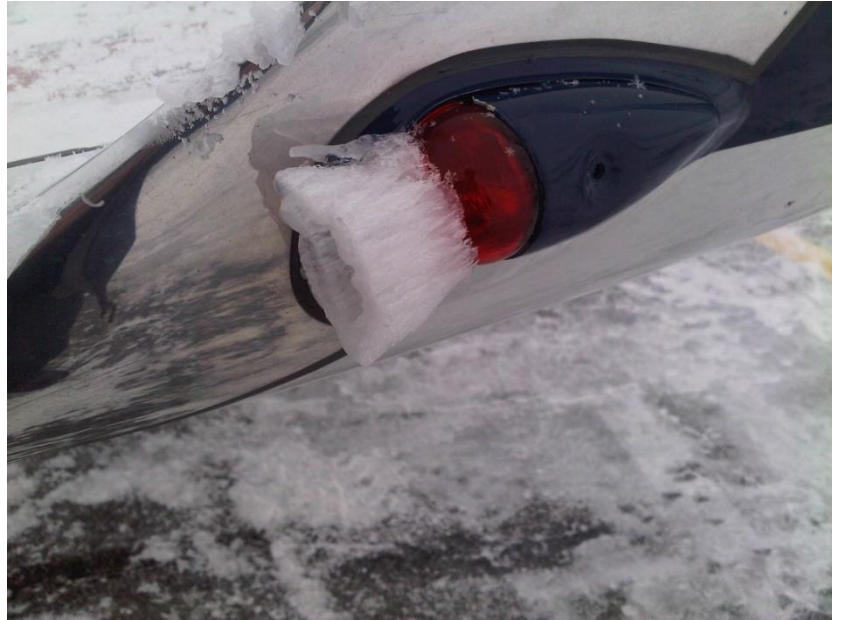
Rime ice

Rime ice is formed when small, supercooled water droplets freeze rapidly on contact with a sub-zero surface. The rapidity of the transition to a frozen state is because the droplets are small, and the almost instant transition leads to the creation of a mixture of tiny ice particles and trapped air. The resultant ice deposit formed is rough and crystalline and opaque, and because of its crystalline structure, it is brittle. It appears white in colour when viewed from a distance: for example, from the flight deck when on a wing leading edge.

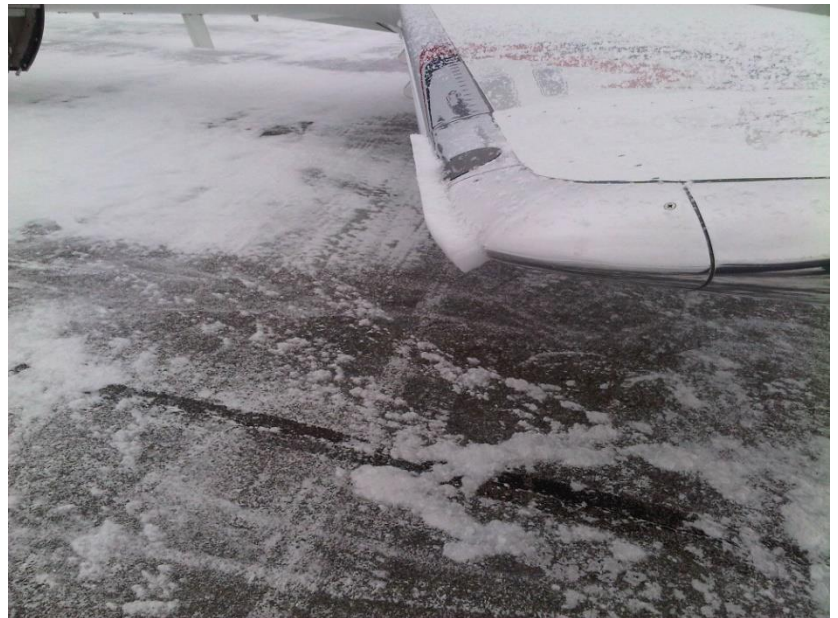
Rime ice

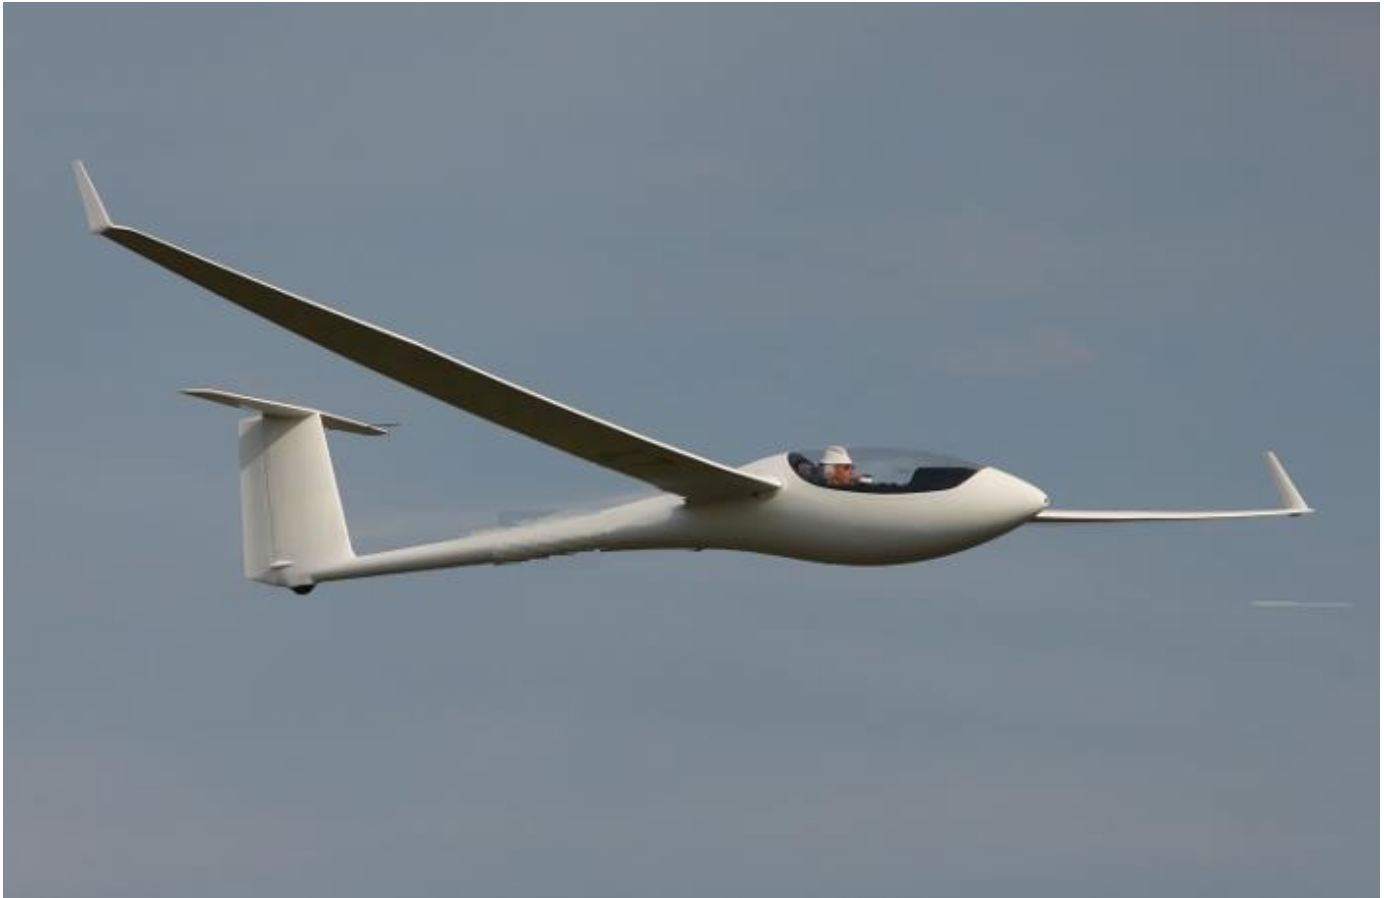
Figure 1: Schleicher ASW 27 glider, (Münch, n.d.)

On August 28, 2006, a Hawker 800XP on descent near Reno, Nevada—collided with a Schleicher ASW 27 glider, as seen in Figure 1, at approximately 16 000 ft above sea level. According to the National Transportation Safety Board (NTSB) report (Charnon, 2008), “...damage sustained by the Hawker disabled one engine and other systems; however, the flight crew was able to land the airplane. The damaged glider was uncontrollable, and the glider pilot bailed out and parachuted to the ground” (p. 1). The NTSB’s findings indicated that the closure rate between the aircraft rendered collision avoidance was improbable, if not impossible once the conflict became apparent. Moreover, the lack of a transponder signal from the glider led to a degraded state of air traffic control (ATC) and aircrew situational awareness, which contributed to the mishap.

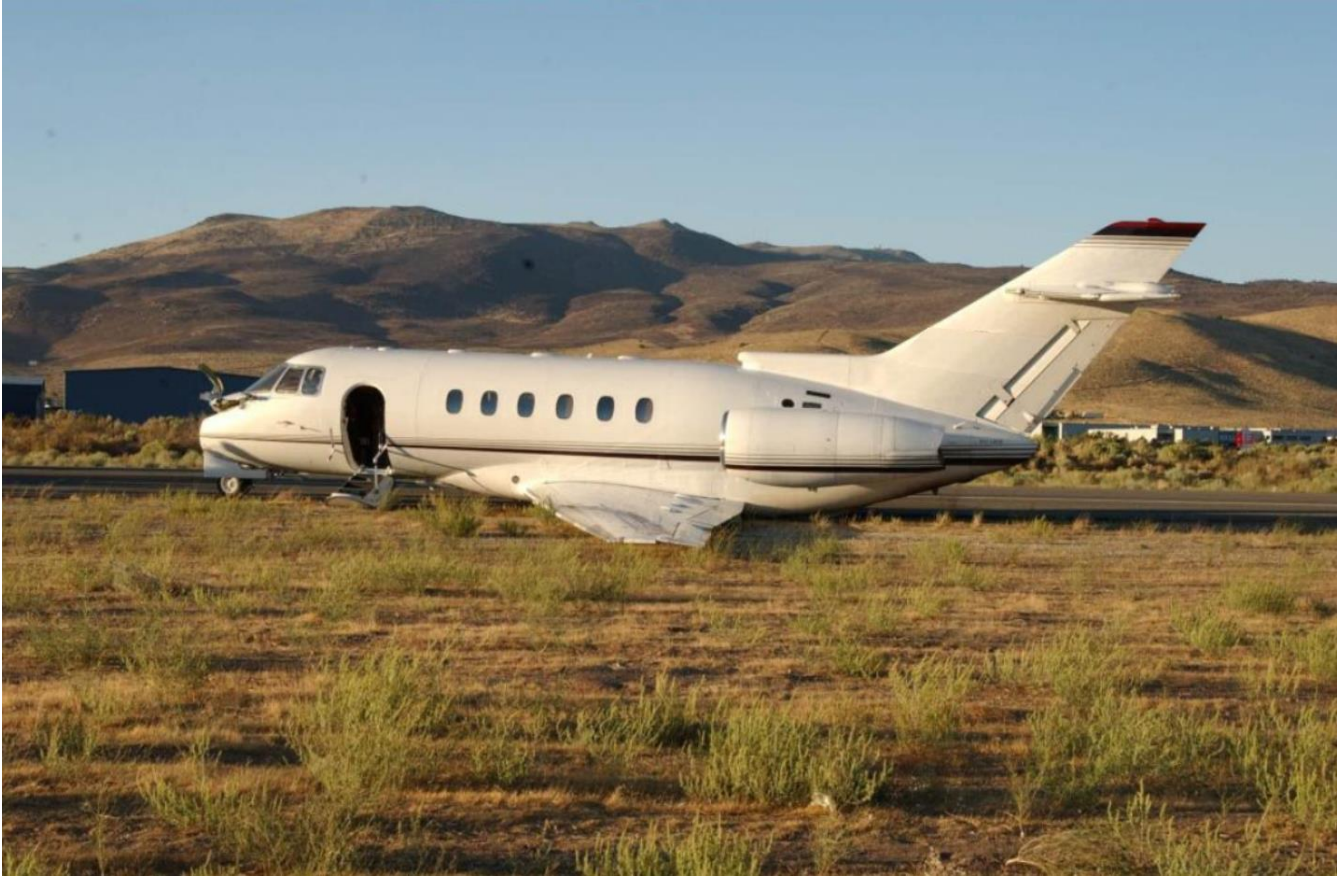
*Figure 2: Hawker 800XP following a mid-air collision with glider
(National Transportation Safety Board, 2006)*

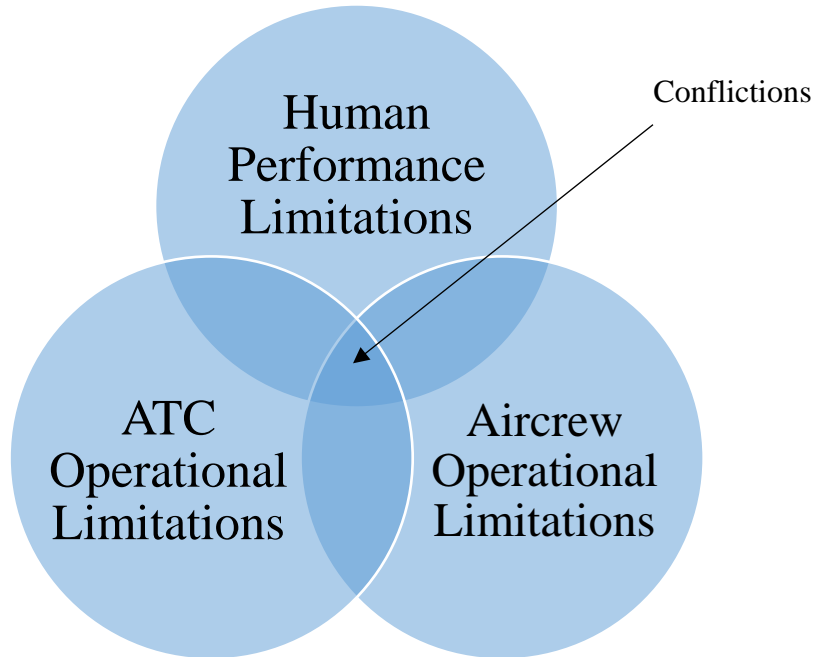
Figure 3: Risk driver relationships and interactions

From this review, three key elements of conflicts, including their relationships, were identified as summarized below, as well as in Figure 3.

Where limitations in Figure 3 overlap and interact, conflicts are more likely to occur. The following sections describe these interactions in greater detail.

Based on the drivers in Figure 3, identifying probable confliction locations within Canada required S&Q to explore areas with a mixed requirement for ATC clearances, communication, navigation and surveillance, coupled with significant mixed flight rules and performance elements. Further review suggests that this complexity occurs more frequently within Class E airspace, where VFR aircraft operate without the element of a control service and where transponder requirements vary in accordance with the Designated Airspace Handbook. Consequently, Class E airspace is a probable driver for conflictions within controlled airspace.

Recalling Figure 3, prominent best practices surfaced towards the development, maintaining and recovering of situational awareness and may largely be divided by perspective.

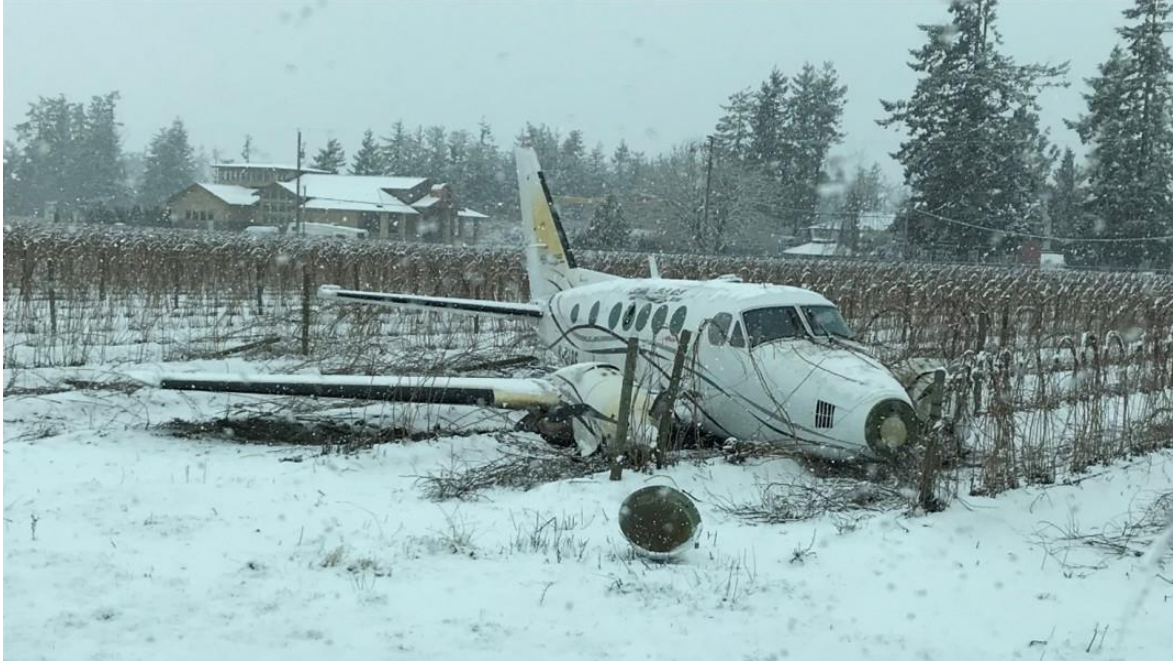
Figure 1: Occurrence aircraft where it came to rest (Source: Transport Canada)

The impact point was between Runway 07 and Taxiway C. The terrain at the initial point of collision was flat and not frozen at the time of the occurrence; however, it was covered by approximately 3 cm of snow. After the initial collision with terrain, the aircraft skidded about 760 ft across the ground and Taxiway C before it came to rest in a raspberry patch about 800 ft left of the runway centreline and about 7 500 ft from the runway threshold (Figure 1). The left wing broke off, just outboard of the left engine nacelle during the impact sequence.
