DCIEM No. 88-TR-16

EJECTION SYSTEMS
and
THE HUMAN FACTOR:
A GUIDE FOR FLIGHT SURGEONS
AND AEROMEDICAL TRAINERS

Defence and Civil Institute of Environmental Medicine
1133 Sheppard Avenue West
P.O. Box 2000
Downsview, Ontario M3M 3B9

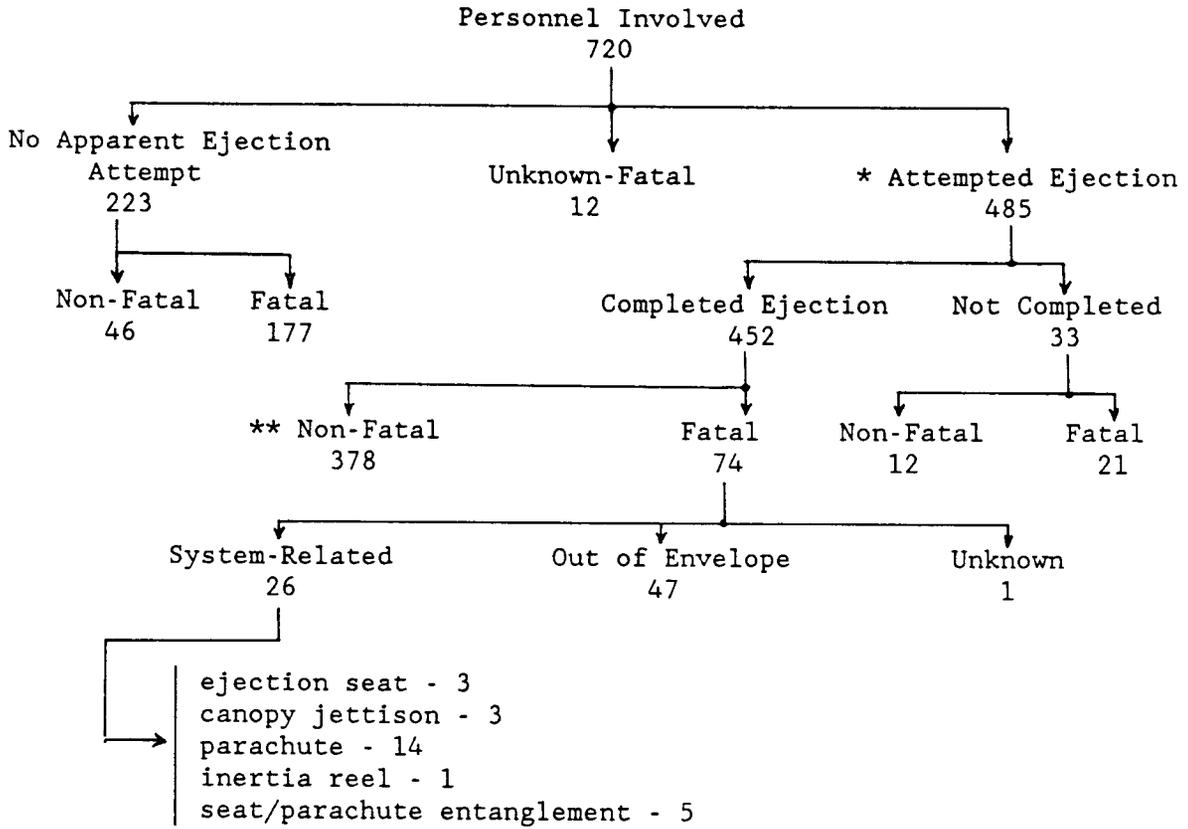
Table 6. RCAF/CF Ejection Seat Mishaps - April 52 to Dec 87

* includes 5 bail-outs and 3 inadvertent ejections

** includes 2 cases of fatal hypothermia and 3 drownings

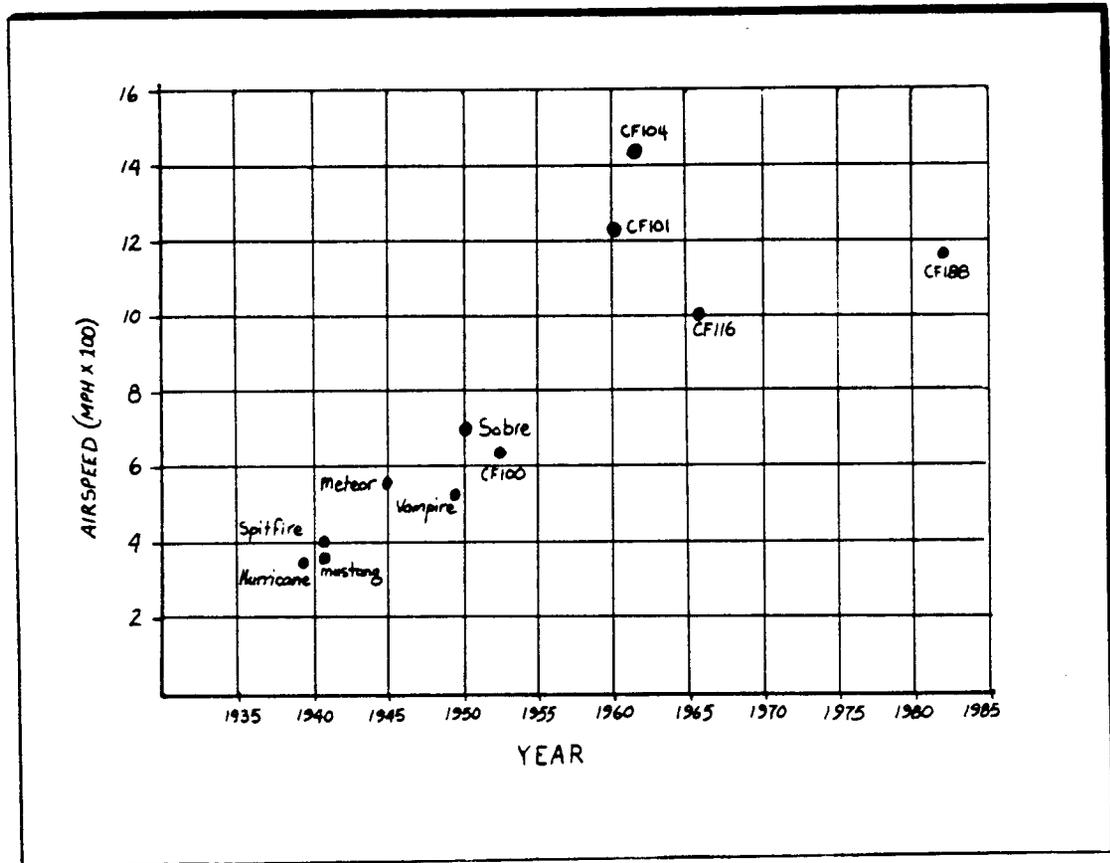
Figure 1. Aircraft Airspeed - 1940-1985

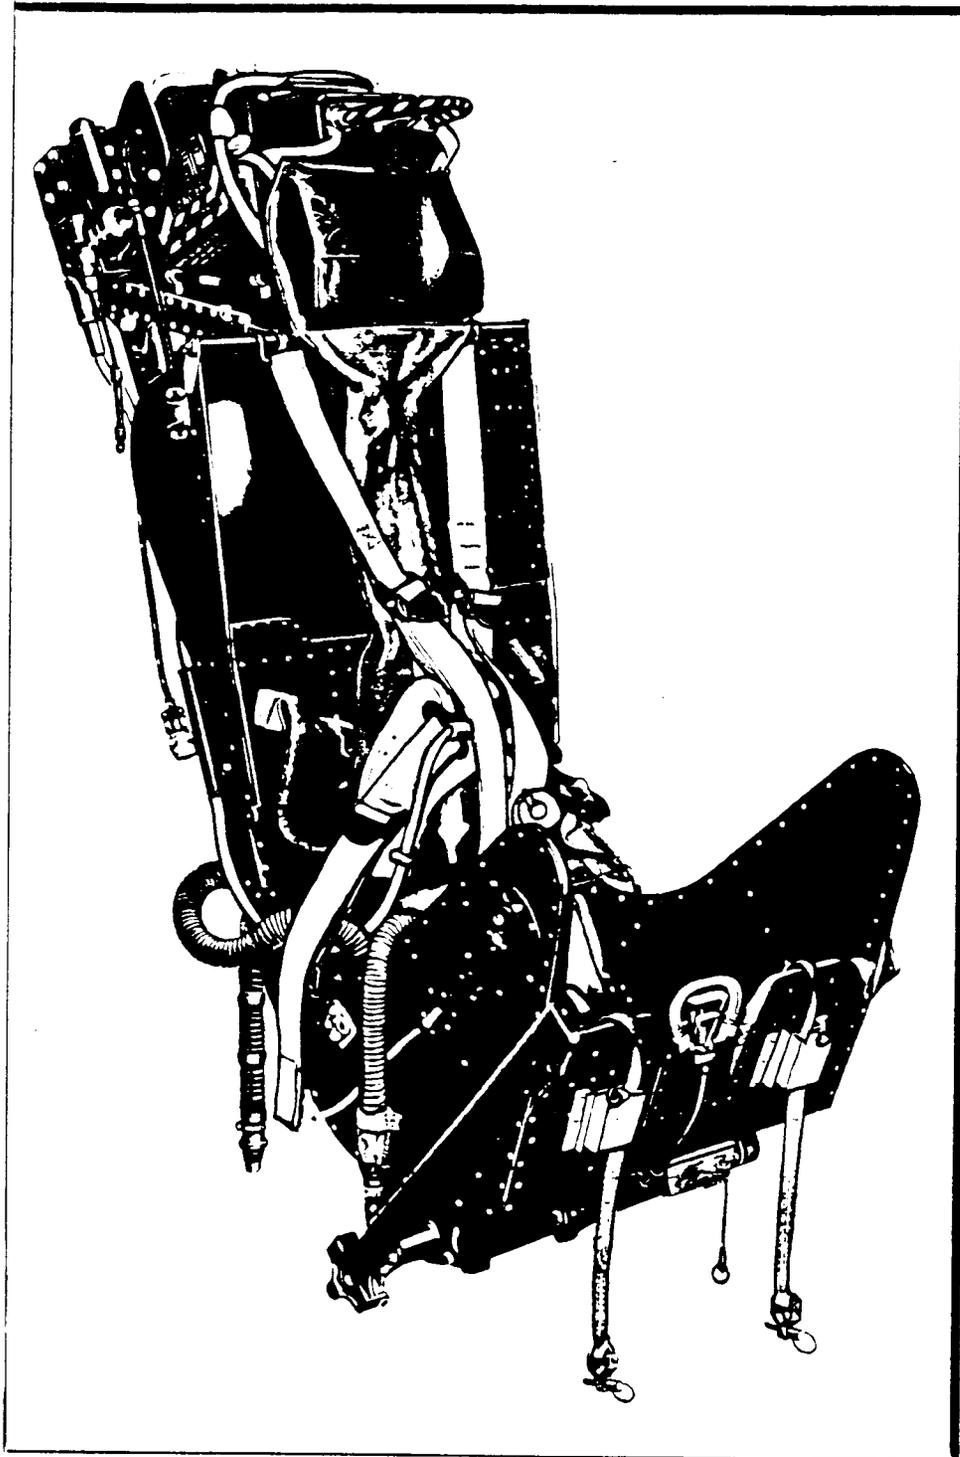
Figure 2. The CF100 Ejection Seat (1967)
(EO-55-50-2C)

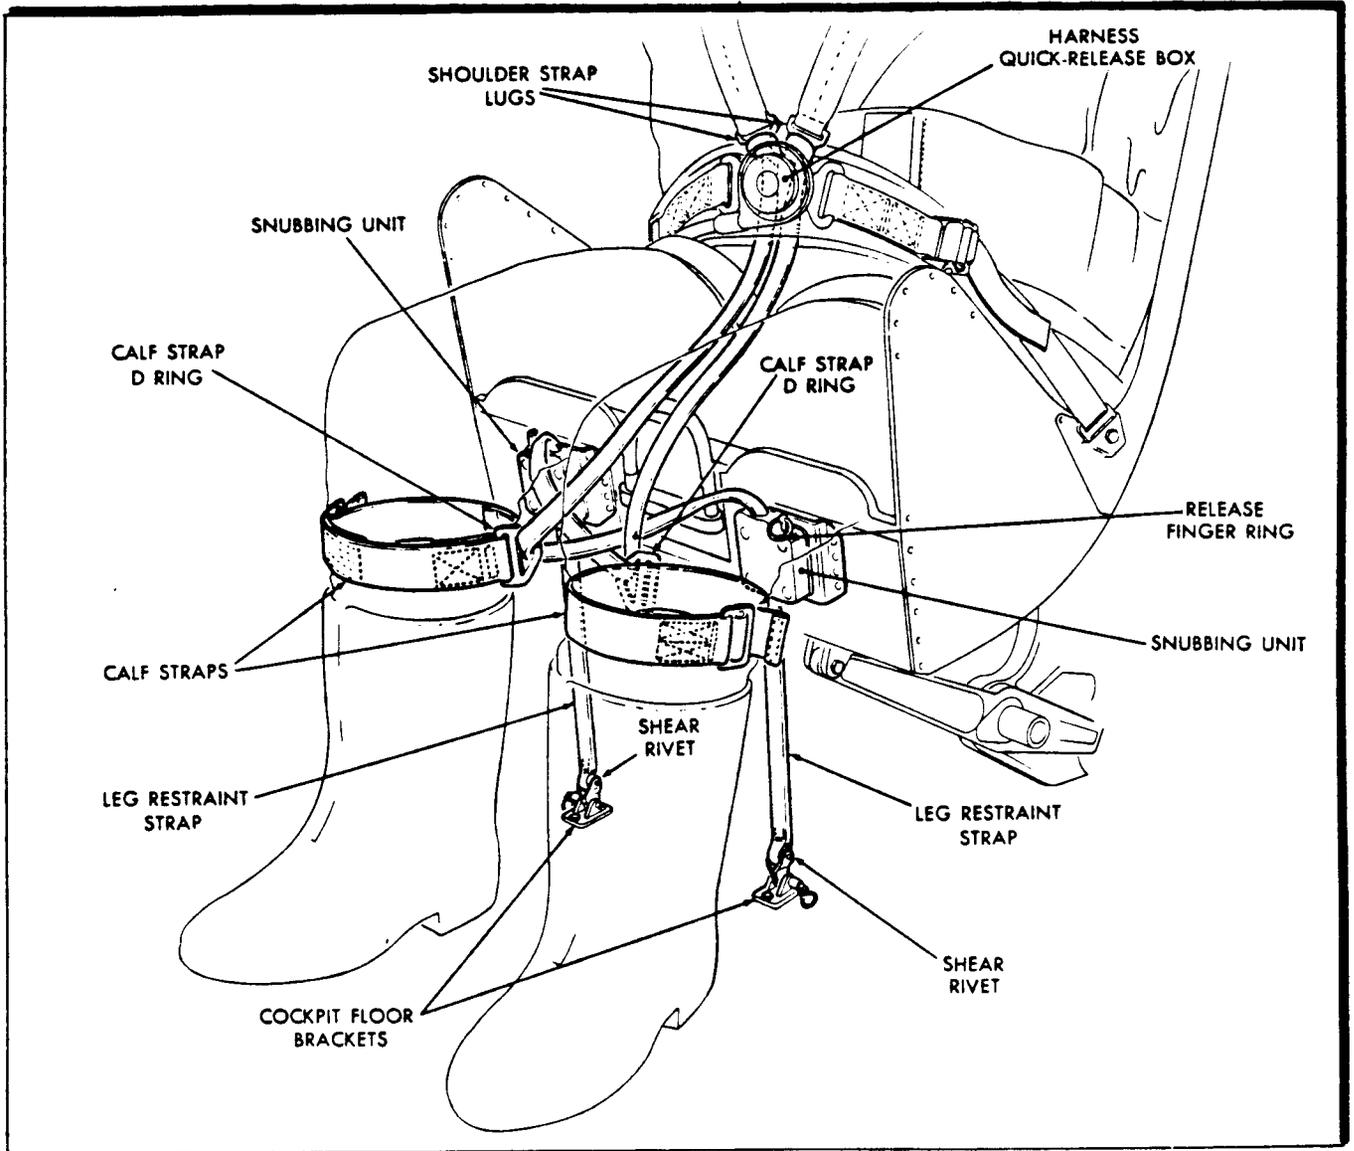
Figure 3.a. Leg Restraint System

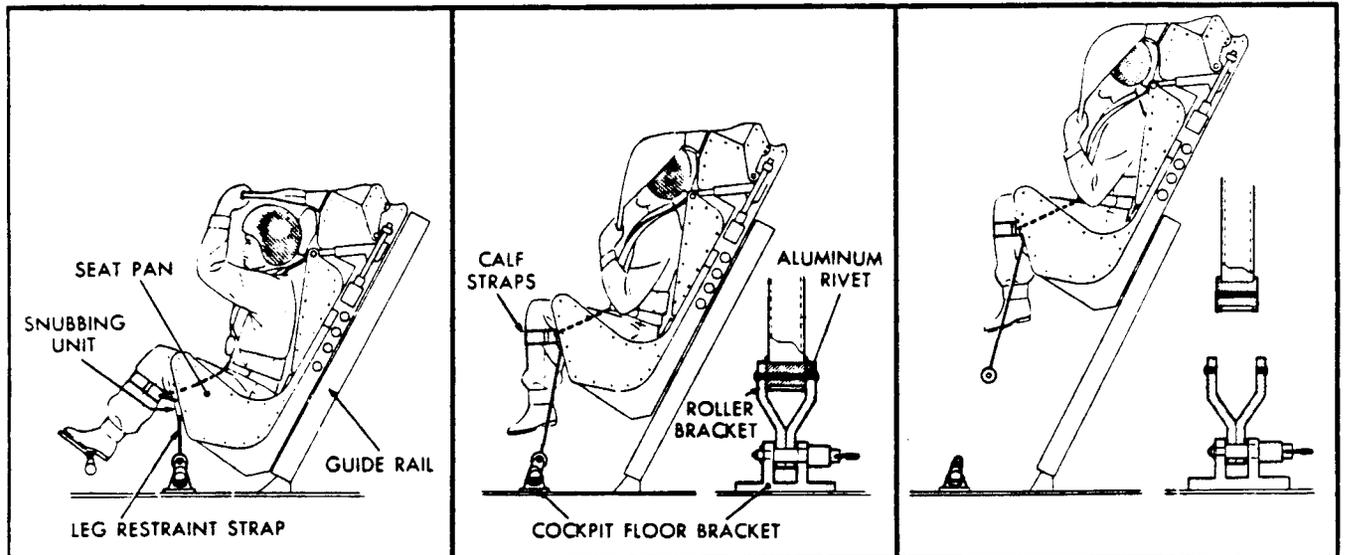
Figure 3.b. Operation of the Leg Restraint System

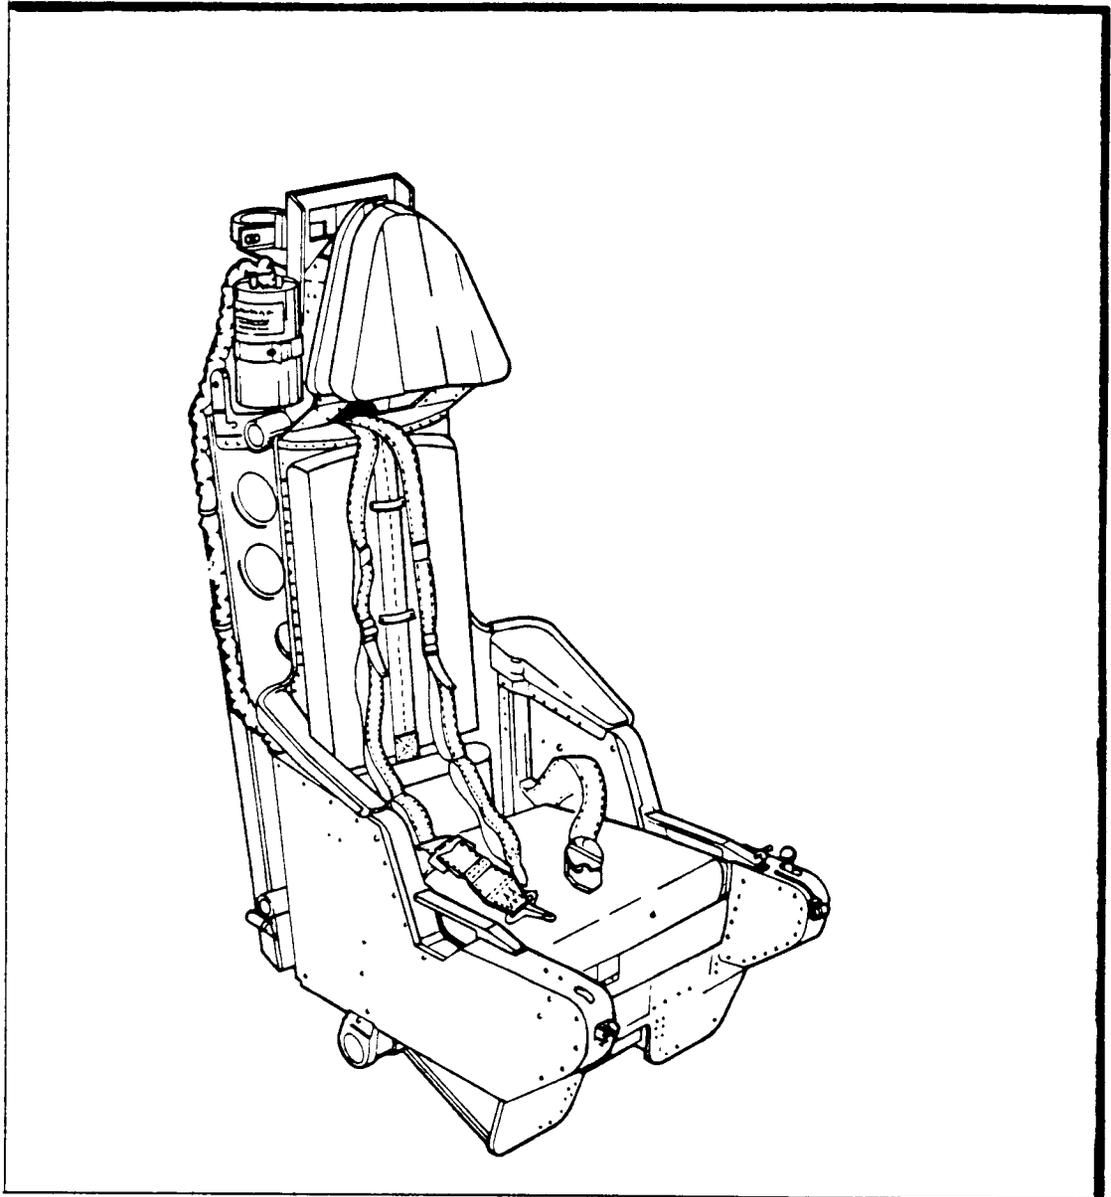
Figure 4. CF101 Ejection Seat (T.O. 13A5-18-3)

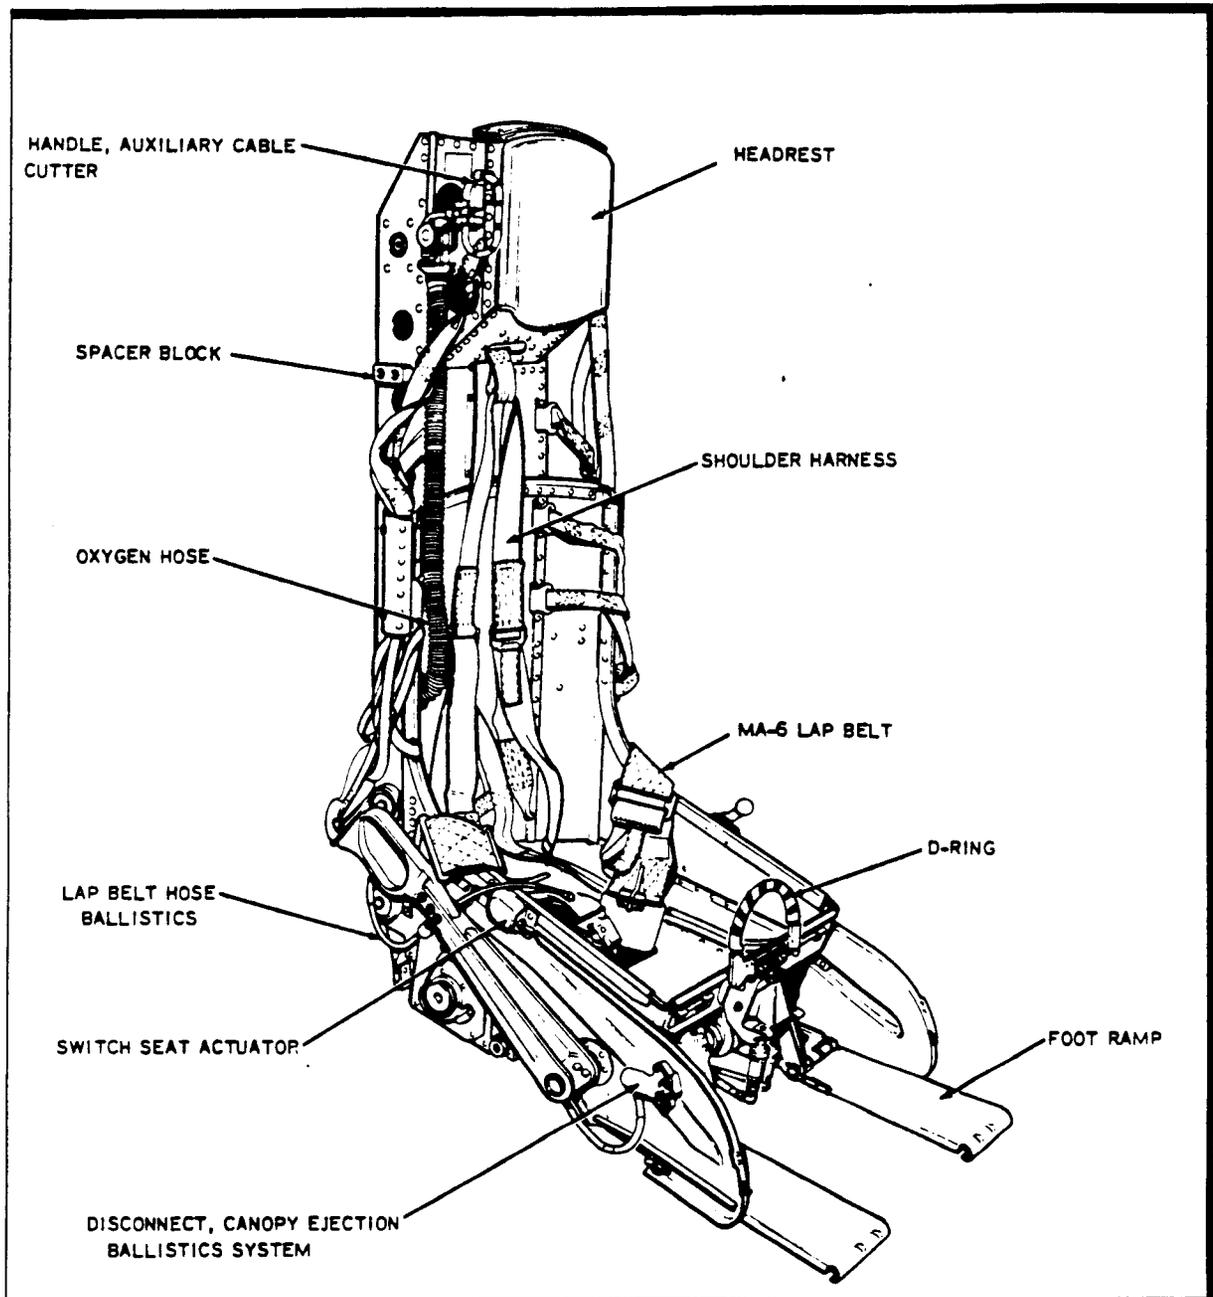
Figure 5. CF104 Ejection Seat (EO 55-50A-3)

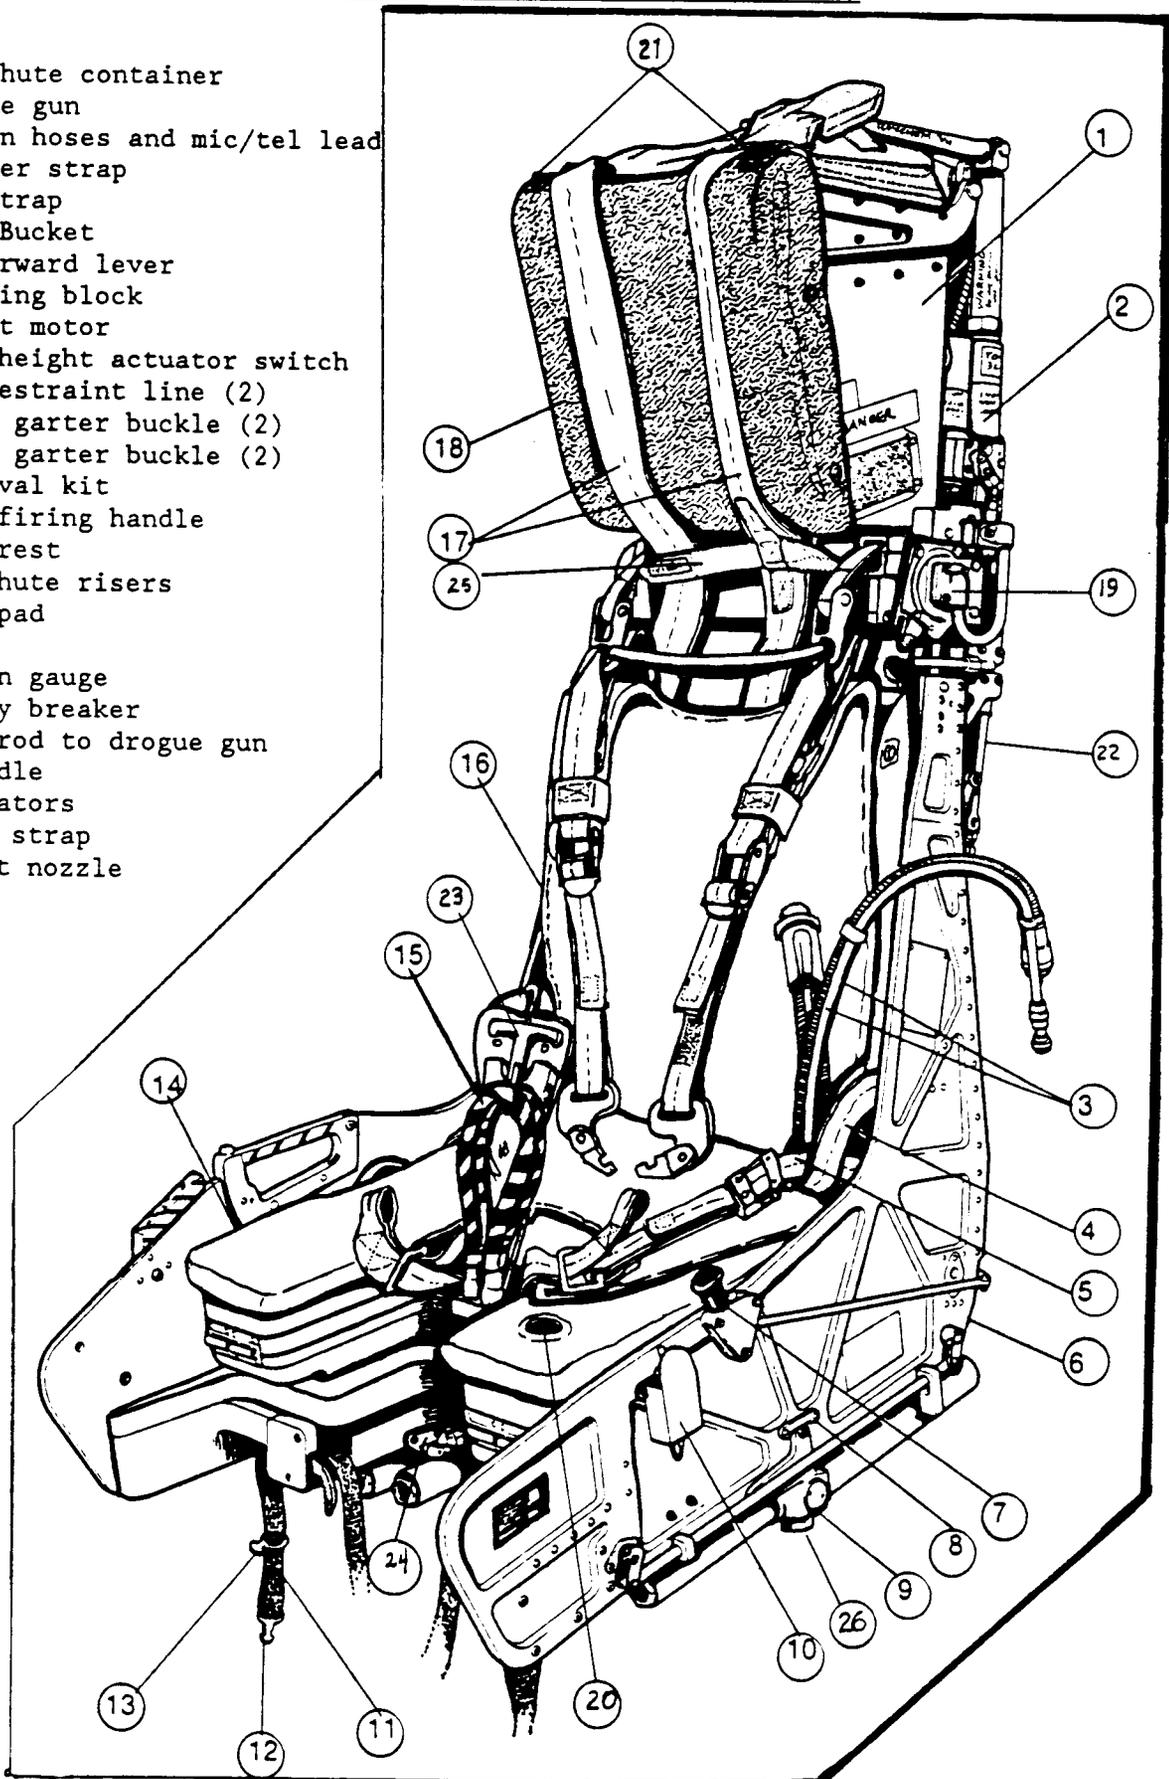
Figure 6. SJU-9/A CF188 Ejection Seat (left-hand view)

1. Parachute container
2. Drogue gun
3. Oxygen hoses and mic/tel lead
4. Sticker strap
5. Lap strap
6. Seat Bucket
7. Go-forward lever
8. Locating block
9. Rocket motor
10. Seat height actuator switch
11. Leg restraint line (2)
12. Lower garter buckle (2)
13. Upper garter buckle (2)
14. Survival kit
15. Seat firing handle
16. Back rest
17. Parachute risers
18. Head pad
19. BIR
20. Oxygen gauge
21. Canopy breaker
22. Trip rod to drogue gun
23. T handle
24. Initiators
25. Cross strap
26. rocket nozzle

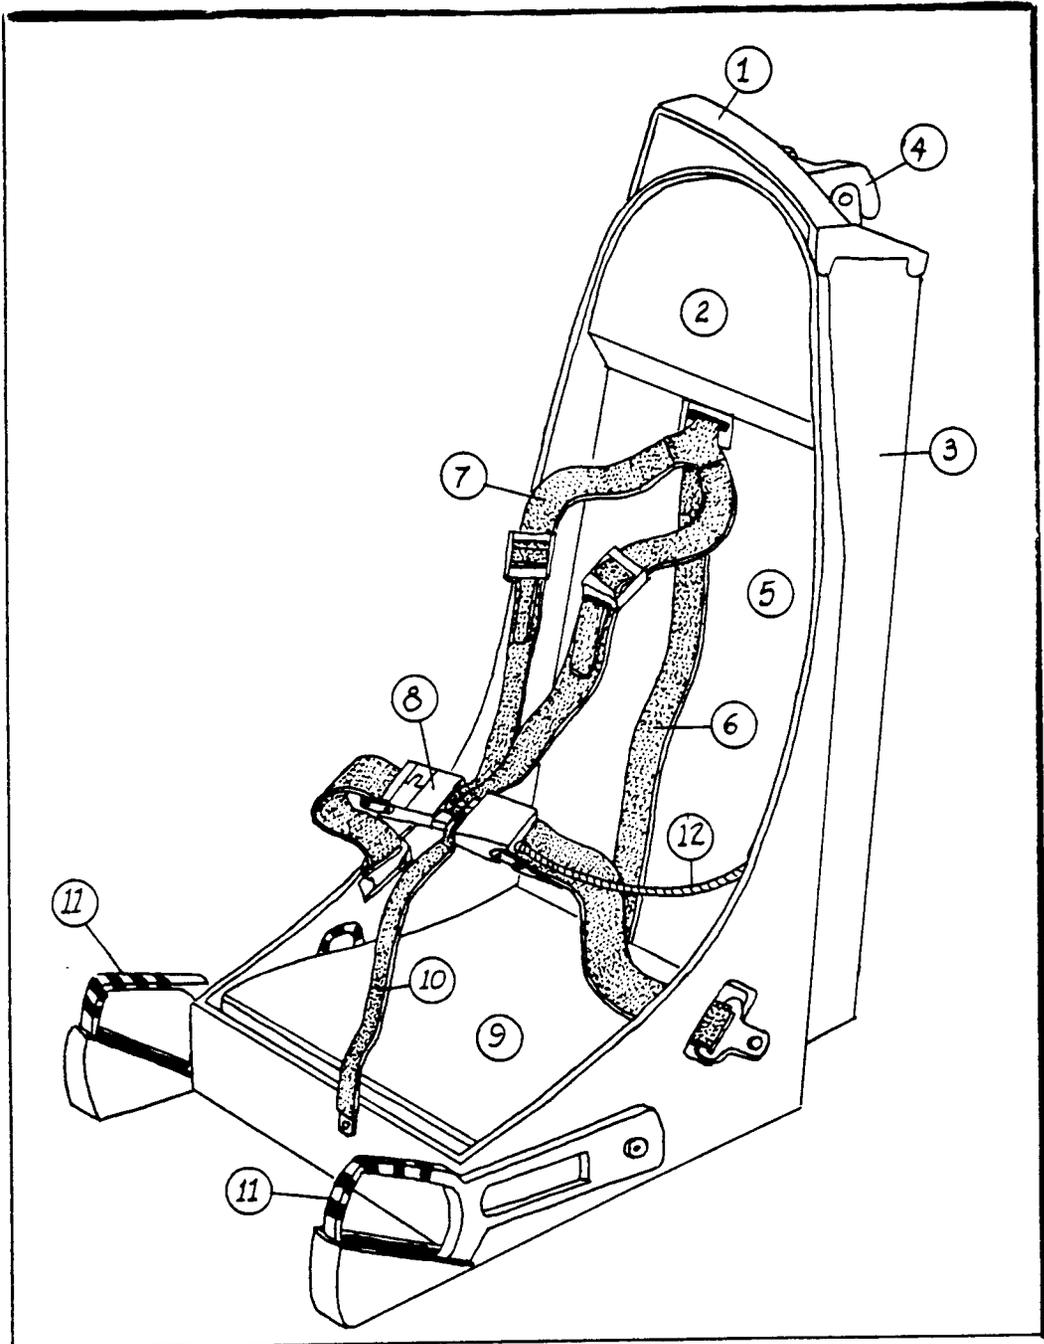
Figure 7.a. BASIC COMPONENTS OF CONVENTIONAL EJECTION SEAT Showing: canopy breaker (1), headrest (2), seat frame(3), ROCAT attachment (4), seat bucket (5), rotary actuator (6), shoulder harness (7), RPI lap belt (8), seat kit (9), negative-G strap (10), ejection handles (11) and ballistic hose (12).

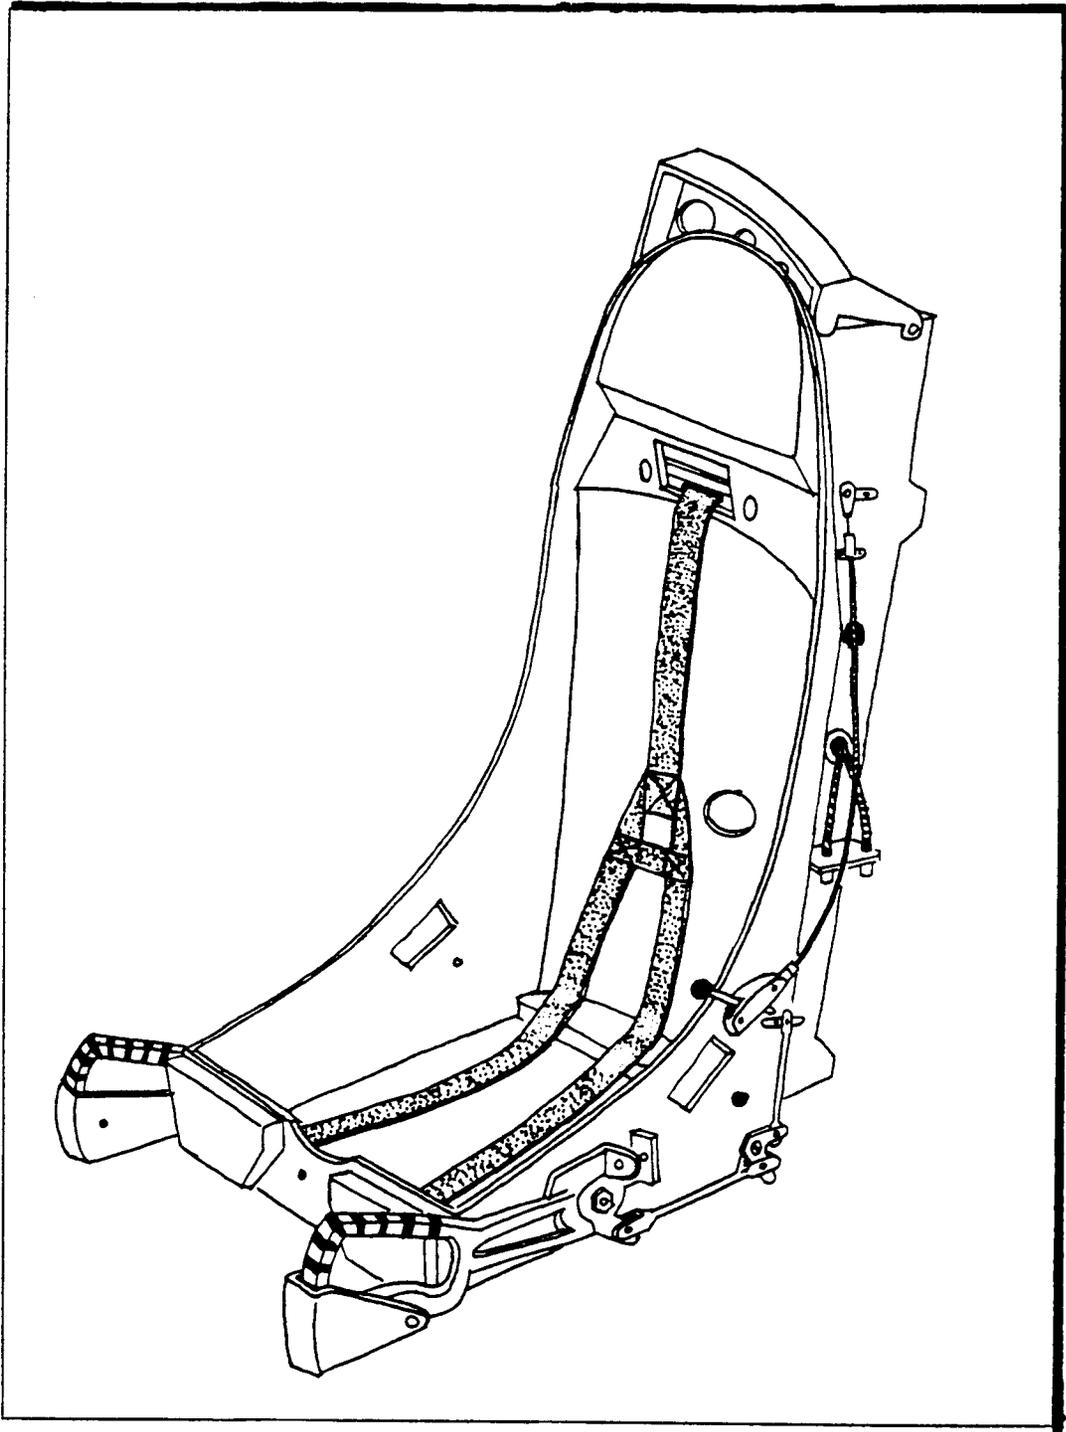
Figure 7.b. CT114 Ejection Seat Schematic showing Rotary Actuator Webbing

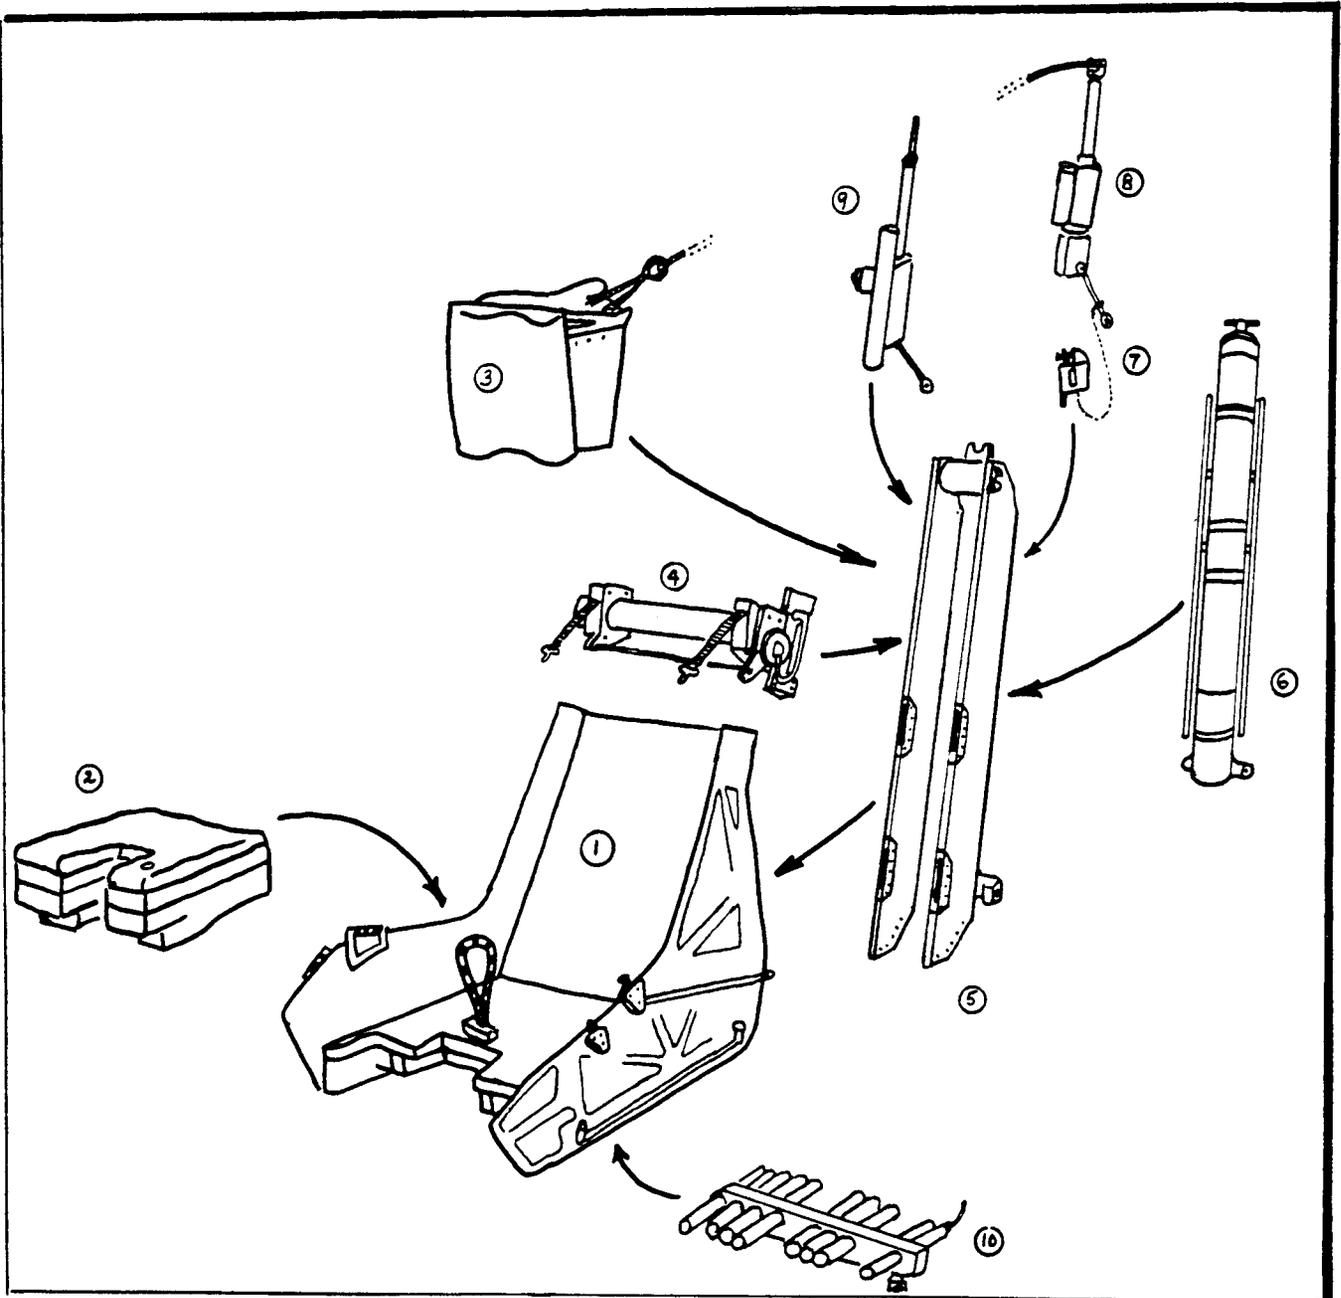
Figure 7.c. CF188 Ejection Seat Components

| 4. Ballistic Inertia Reel | 9. Barostatic time delay/G limiter/

shackle release |

| 5. Main Beams | 10. Rocket Motor |

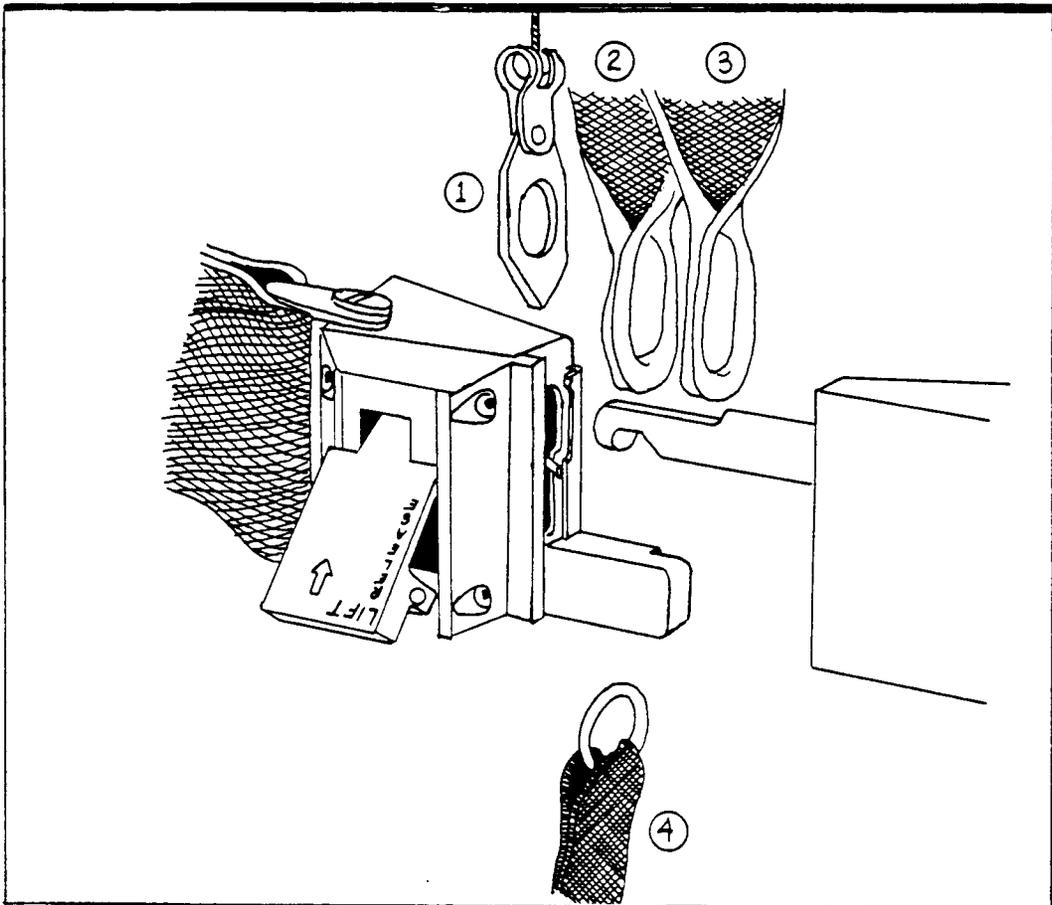
Figure 8.a. RPI Lap Belt Buckle showing: parachute arming key (1) right shoulder harness (2), left shoulder harness (3) and negative-G strap (4).

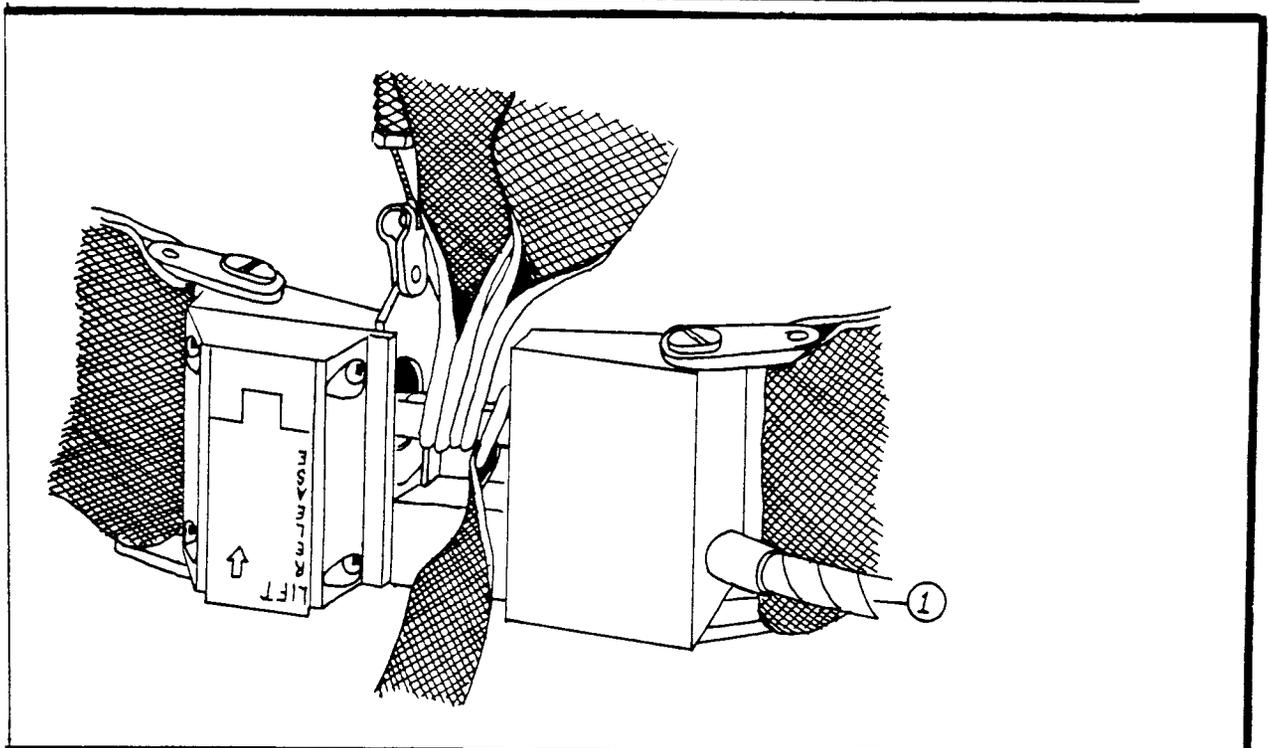
Figure 8.b. RPI Lap Belt in Lock Position showing: ballistic cable (1)

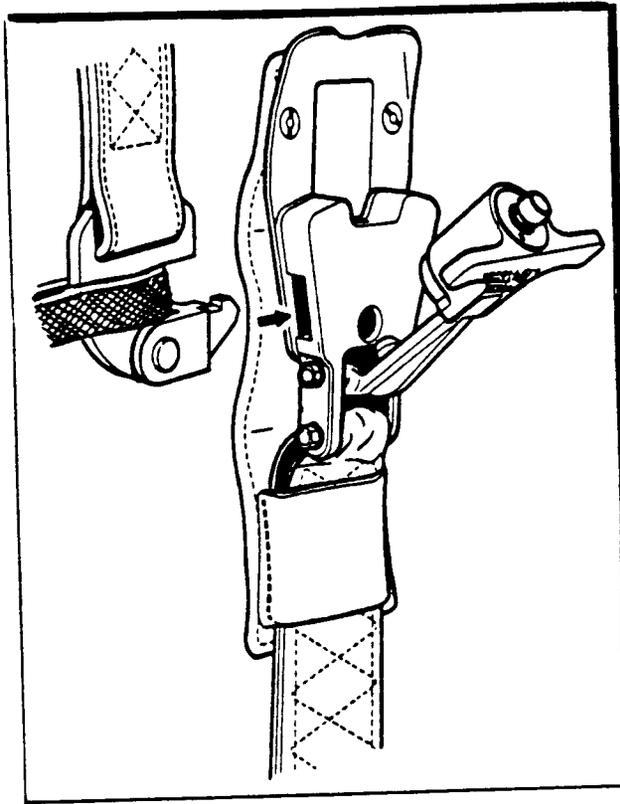
Figure 9.a. Quick-Release Fitting - Don Position

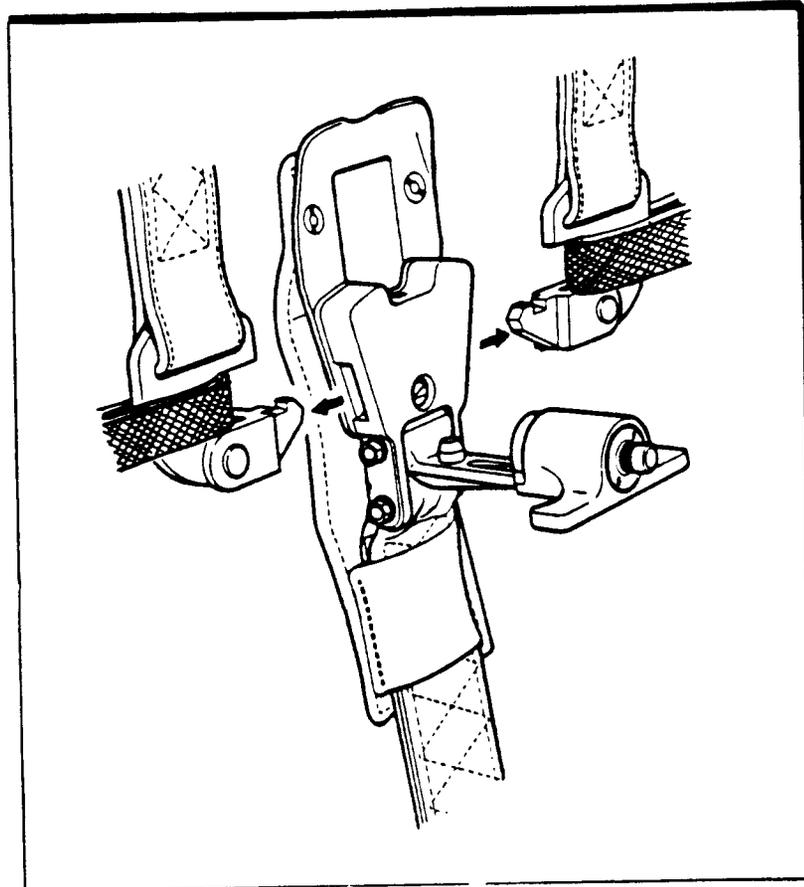
Figure 9.b. Quick-Release Fitting - Unlocked Position

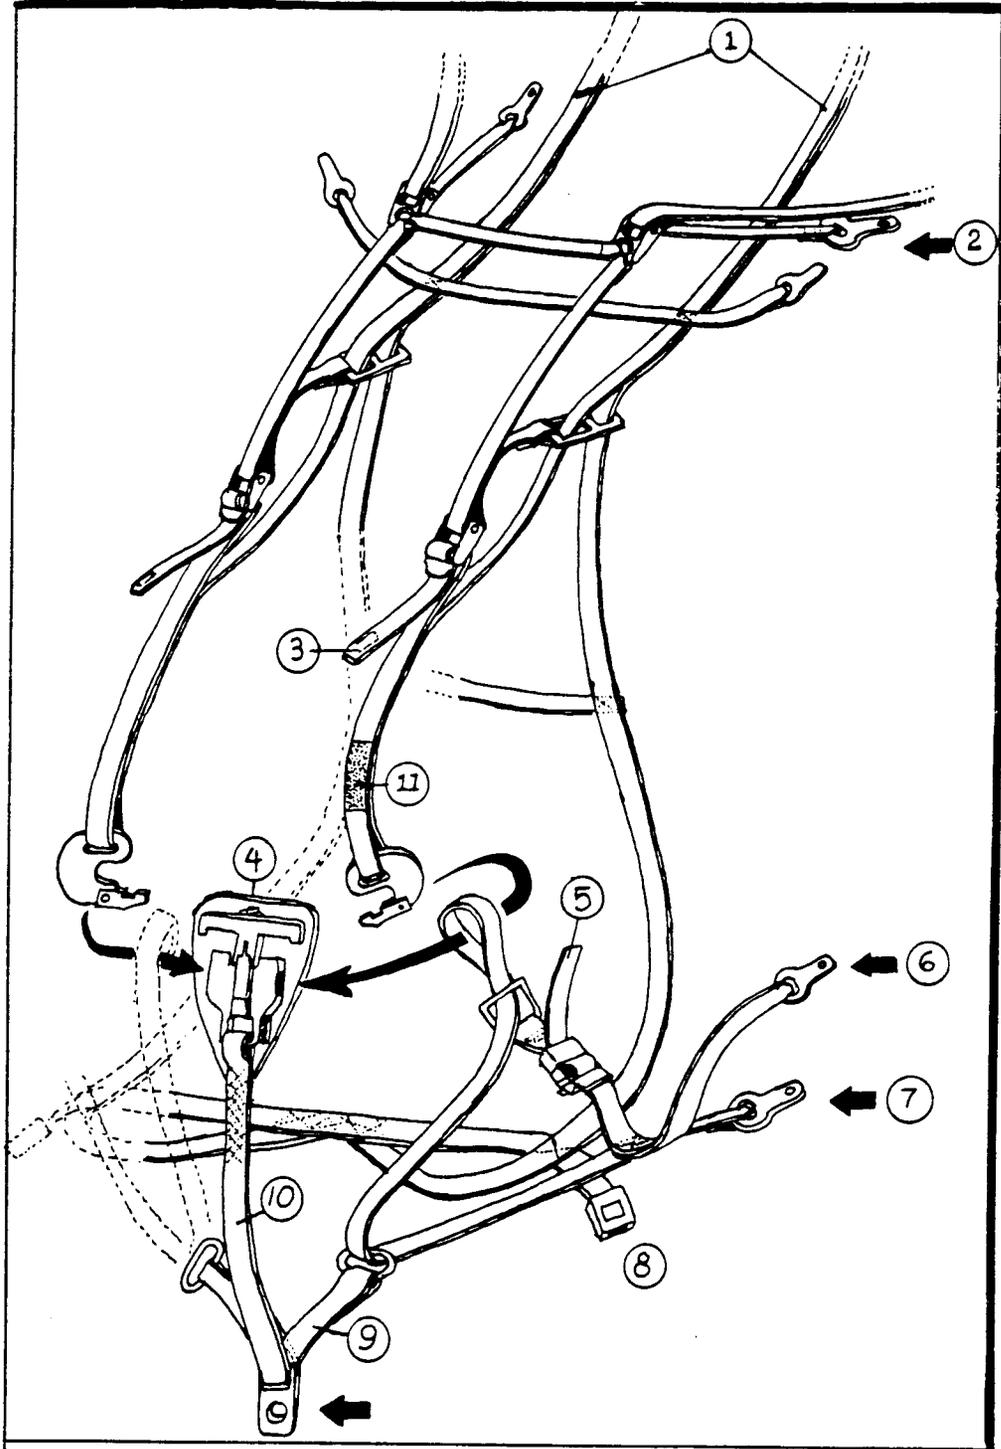
Figure 9.c. CF188 Simplified Combined Harness (SCH) showing: seat attachment points (←); risers (1), BIR attachment (2), shoulder strap adjust (3), T-handle (4), leg strap adjust (5), sticker clip (6), lower harness lock lug (7), seat pack connect (8), V-strap (9), negative-G strap (10), and velcro patch for oxygen regulator (11)

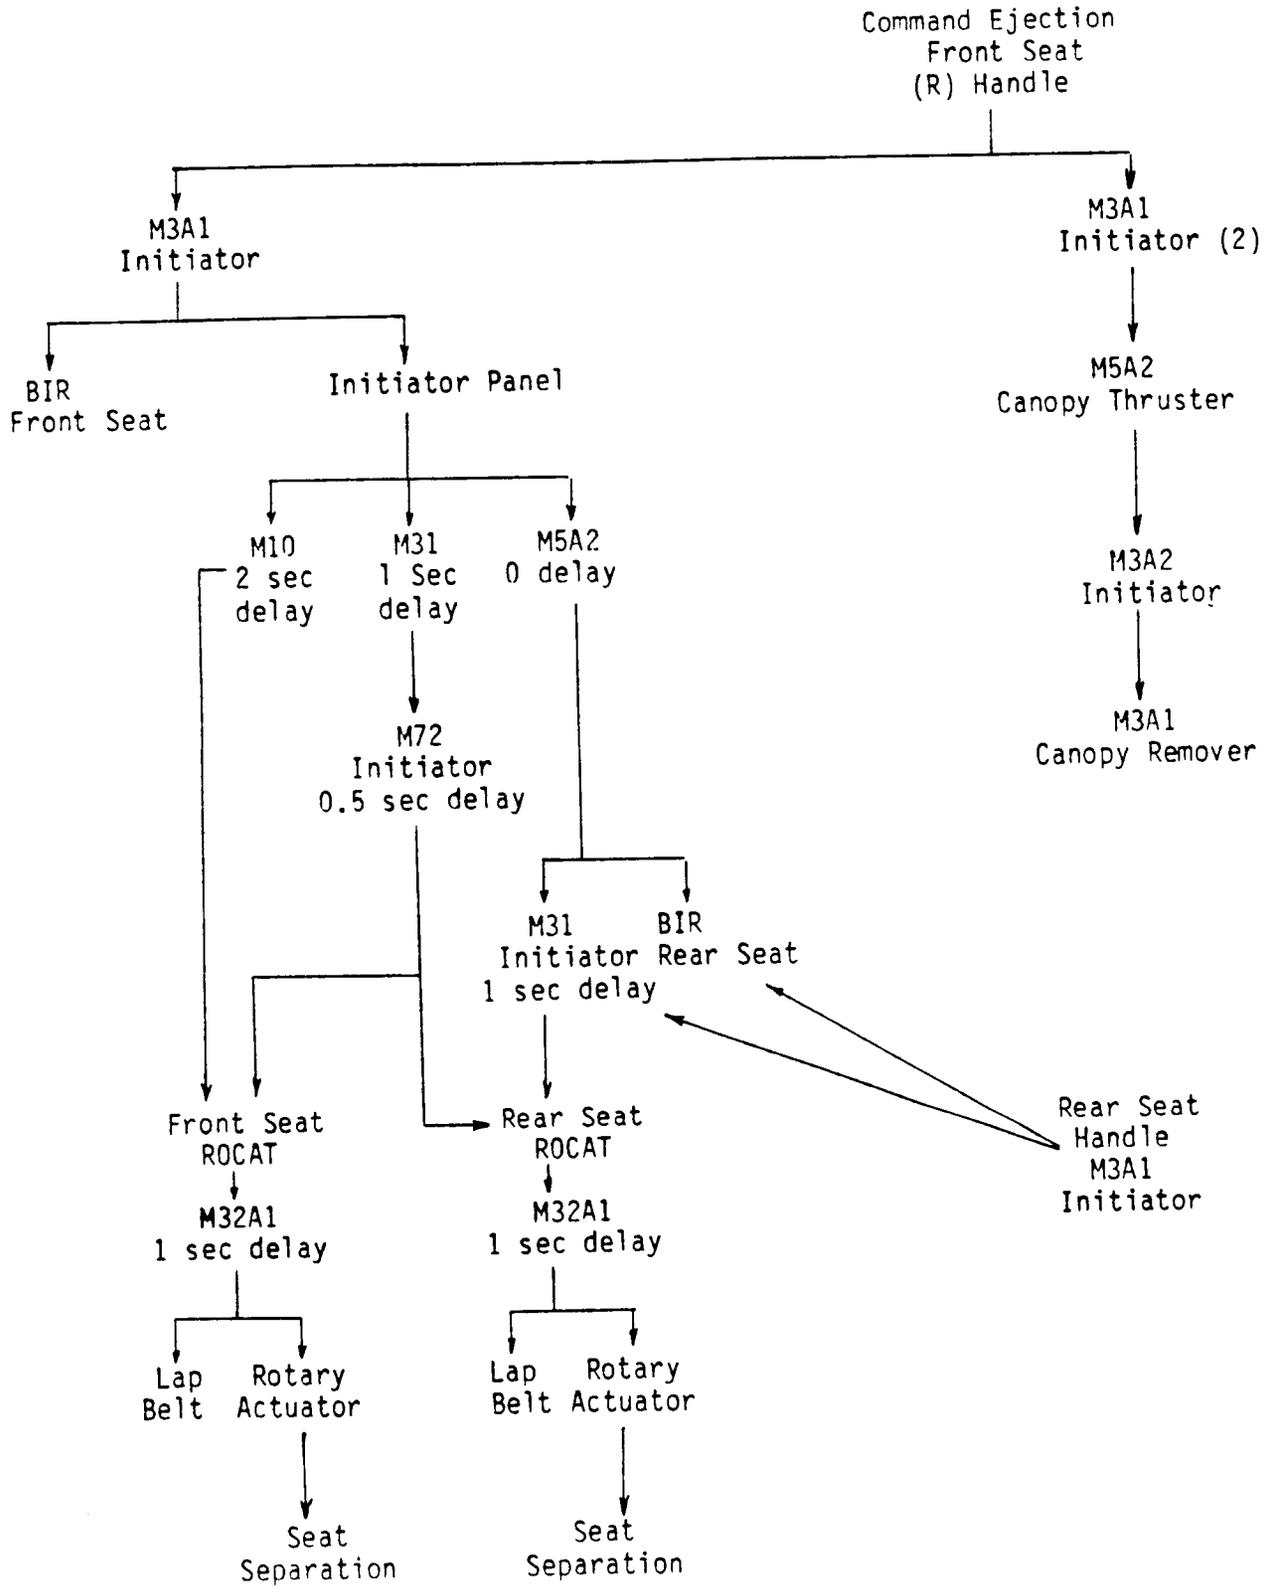
Figure 12. CT133 Ejection System Schematic
