DCIEM No. 88-TR-16

EJECTION SYSTEMS
and
THE HUMAN FACTOR:
A GUIDE FOR FLIGHT SURGEONS
AND AEROMEDICAL TRAINERS

Defence and Civil Institute of Environmental Medicine
1133 Sheppard Avenue West
P.O. Box 2000
Downsview, Ontario M3M 3B9

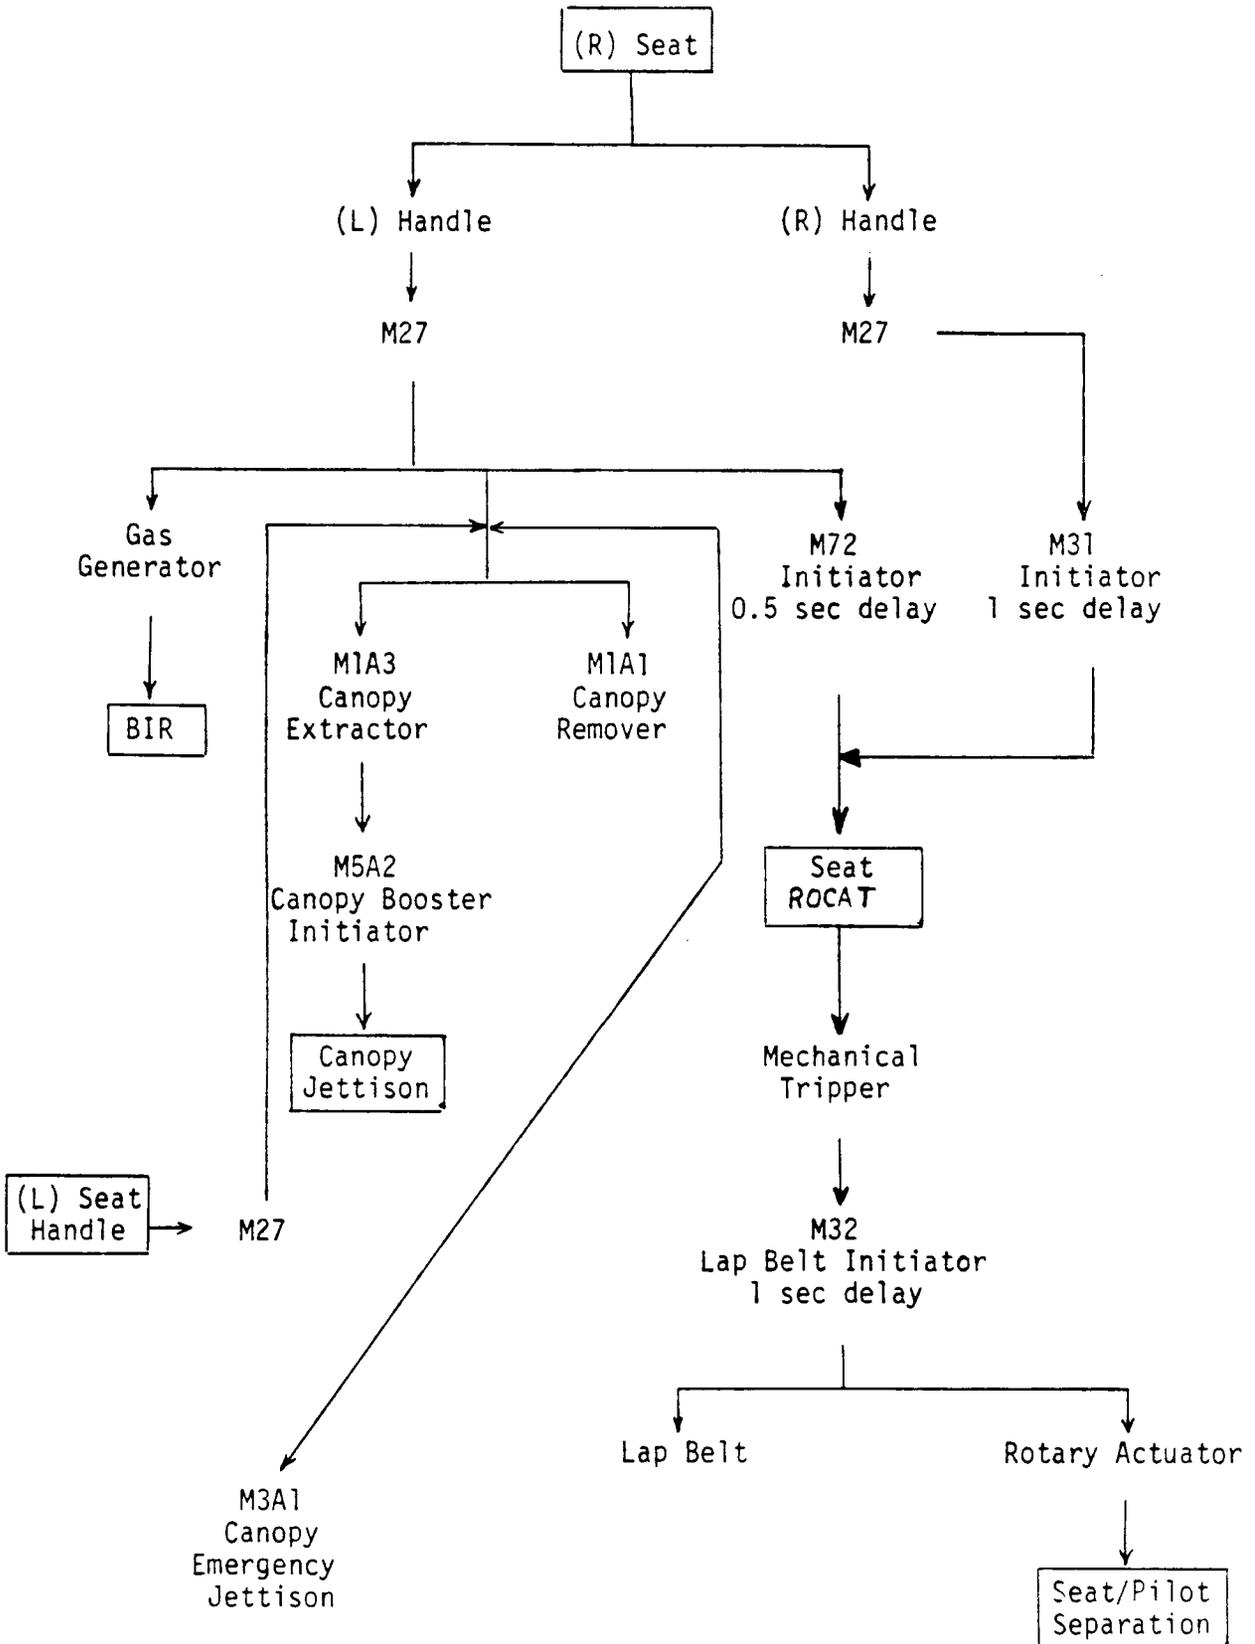
Figure 13. CT114 Ejection System Schematic

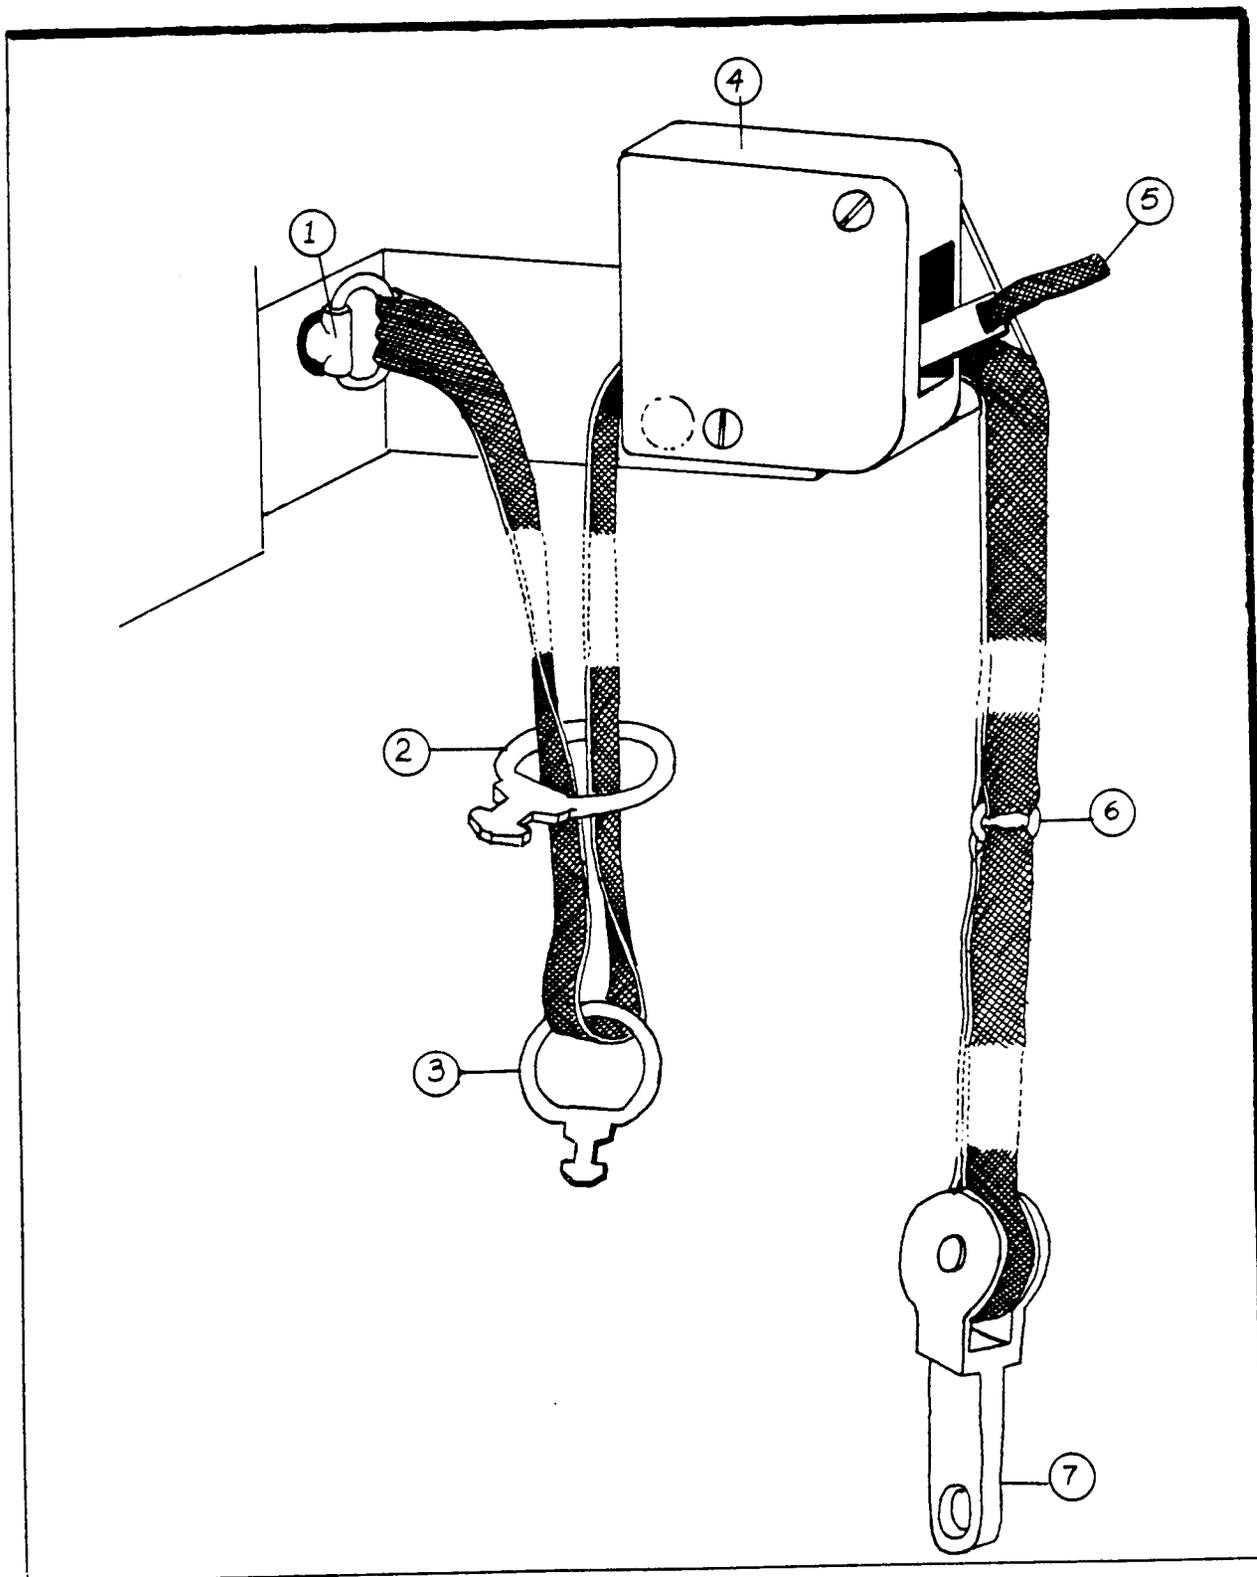
Figure 10. CF188 Leg Restraint system showing: Taper plug (1), upper garter attachment (2), lower garter attachment (3), snubbing box (4), release tab (5), break link (6), and floor attachment (7) (right-hand side)

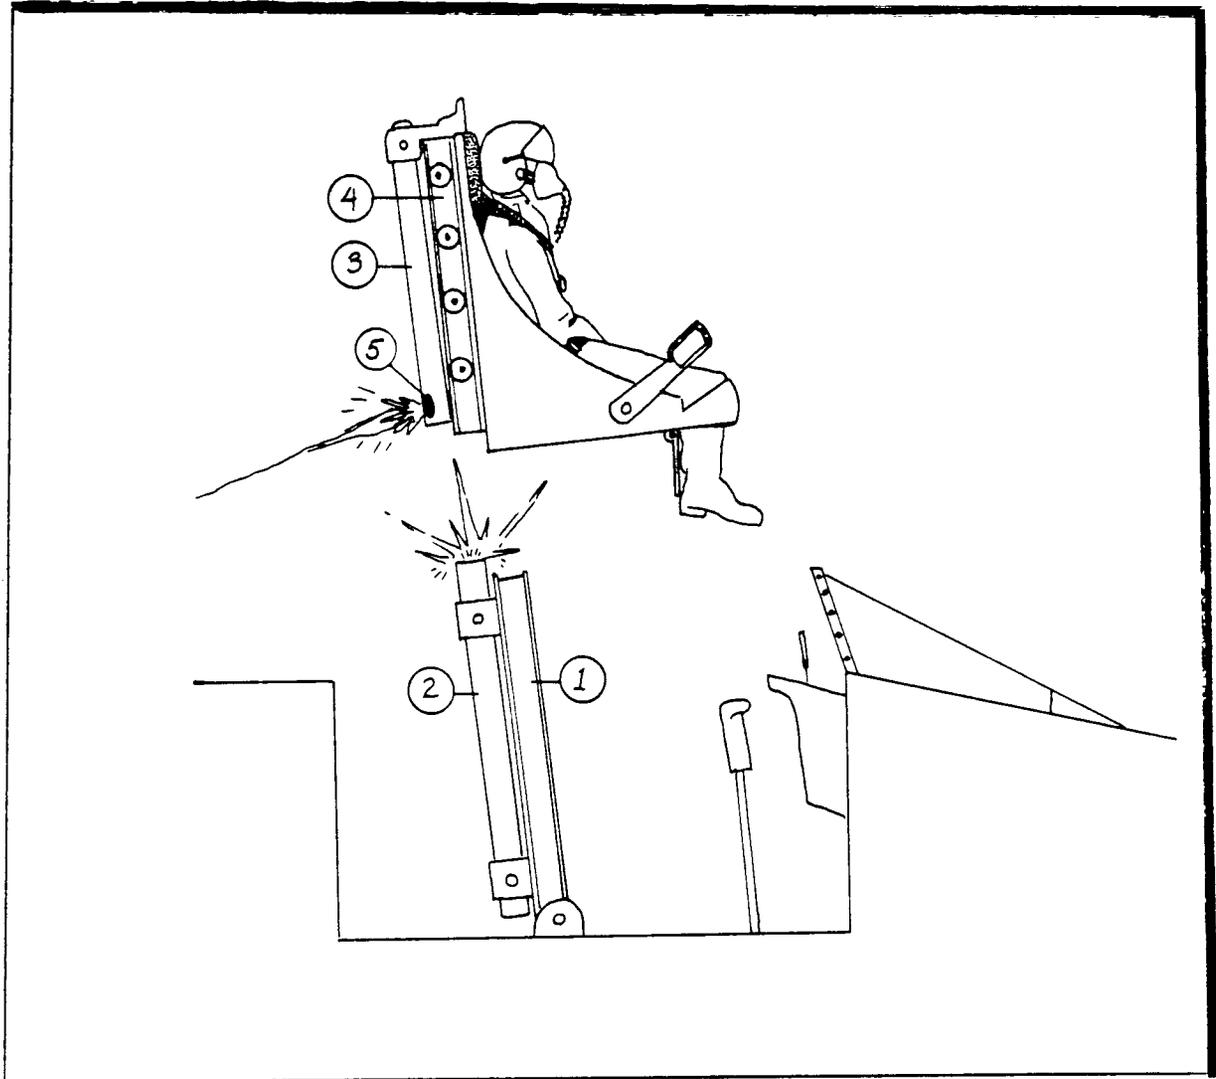
Figure 11. Conventional Rocat System
showing: ejection seat guiderail (1), catapult (2), rocket (3),
main beams (4) and venturi (5).

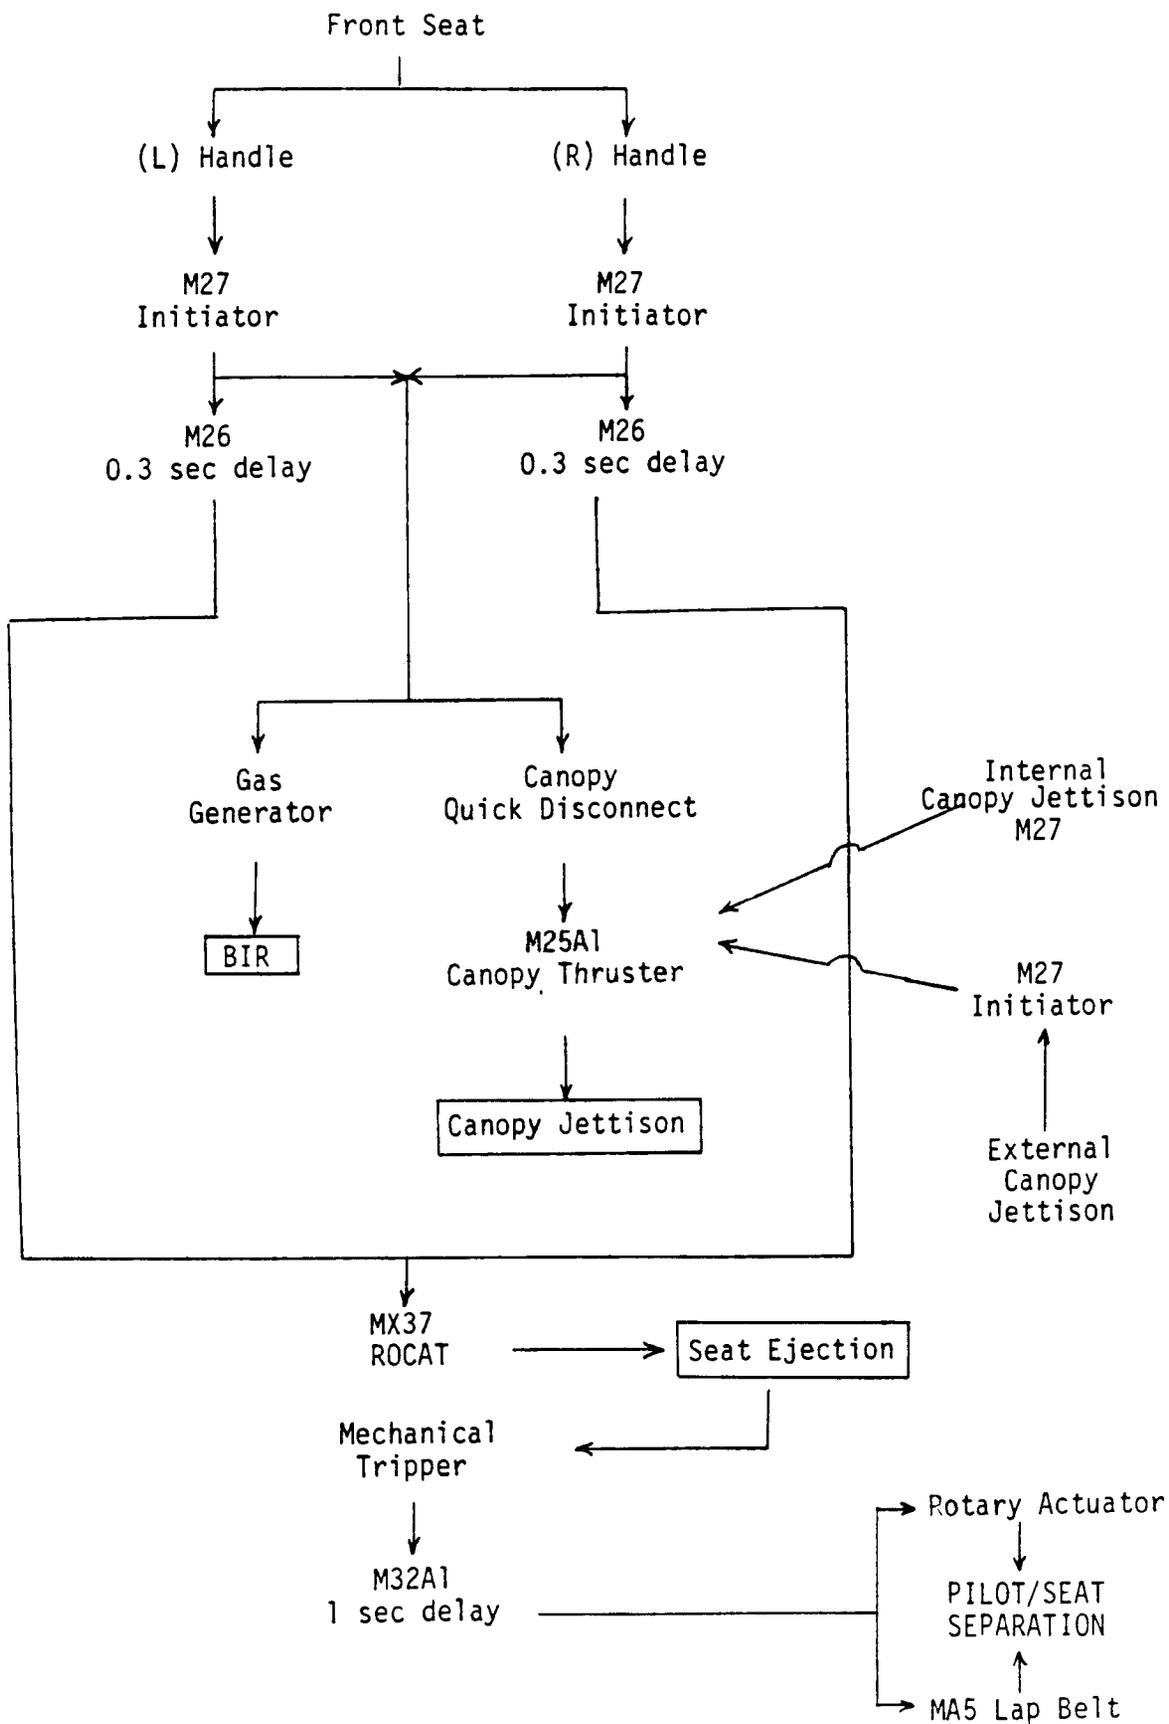
Figure 14. CF 116 Ejection System Schematic

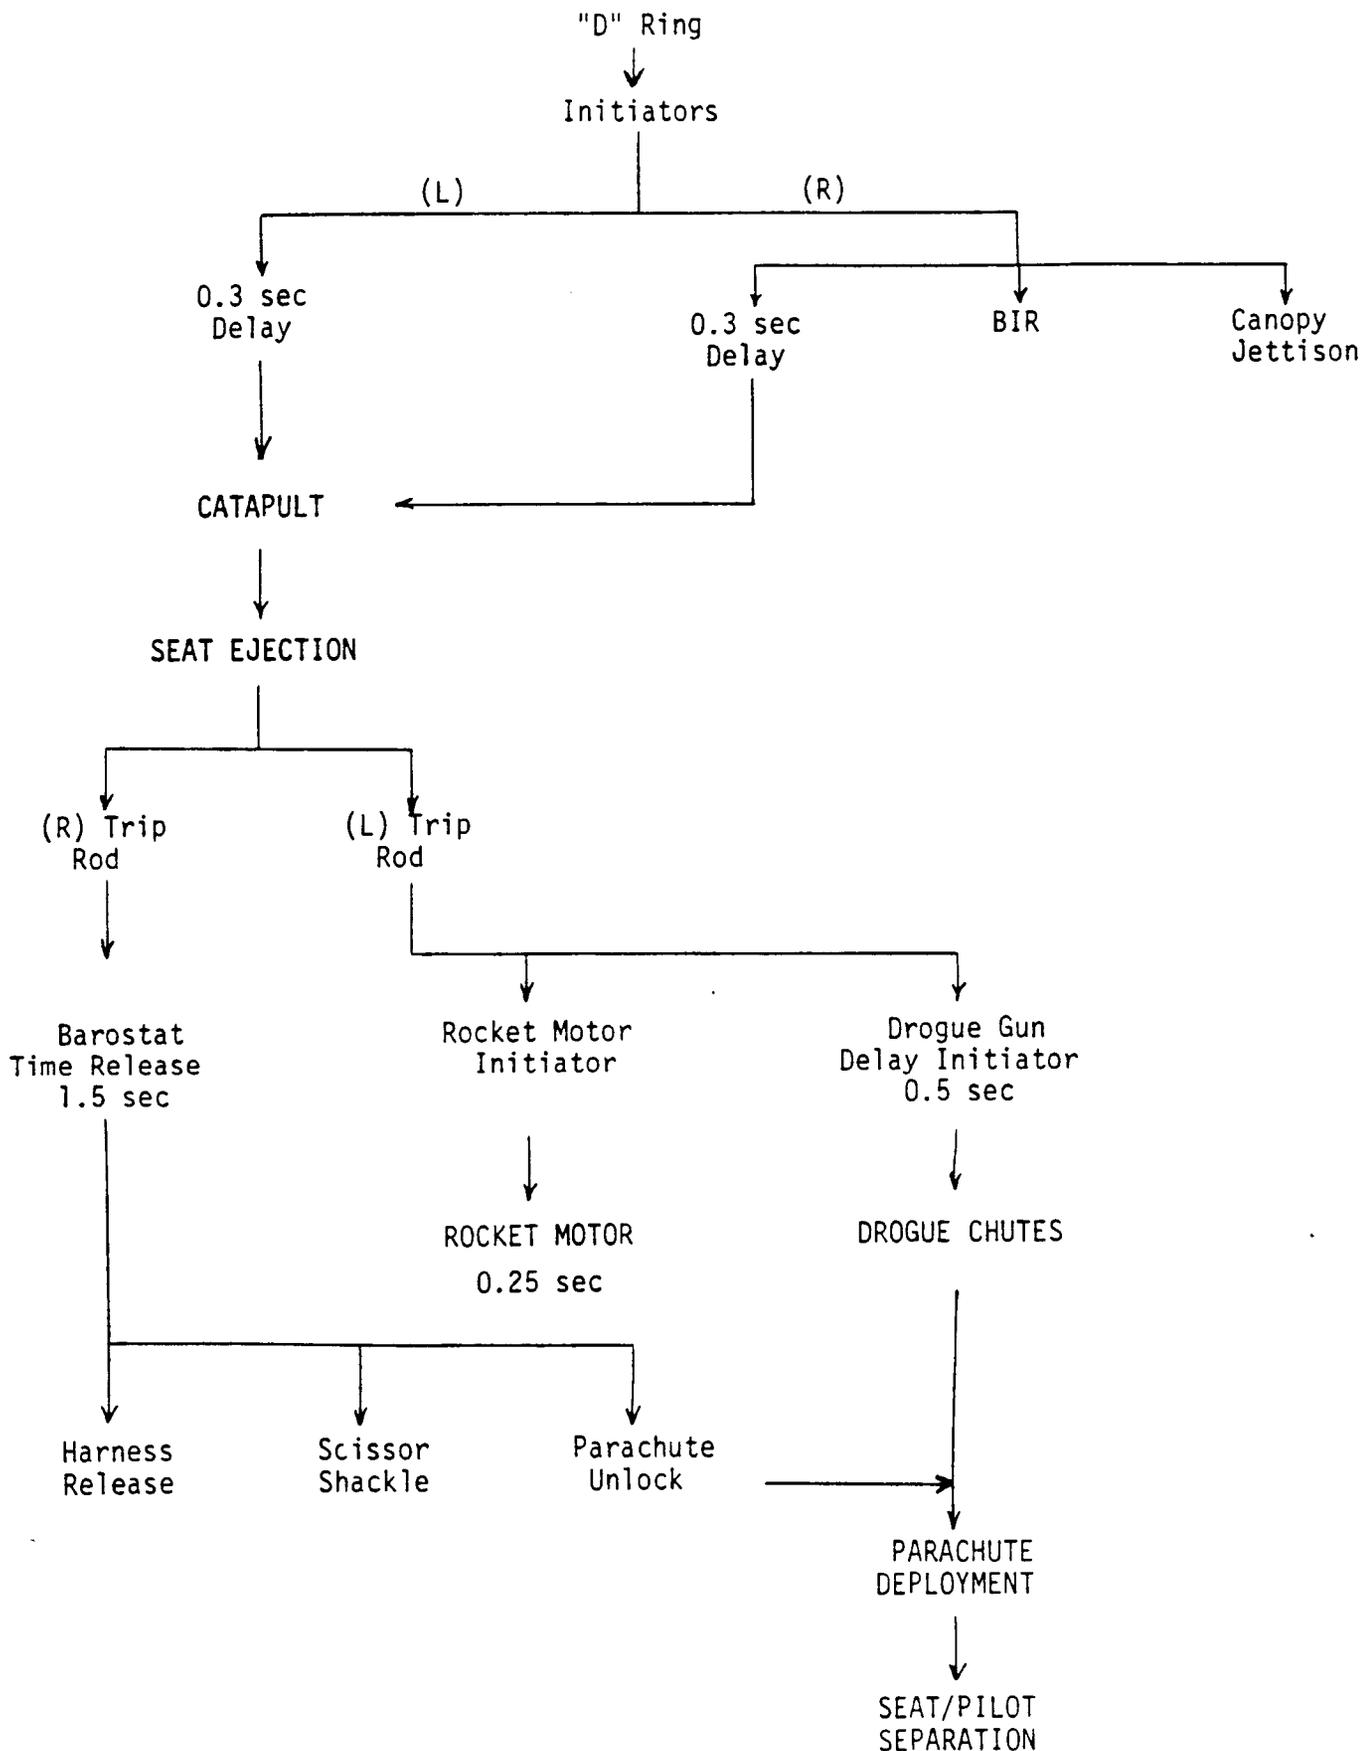
Figure 15. CF188 Ejection System Schematic

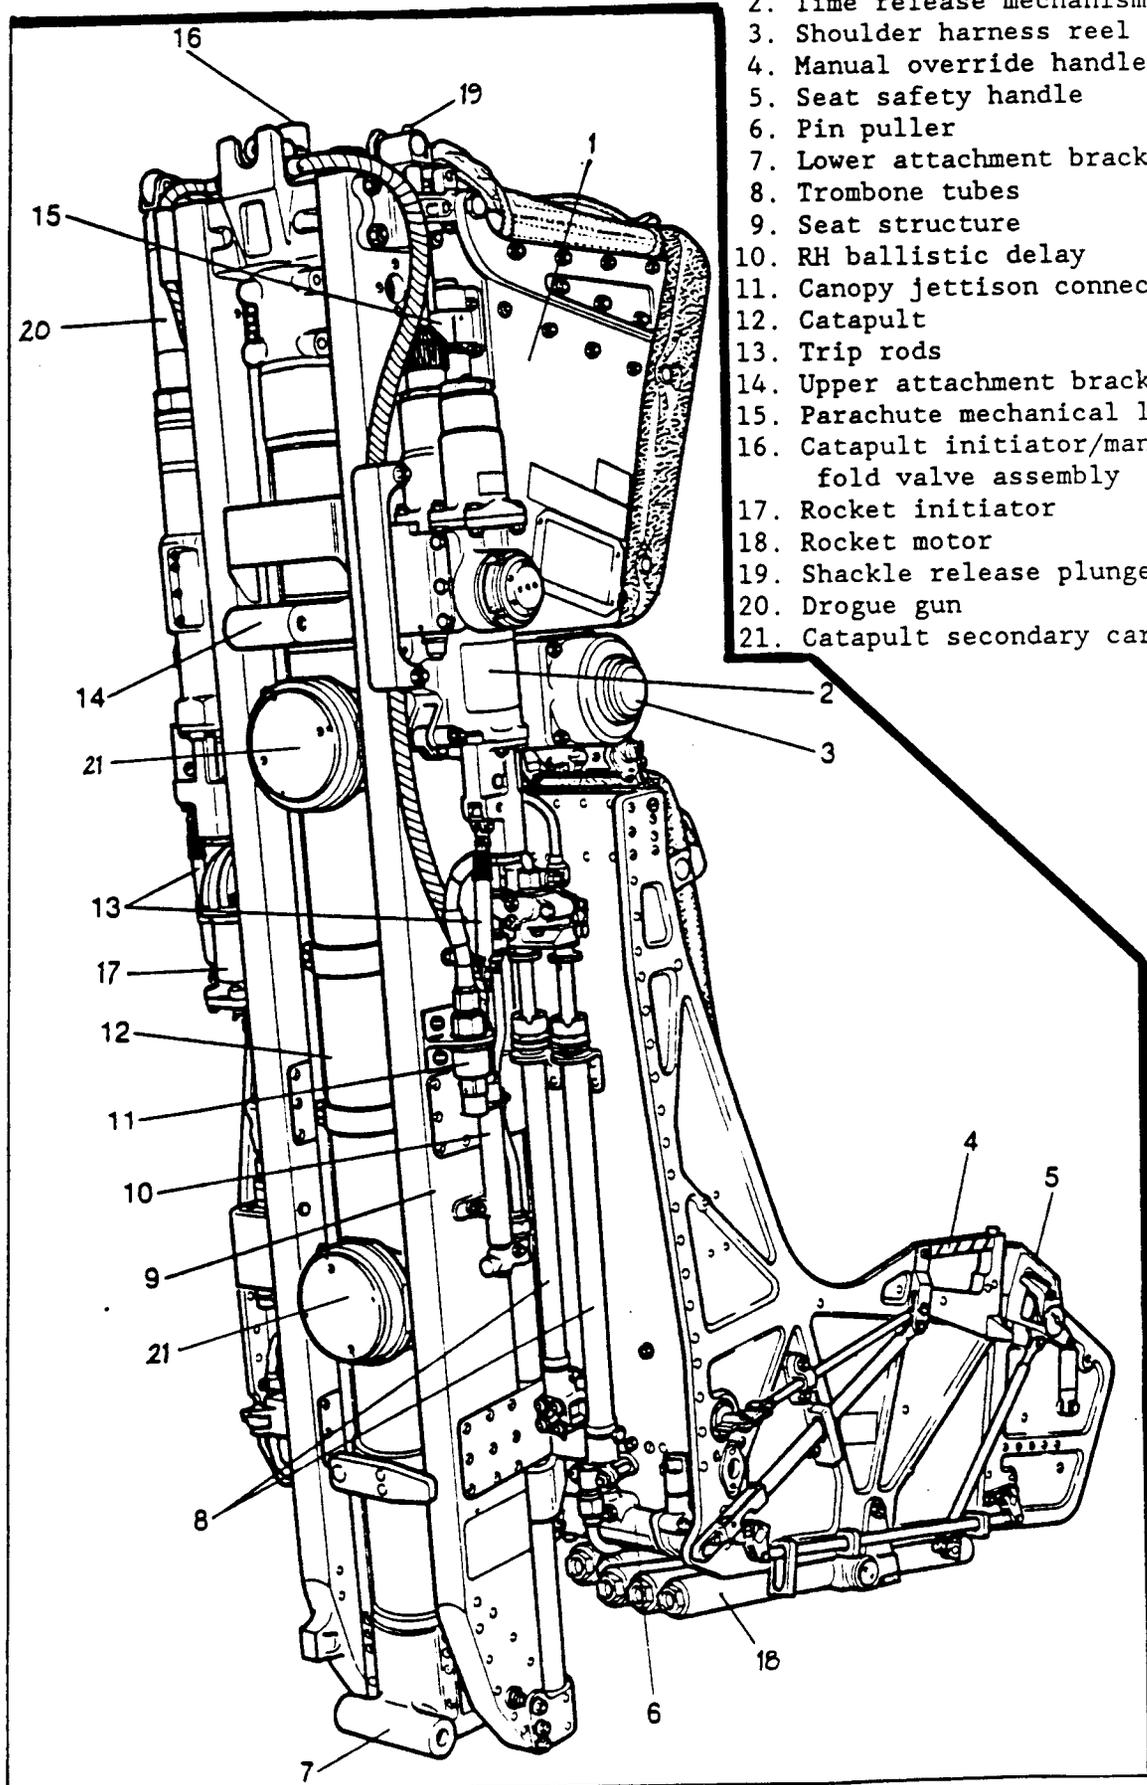
Figure 16. SJU-9/A Ejection Seat

1. Headbox
2. Time release mechanism
3. Shoulder harness reel
4. Manual override handle
5. Seat safety handle
6. Pin puller
7. Lower attachment bracket
8. Trombone tubes
9. Seat structure
10. RH ballistic delay
11. Canopy jettison connector
12. Catapult
13. Trip rods
14. Upper attachment bracket
15. Parachute mechanical lock
16. Catapult initiator/manifold valve assembly
17. Rocket initiator
18. Rocket motor
19. Shackle release plunger
20. Drogue gun
21. Catapult secondary cartridges

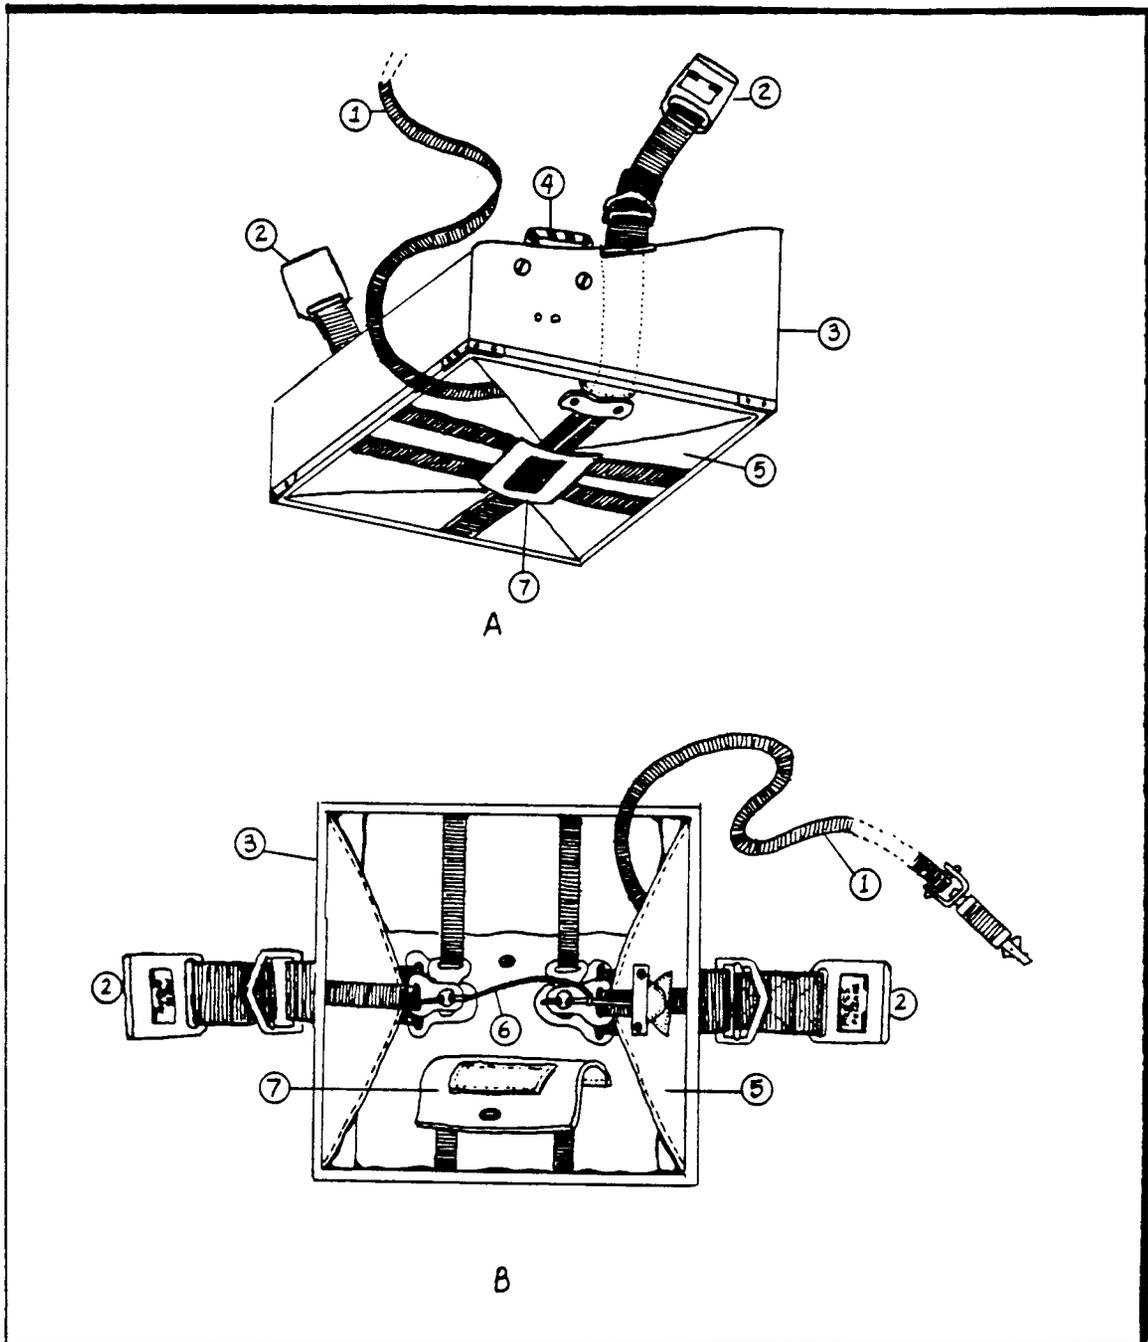
Figure 17. CT114 Seat Kit (A), and Details of Bottom Lock Mechanism (B) showing: lanyard (1), airlock connector (2), fibreglass kit (3), deployment handle (4), canvas closure (5), pins (6) and pin cover (7).

Seat Pack/Survival Kit. (Figure 17) The emergency seat pack fulfils three basic functions: provides a seat cushion during normal operation, provides a relatively firm and stable base in the event of ejection, and provides containment for the storage of emergency survival items. The seat pack is of contoured fibreglass and is held to the parachute harness by left and right "airlock" fasteners. The pack has an actuating handle on the right side which when pulled, deploys the pack contents. The pack contents are physically secured to the pilot via a nylon lanyard connected to either the parachute harness or the life preserver when worn. The basic contents of all ejection seat kits are standardised, although there is variation between aircraft and squadrons as to additional items carried. The quantity and type of items carried is dependent on the volume of the seat kit. Basically, all kits contain a survival items packet, a food packet, life raft, first aid kit and sleeping bag. Table 5 lists the various items found in the CF116 (CF5) seat kit as an example. Following ejection, the seat pack is normally deployed by pulling the actuating handle at an altitude of about 500 to 1000 feet above ground, unless descent is made into a wooded area, then it is recommended that it not be deployed.

For all aircraft except the CF188, deployment of the seat kit occurs by the retraction of two retainer pins on the seat kit bottom (Figure 17). The withdrawal of the pins allows the canvas cover to open, spilling out the

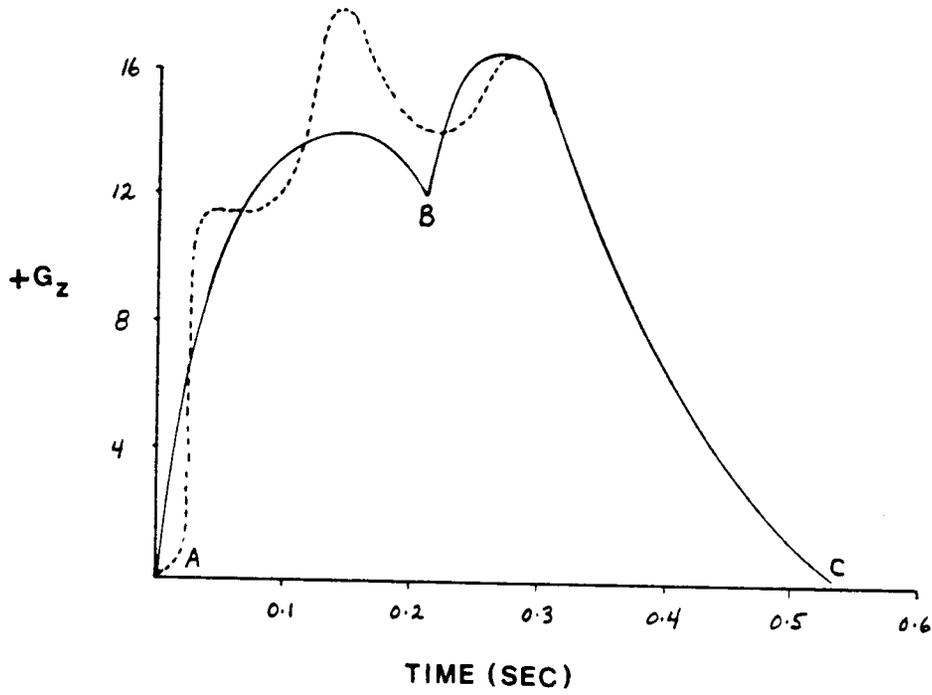
Figure 19. Ejection Loading as a Function of Time for a Typical Rocat Seat Line AB, catapult acceleration phase; BC rocket phase; dotted line - occupant acceleration (modified after White 1985).

Figure 19 illustrates a "typical" acceleration versus time pulse of a ROCAT seat. A ballistic charge or charges explodes creating pressure that, contained within telescoping tubes, propels the pilot/seat system up the guide rails. As it does so, a mechanical tripper or wire fires the rocket motor that provides a fairly constant acceleration over the next 0.25 seconds or so. The initial impulse thrust is approximately in the Gz plane, varying from 10 to 22 degrees rearwards of the vertical, depending on seat type, to allow instrument panel knee clearance. Since the centre of gravity of the head and torso lies anterior to the vertebral column, the head is rotated forward and down creating flexion and strain of the cervical spine and musculature. In addition, the inertia of the viscera connected to the rib cage and spine increases the load on the vertebral column. The vertebral column is a compound "S" curve that can be divided into four regions of alternating curvature:

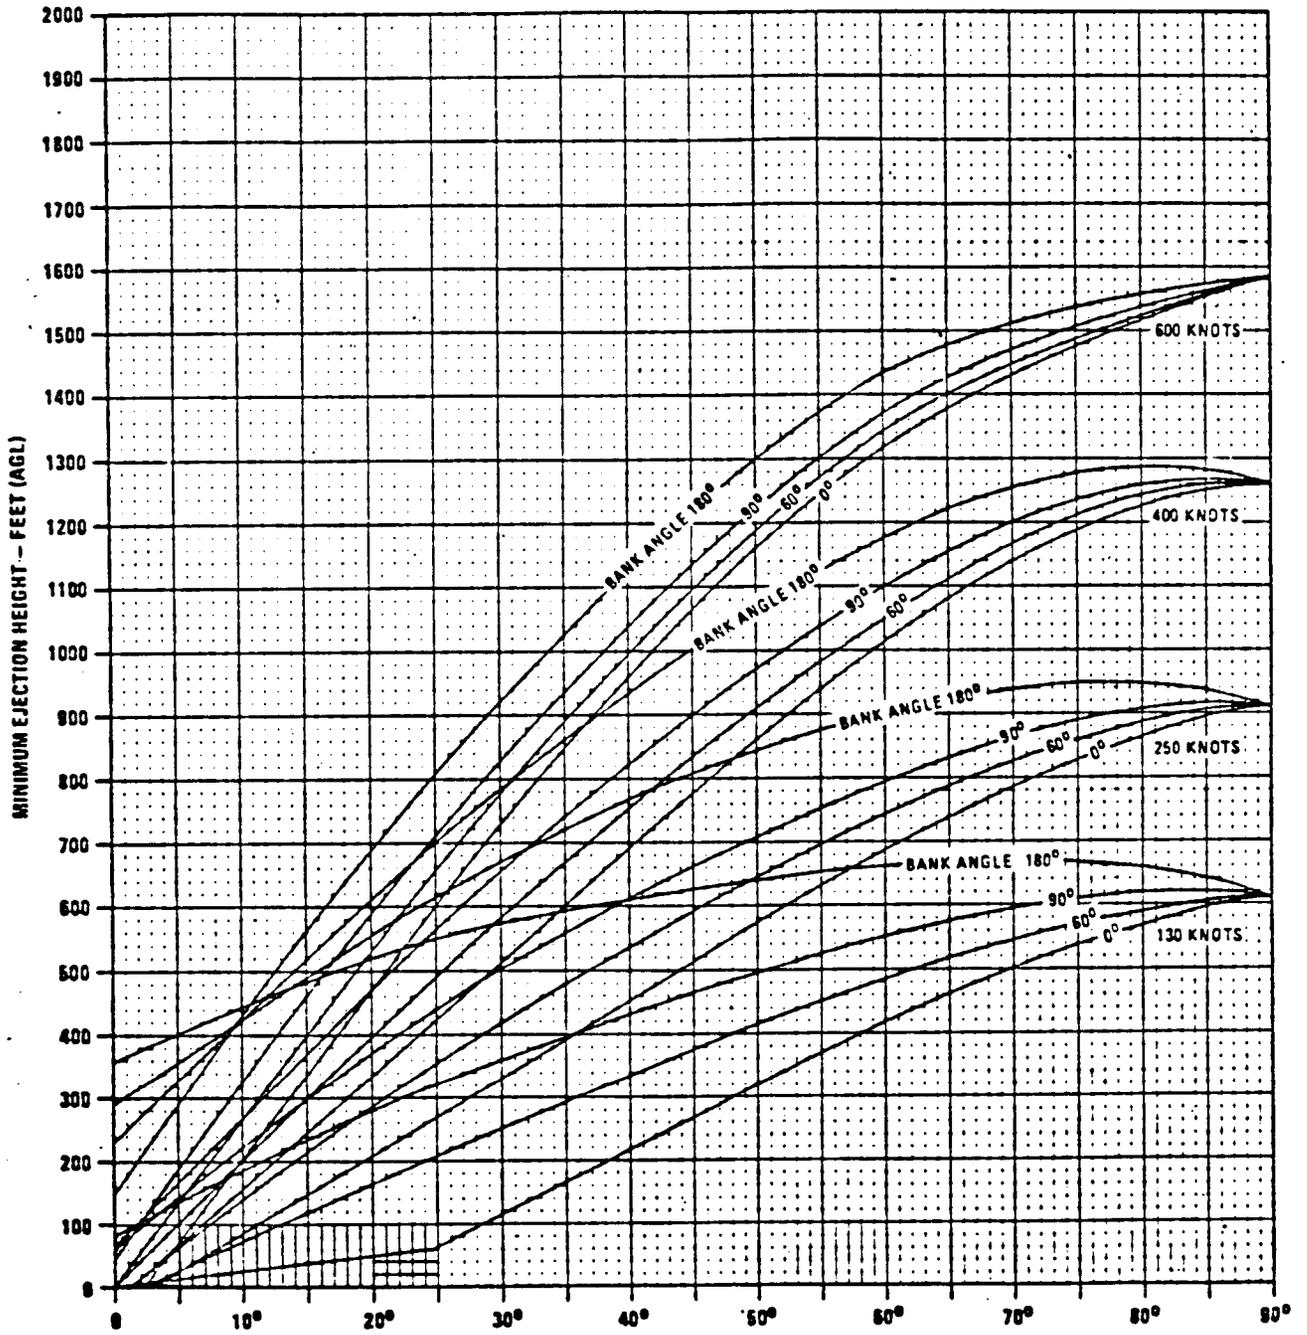
Figure 20. Minimum Ejection Altitude (CF188A)

The "ejection envelope" is a set of defined physical parameters within that an ejection may be successfully executed. It is primarily an interaction of two independent sets of parameters: the physically designed characteristics of the particular ejection system, and the dynamics of the aircraft flight profile at the moment of ejection. Although not a part of the ejection phase per se, it is an operating pre-condition to ejection success, and will be covered with "ejection". Each ejection system has a minimum fixed operating time from ejection to parachute deployment varying from 3.5 seconds plus canopy inflation time for the CT133, to 1.8 seconds plus canopy inflation time for the CF188. Full canopy inflation may take an additional two to three seconds. The minimum time available for a successful ejection must be at least equal to pilot reaction time plus system operation time. The dynamics of the aircraft flight profile that will affect ejection success are: altitude, bank angle, pitch angle, airspeed, and sink rate. In most situations, all these flight parameters are operating simultaneously, and their net effect determines ejection success. The interaction of these factors is normally presented graphically in the aircraft technical manual. An example is given at Figure 20.

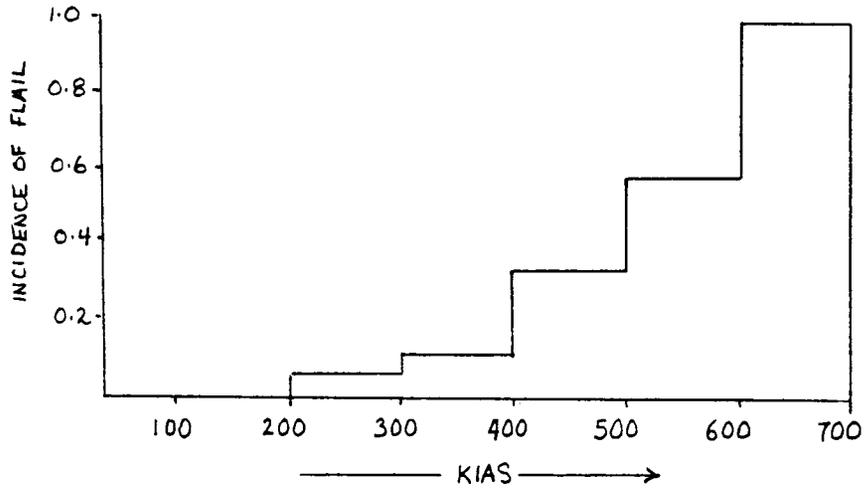
Figure 21. USAF Ejection Flail Injury Versus Airspeed/1964-1972
(Brinkley 1973)

A 1973 USAF Aeromedical Research Laboratory study (Brinkley) concluded that the incidence of limb flail following ejection increases exponentially with airspeed, being "significant" in the 300 to 400 KIAS range averaging 32% in the 400 to 500 KIAS range) and reach 100% in the 600 KIAS range (Figure 21).

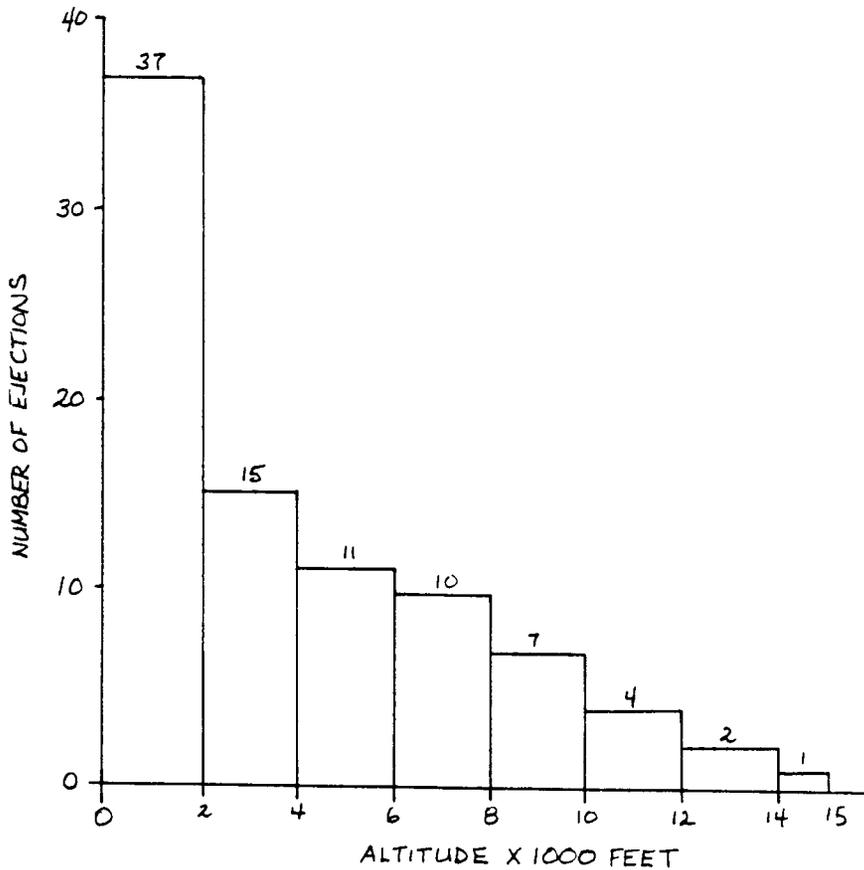
Figure 22. Altitude Distribution of 87 Successful Ejections - 1972-1986
(Data extracted from Annex B)

- a. Altitude. The greater the altitude above ground level, the longer the descent time. Most CF ejections since 1972 have been under 2000 feet (Figure 22);
- b. Bank Angle. Increasing the bank angle reduces the vertical component (i.e. height) of the ejection seat thrust. At a 30 degree bank, the vertical component is reduced 14%; at a 60 degree bank there is a 50% reduction; and at 90 degrees, a 100% reduction. To illustrate using CF188A data (60 degree dive, 130 kts), to be successful a zero degree bank requires a minimum ejection altitude of 420 feet AGL; a 60 degree bank, 480 feet AGL; and a 90 degree bank, 550 feet AGL;
- c. Climb/Dive. In a climb, the vertical component of the aircraft velocity vector will add to that of the ejection seat. As a result, a higher ejection trajectory is attained and ETA is increased. In a dive the opposite occurs and the downward

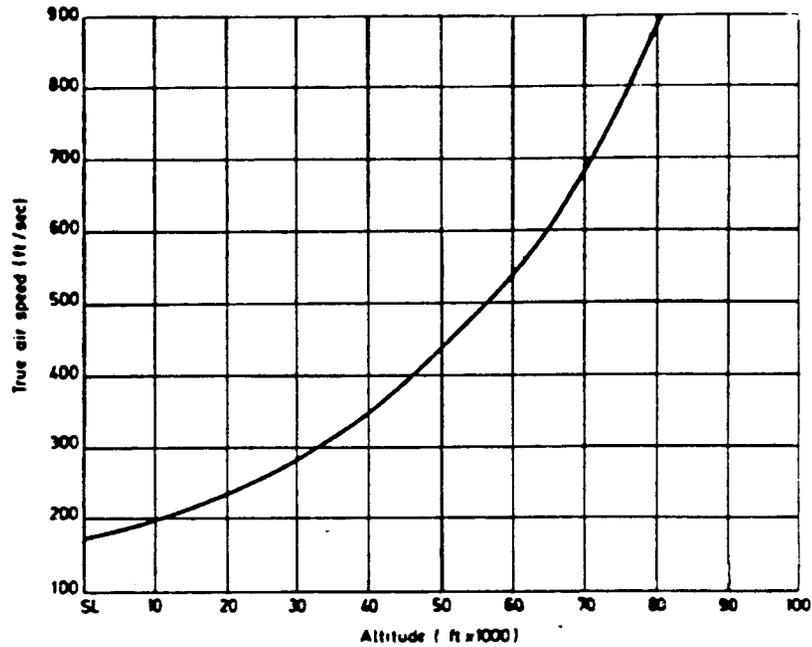
Figure 23. The Relationship Between Altitude and True Air Speed At Terminal Velocity in a Free-Falling Man (Ernsting 1978)

- a. Freefall (Terminal Velocity). Figure 23 illustrates the relationship between altitude and true air speed (TAS). Freefall velocity varies directly with altitude, being balanced by acceleration because of gravity and the "drag" force of air resistance. Wind drag may cause buffeting, flailing, and injury to exposed skin surfaces from thermal and friction effects.
- b. Spinning and Tumbling. During freefall, tumbling and/or spinning may occur that, if uncontrolled, may reach extremely high rotational rates upwards of 400 rpm. Centrifugal forces compel arms and legs to move outwards cartwheel fashion, and generate

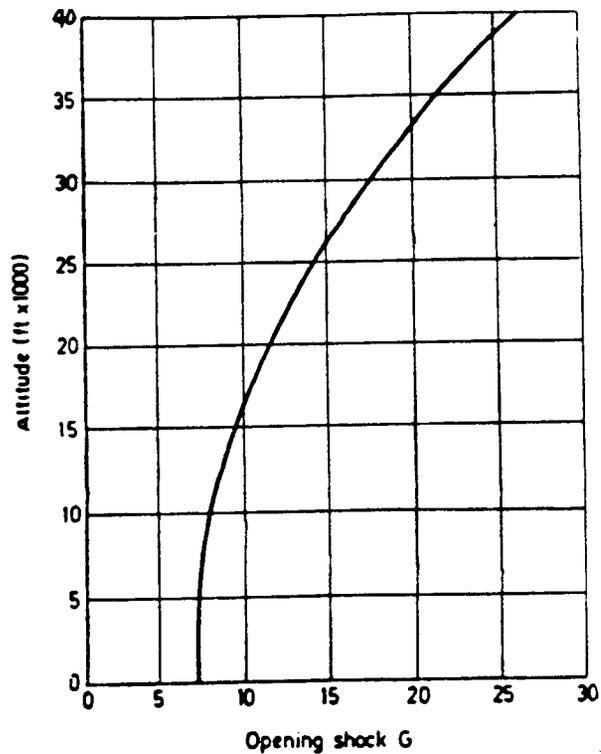
Figure 24. Parachute Opening Shock at Various Altitudes of Deployment. (Values shown are typical of those obtained at the terminal velocity of man using a 28 foot canopy.)

Parachute Opening Shock. All CF parachutes except for the CF188 (that deploys at 13000 plus or minus 1500 feet) are designed to automatically deploy at or below 16000 feet ASL. They may, however, be manually deployed at higher altitudes by pulling the "D" ring located on the left-hand side of the parachute. (The exception is the CF188 parachute that is located in the headbox and cannot be manually deployed.) The opening characteristics of a parachute canopy depend on TAS, that in turn varies inversely as the square root of air density, i.e., TAS increases with altitude. Generally, a parachute must travel six to eight times its diameter before being fully inflated, therefore, since TAS is greater at altitude, a parachute opens faster at higher altitudes. Coupled with a faster terminal velocity, this may result in high decelerative "G" loads (Figure 24). High opening shocks may damage the escape system (tear the parachute canopy and risers), cause loss of life support equipment and clothing (boots, gloves), and result in personal injury. For example, parachute deployment at 30000 feet exerts about 18 G on the body, while automatic opening at 16000 feet is equivalent to an 8G load.
