## COMPOSITE MASONRY WALL TIES: Final Report

# COMPOSITE MASONRY WALL TIES

## **Final Report**

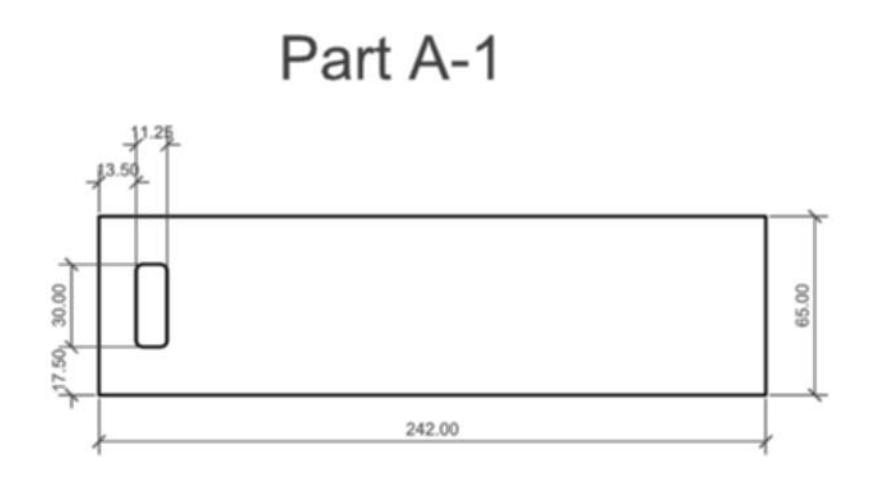
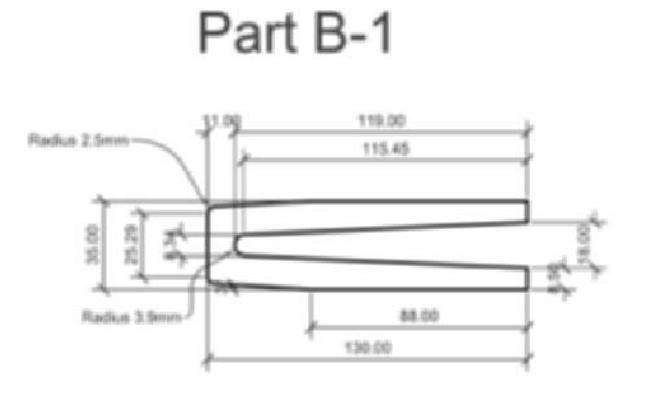
Figure 2- Basic Prototype

3.15mm (1/8") Plate material

Adopting the limitations of the manufacturing process, the basic design was developed based on pultruded material properties (see Figure 2). No other suitable shapes other than flat strips or plates were found. Initially, two material thicknesses were considered: 3.18 and 4.76mm (1/8" and 3/16"). Both parts of the tie were cut from flat strips. The thicker material was theoretically acceptable for embedment into mortar joints (being less than one half of nominal mortar joint thickness); however, working with the material and masonry, it was found that the thickness was unacceptable. It was very difficult in the laboratory to place the tie and keep the mortar joint to 10 mm. It should be noted that the testing reported by Burdette [37] used only 4.76 mm thick ties in all tests. However problems encountered in trial masonry sample preparation led to the decision to carry out further development with 3.18 mm thick material only. The material properties are included in Table A1 in Appendix A; Figure A1 and show the internal orientation of fibres.

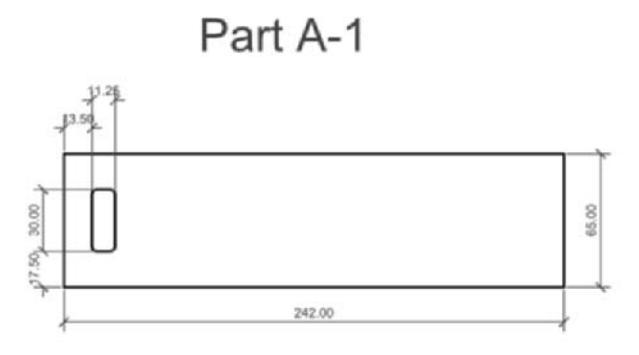
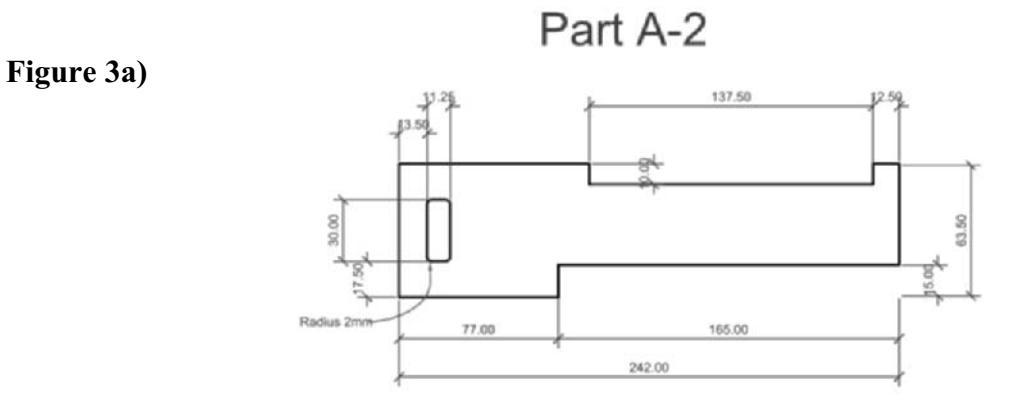
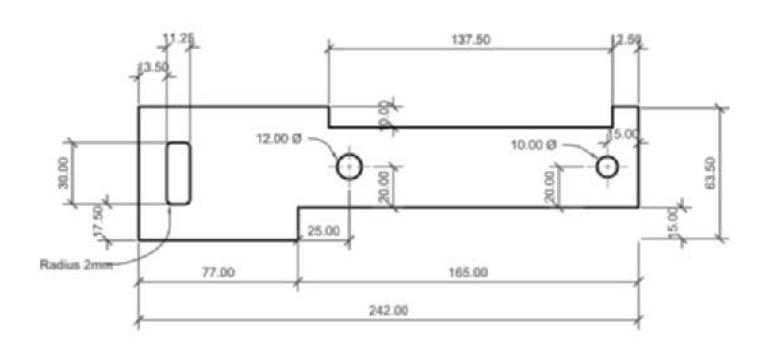
**Figure 3 - Block Ties**

3.15mm (1/8") Plate material

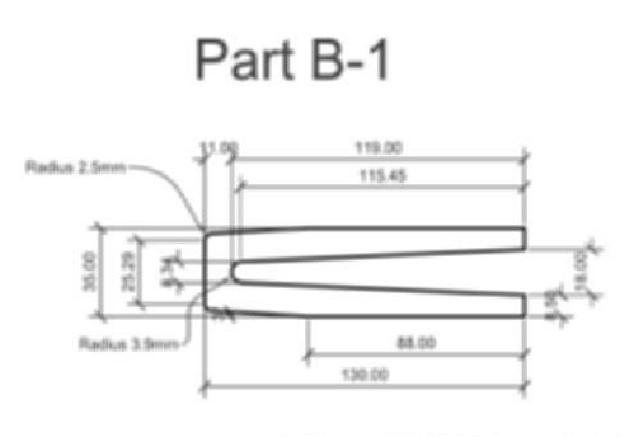
Figure 4a) - Basic brick tie

3.15mm (1/8") Plate material

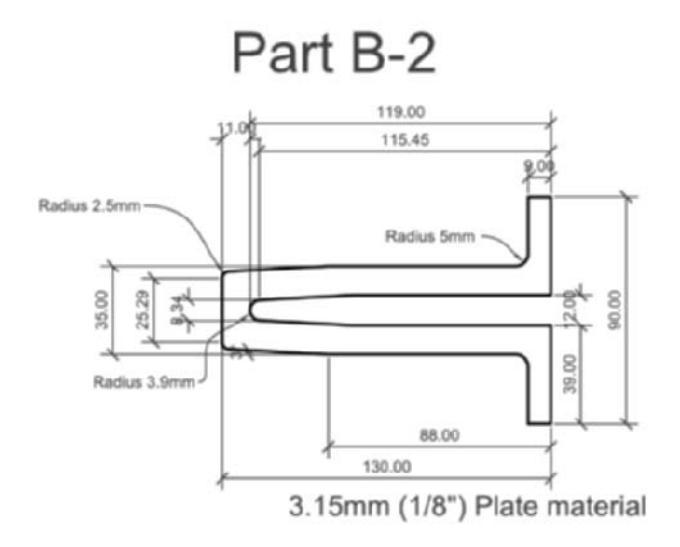
#### Figure 4b) - Brick Tie with end returns

Figure 4 - Brick ties

The end returns acted as an additional anchorage. Hairline cracks formed along the tie just outside the returns, probably initiating the debonding between the tie and the mortar. The returns anchored the tie and caused the failure along mortar/ brick interface, separating the two bricks. In sample 3, the failure of the tie occurred at one its returns; the return broke away from the main body of the tie. It was noted that the failure along the mortar/ brick interface occurred at the closest tie location to this interface.
