Cold Climate Radon Mitigation

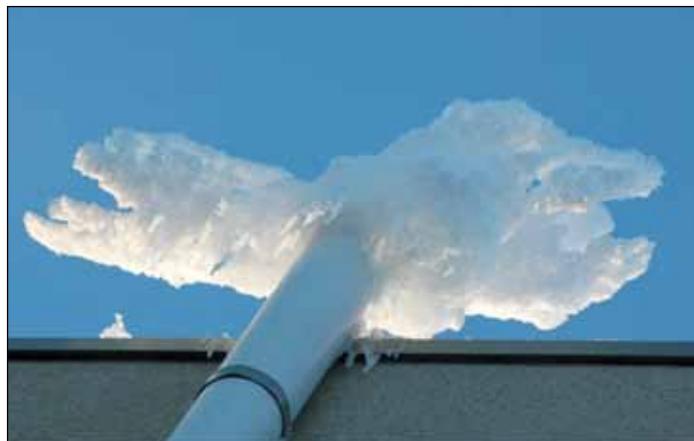
Figure 1 Frost covered radon vent in Winnipeg
Photo credit: Harry Johnson

In contrast, since the mid-1980s radon mitigation has been a relatively common activity in the United States (US) that has been supported by research and programs from the government's Environmental Protection Agency (EPA) and others. As a result, radon mitigation in the US is undertaken following the methods, systems and designs prescribed in guidelines such as the American Society for Testing and Materials (ASTM) E2121-09 "Standard Practice for Installing Radon Mitigation Systems in Existing Low-Rise Residential Buildings". While most American installations use a fan and exhaust venting located outside the house envelope, there is a concern that the system could be susceptible to ice build up particularly in colder regions.

The recipient reported that all mitigation contractors contacted located the fan outside the house envelope and had the radon vent discharge at or above the roof level. No one volunteered that they were using side-wall venting or fans located inside the house. There were reports of icing in the venting systems and suggestions were received of various ways to reduce the possibility of icing. These included the following:
