Effect of Snow and Ice on Exterior Ramp Navigation By Wheelchair Users

Research Highlight

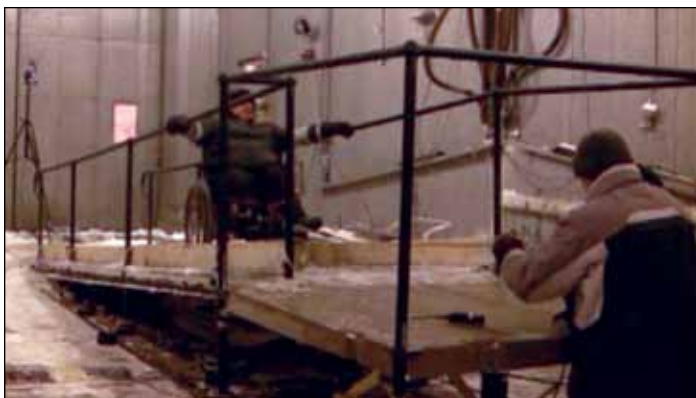
Figure 1 Ramp ascent on ice-grit using handrails.

Even with sufficient grit, the more active subjects frequently had wheel slip issues during ascent at the 1:10 and 1:12 slopes (that is, stronger propulsive motion surpasses wheel-ice-grit friction). These subjects typically used a two-handrail pull approach to reinitiate motion and then reverted to standard propulsion. Recommendations could be made to use two-handrail propulsion under ice conditions since friction issues are resolved (that is, no propulsive force on

wheel rims), control of wheelchair trajectory is improved, and stronger propulsive forces can be generated.

- For ice-grit ramp navigation, two-handrail propulsion is a preferred strategy, as it enhances trajectory control and reduces the potential for wheel slip problems.

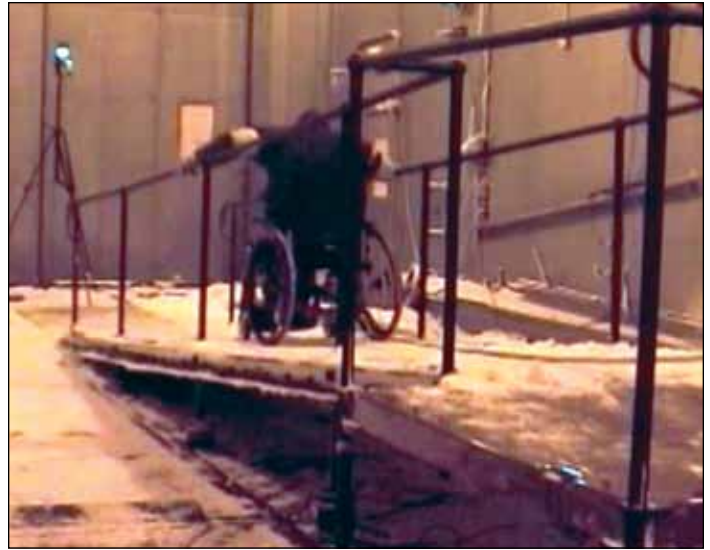
Figure 2 Backwards ramp ascent.

One subject successfully ascended the ramp backwards, at all grades, by reaching back and pushing on both handrails. Since this subject was at a moderate functional level, the backwards strategy could be applicable for most people who manually propel their wheelchair in winter. The shoulder and trunk ranges of motion were also typical. More research on backwards ascent is warranted to verify how this approach can be used by lower-functioning wheelchair users and to determine if wheelchair and environmental issues exist when extended to a larger population.

- Backwards ramp ascent for snow conditions should be considered for people with sufficient shoulder and trunk ranges of motion, although further research should be performed to verify that the successful outcomes can be generalized beyond the single subject results in this study.
