FIELD MANUAL *on*  
**BUFFER DESIGN**  
*for the*  
CANADIAN  
**PRAIRIES**

Stewart A., Reedyk S., Franz B., Fomradas K., Hilliard C. and S. Hall.  
2010. Field Manual on Buffer Design for the Canadian Prairies. Science  
and Technology Branch, Agriculture and AgriFood Canada. 55p.

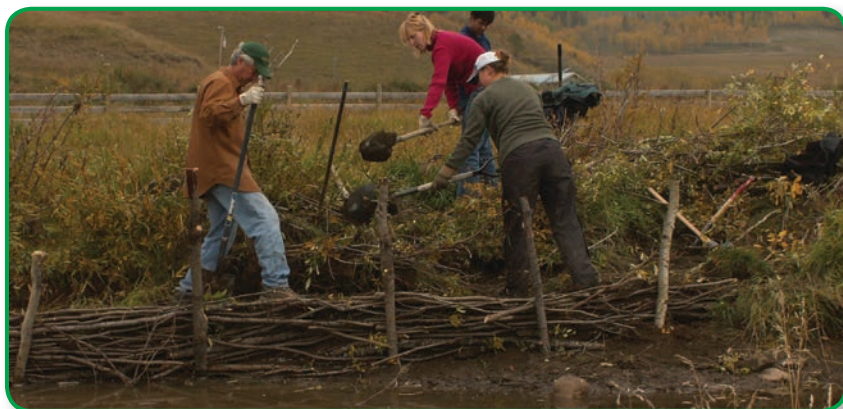
Bioengineered wattle fence.

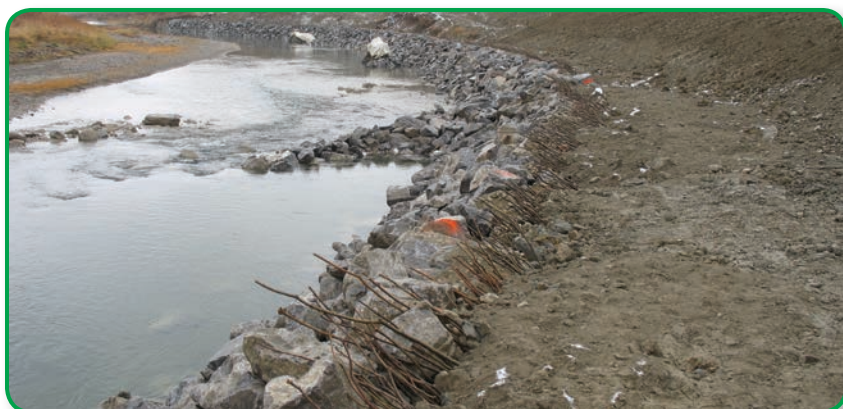
Biotechnical stone toe protection with brush layering.

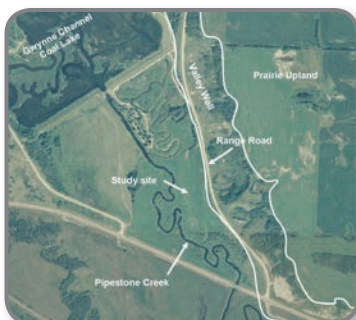
[Figure 6.1.2]

**STEP 1.** The channel at the site is deeply incised. It may have been cleared of in-channel debris when the dam was constructed and the upper section of the channel modified to make the spillway. The channel is a major stream and is clearly well defined. (Figure 6.1.3).

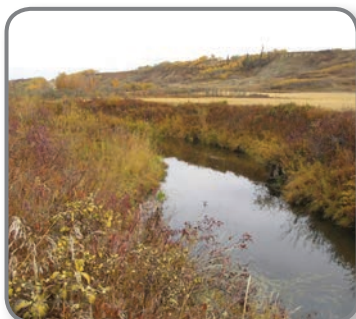
[Figure 6.1.3]

**STEP 2.** The banks of the creek are steep. For the most part they are completely vegetated with grasses, forbs and shrubs, and are stable (Figure 6.1.3). However sections of the bank, mainly on outside bends are eroded or slumped (Figure 6.1.4). The slumping is consistent with in-stream erosion caused by high river flows, although it is possible the bank failures are a result of groundwater seepage weakening the bank. There is no evidence of overland flow entering the channel to cause the bank degradation.

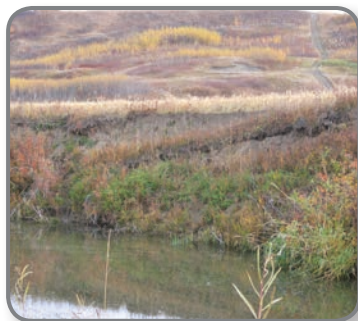
[Figure 6.1.5]

The top of the banks are mostly in grass and shrub vegetation, an extension of the vegetation on the upper banks. In places however, particularly on outside bends, cultivation and cropping may be within a metre of the top of the bank and some bank degradation is occurring (Figure 6.1.5).

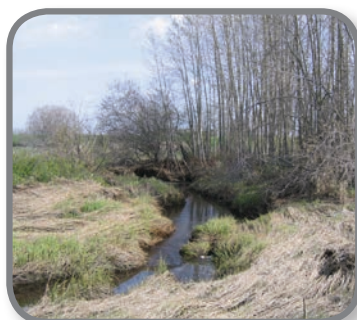
[Figure 6.2.3]

**STEP 1.** On the site, the creek is a well defined channel (Figure 6.2.3)

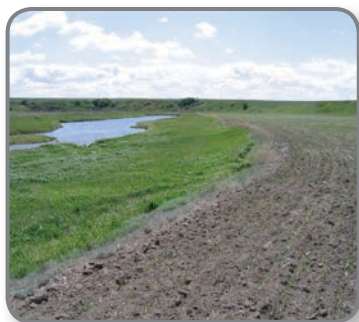
[Figure 6.6.4]

**STEP 2.** The banks are stable and generally well-vegetated except that cropland is cultivated to the very top of the bank and there may be spray damage to the upper bank vegetation (Figures 6.6.4 and 5).

**STEP 4.** The slopes adjacent to the bank and extending to the drainage divides are very gentle (Figures 6.6.4 and 5).
