Flight Comment

ISSUE 1, 2013

*SEA KING 50th
ANNIVERSARY*

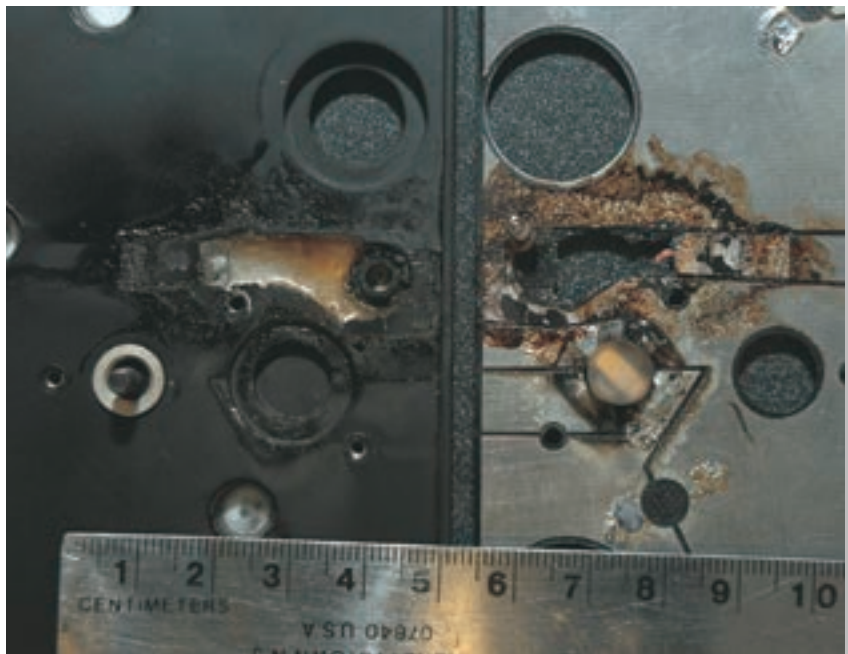
Figure 1

Following 2nd line repair of a Navigation Light Control Panel, the panel was installed on aircraft CC130334 to complete functional testing. When the aircraft power was applied, the panel began to overheat, smoke, and burn through, damaging it beyond economical repair. Power was immediately removed, and the damage was fortunately contained to the panel. The panel was then brought back to the avionics labs under flight safety quarantine for further inspection where it was noted that the damaged area extended outside of the original repair site. (Figure 1)

The avionics technician removed the circuit component in the affected area and using an external power supply, re-applied power to the panel. Immediately, the panel resumed smoking and burning despite the circuit

component removal. During follow-on troubleshooting, technicians began to suspect that the flux used during the previous repair was not suitable for electronic circuit repair and had caused the circuit to bridge and overheat.

A Flight Safety was raised (see FSOMS 151675) regarding the use of improper flux causing a fire in the cockpit of a CC130. The investigation that ensued was very enlightening and produced some noteworthy findings. Scoring high on the list of findings was the belief of many aircraft maintenance technicians that the supply chain ensures compliance of all products received, by verifying that they are in fact what was ordered. It is important to stress that this is NOT the case. Supply acts as the procurement authority for the purchase, but does not, nor can it, ensure compliance of the millions of items received.

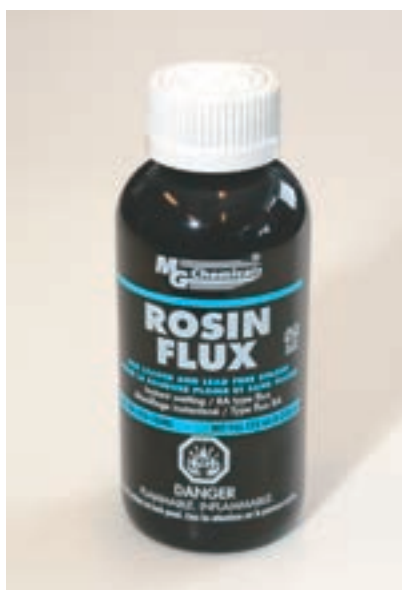
Figure 2

In this particular case, the proper product (Figure 2) was tendered, quoted, and purchased. However, the product delivered did not meet the MIL-F-14256 specification standard associated with NATO Stock Number (NSN), 3439-01-007-5494 (Flux, Soldering), found on the order form. The distributor instead shipped a soldering flux that met the standard of Fed AA51145 (Figure 3) which corresponds to a different NSN. The reference contains the detailed specification related to the flux received and contains a quote stating "This flux is not intended for use in soldering electronic or electrical circuits." The specification also indicates that the flux residue is **conductive**. The product was labelled "SOLDERING FLUX", but only close inspection by someone with comprehensive knowledge and understanding of the product would have been able to identify the discrepancy. Nowhere on the bottle

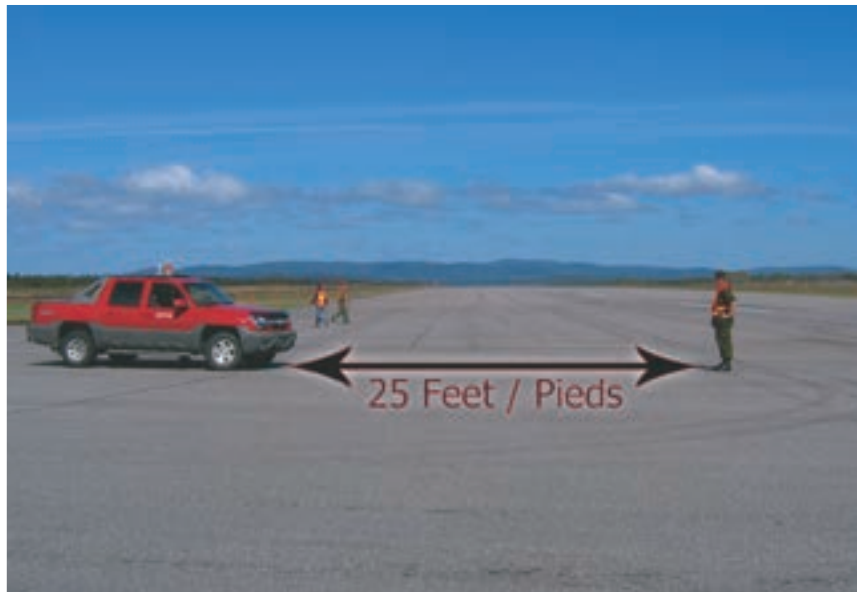
Approximate distance between the vehicle and *Beech* 1900 wing tip (marked by the person).

The investigation determined that the ground controller (GC) did not use the term “negative” to issue a restriction to the vehicle operator’s (VO) request to cross the runway and that the VO did not actively scan the runway for potential traffic conflicts prior to proceeding onto the active runway. Additionally, the VO’s misinterpretation of the GC’s clearance was exacerbated by the VO’s expectancy to hear the term “proceed” or “negative.” Upon hearing “proceed,” the VO erroneously assumed that he was cleared to his requested destination. It was further determined that non-standard phraseology was used by CYYR Air Traffic Control (ATC) and that 1 Cdn Air Div publications did not define currency or specify a validity period for the Ramp Defensive Driving Course (DDC) qualification.

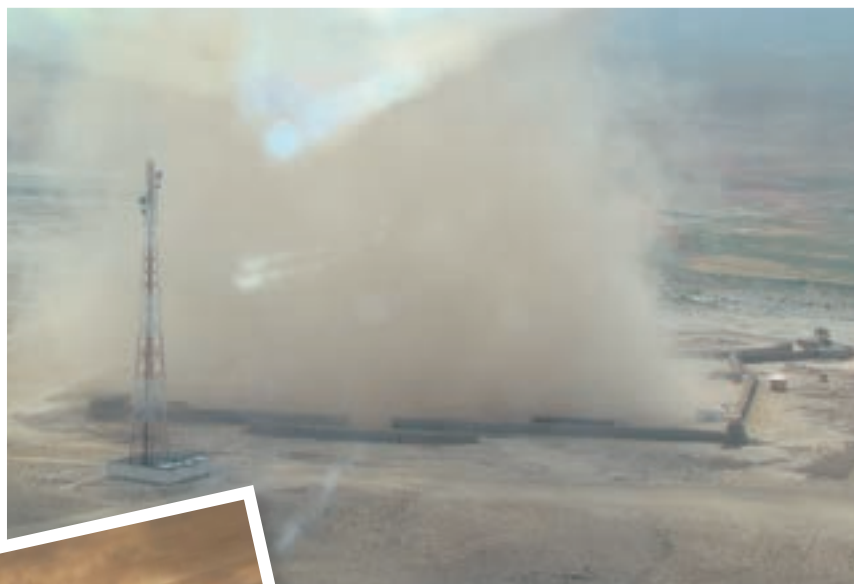
Dustball during morning landing.

Griffon 434 was tasked to transfer two passengers to and from a Forward Operating Base (FOB). As power was increased for the takeoff a very large dustball developed. Immediately after takeoff, the aircraft drifted forward and to the right, struck a barrier, rotated left, rolled onto its right side and caught fire. One pilot was unharmed, one sustained minor injuries and one passenger suffered serious injuries. The remaining three personnel tragically perished in the crash. The aircraft was destroyed.

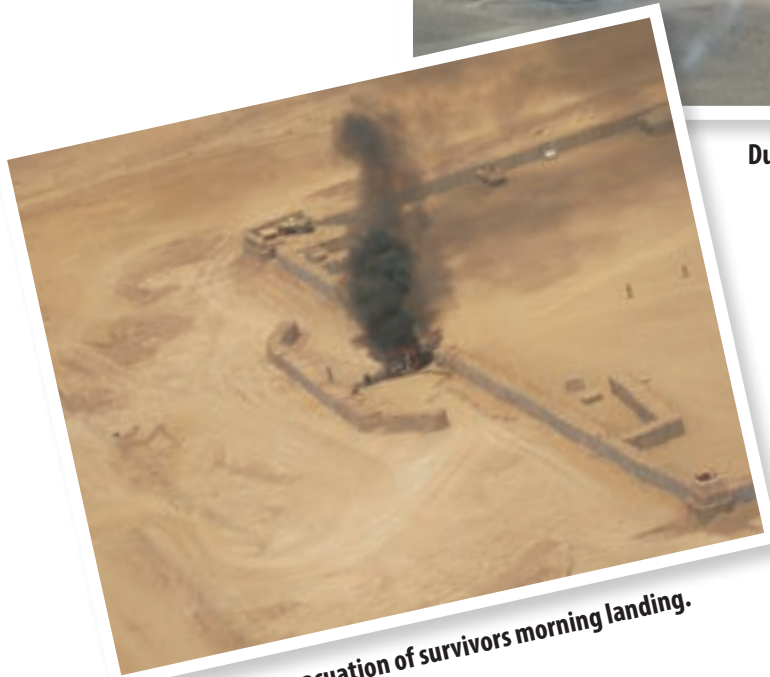
Crash site after evacuation of survivors morning landing.
