**AVIATION INVESTIGATION REPORT
A05C0153**

LOSS OF SEPARATION

**NAV CANADA
EDMONTON AREA CONTROL CENTRE,
NUNAVUT SECTOR
HALL BEACH, NUNAVUT, 135 nm NW
09 AUGUST 2005**

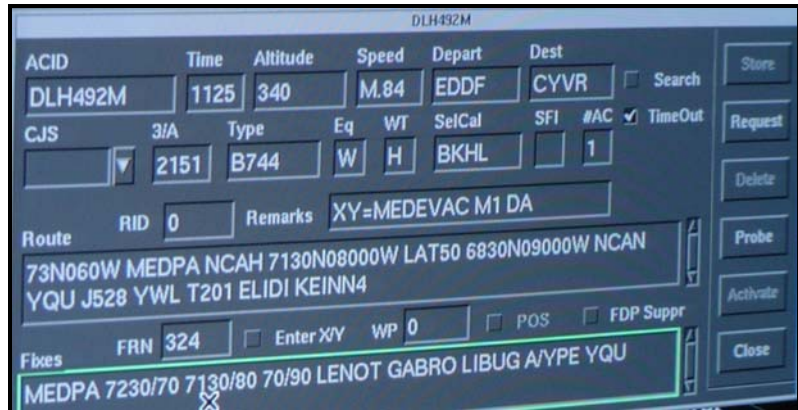
Figure 1. NSiT flight plan window at 0544, with fixes field selected (times shown are Coordinated Universal Time)

Flight plan information sent to the ACC is first received by the air traffic operations specialists section, where it is reviewed for proper format, and then distributed electronically to the appropriate sectors for set up in the NSiT by the sector controller. When the NSiT receives the flight plan, the route field is automatically populated with the route information applicable to the ACC. Flight plans must be prepared for operational use by controllers doing a manual setup. The flight plan setup requires that aircraft altitude, speed, fixes, and an estimated time of arrival (ETA) at the entry point be entered into associated fields in the flight plan window on the NSiT (see Figure 1).

The route field gives the controller a reference to the aircraft's flight planned route as filed by the operator, but it is not used by the NSiT for calculations. Instead, fixes that define the route are used by the NSiT for calculations. The fixes are entered either by typing data directly into the fixes field, or by entering a fix reference number (FRN) into the FRN field. Each FRN is a three-digit number associated with pre-determined fixes that define a specific route. When an FRN is entered, the fixes field is automatically populated with the pre-determined fixes associated with that FRN. The NSiT does not automatically verify that the fixes in the fixes field match the route in the route field (route conformance); instead, the controller must manually verify that they match.

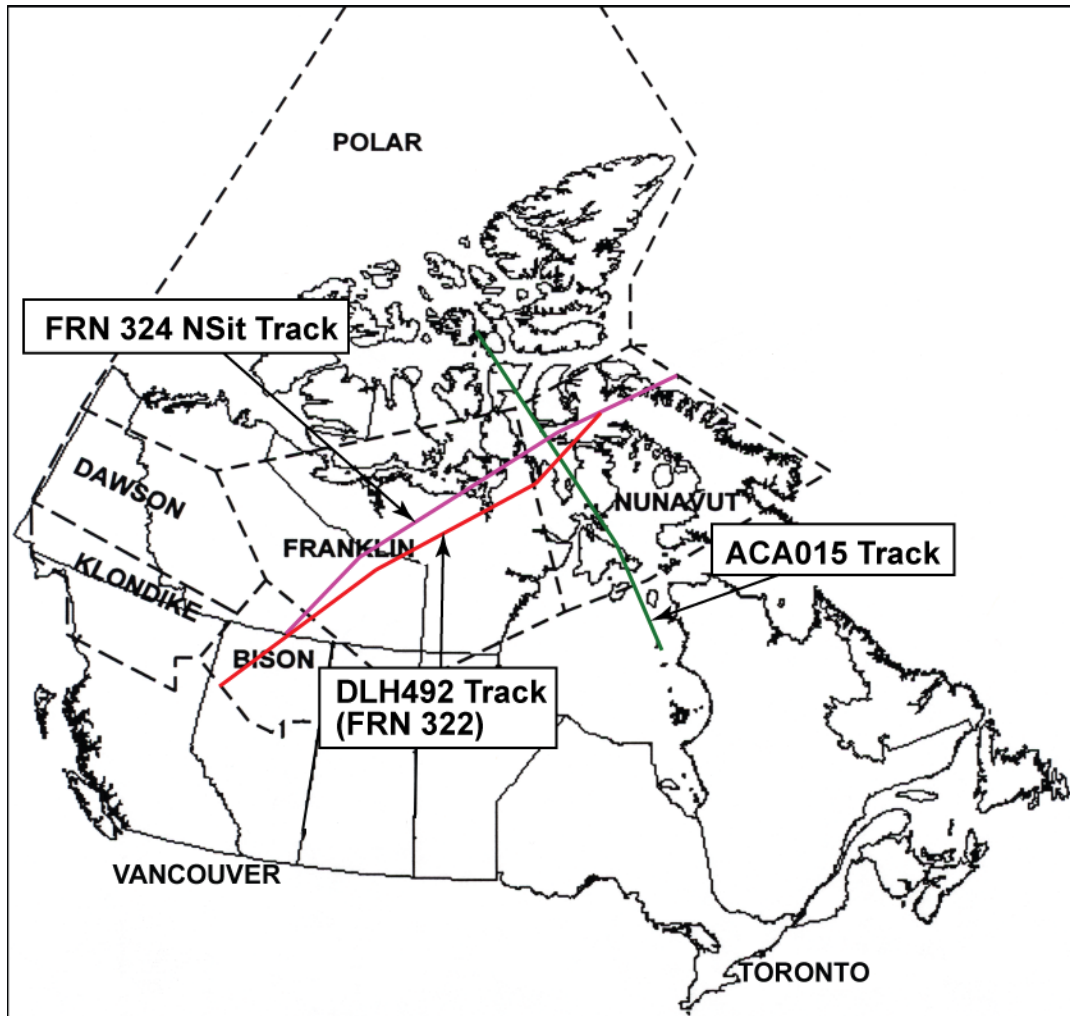
*Appendix A – Sector Boundaries with Aircraft and Northern
Airspace Display System Situational Display
(NSiT) Tracks*

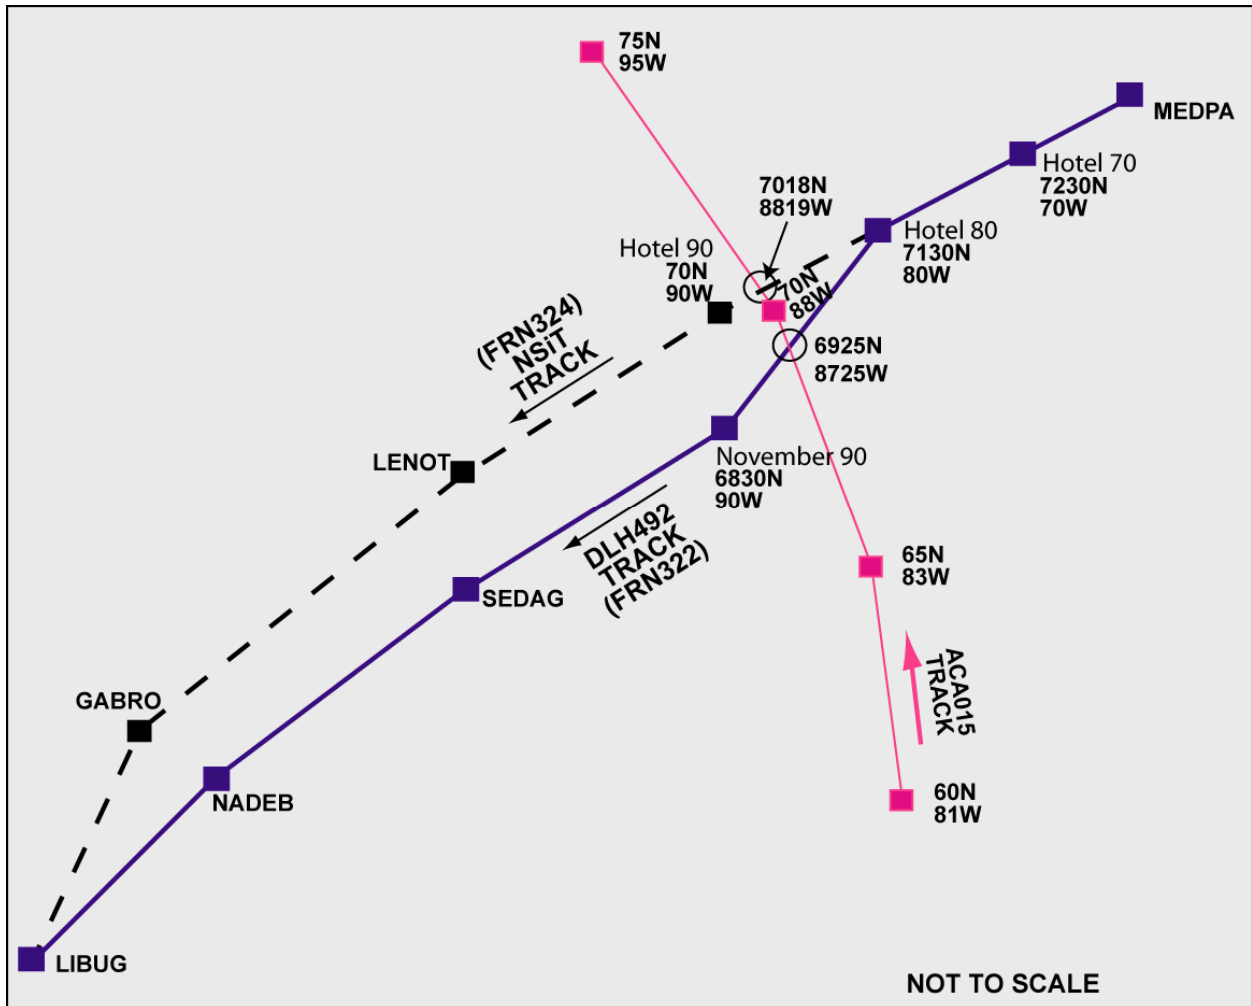
Appendix B – Aircraft and Northern Airspace Display System Situational Display (NSiT) Tracks

⁵ The flight planned route of DLH492 was MEDPA NCAH 7130N08000W LAT50 6830N09000W NCAN YQU. The fixes MEDPA, 7230N 70W, 7130N 80W, 6830N 90W, SEDAG, NADEB, LIBUG correspond to this route, and were associated with FRN 322 (see Appendix B).

⁸ The fixes associated with FRN 324 were MEDPA, 7230N 70W, 7130N 80W, 70N 90W, LENOT, GABRO, LIBUG (see Appendix B).

⁹ The flight planned route of ACA015 was 60N 81W, 65N 83W, 70N 88W, 75N 95W (see Appendix B).

The route of ACA015 crossed the NSiT FRN 324 route for DLH492 at 7018N 8819W; this is the route cross position at which NSiT conflict probes for ACA015 and DLH492 were based. In fact, the route of ACA015 crossed the actual route of DLH492 (FRN 322) at 6925N 8725W (see Appendix B). Calculations later determined that DLH492 passed this position at 1114 and that ACA015 passed this position 10 minutes later at 1124. The required separation, before and after the cross, was 15 minutes.

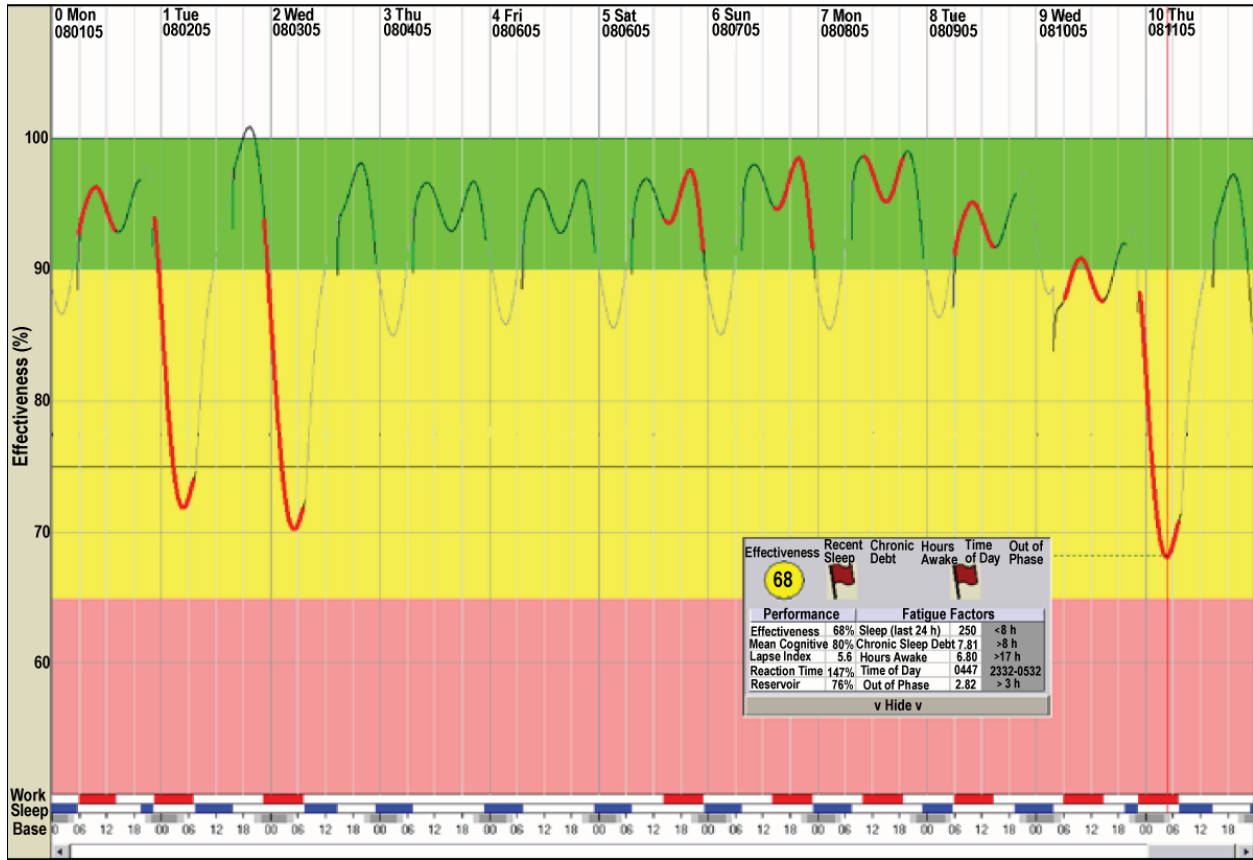
Appendix C – Fatigue Avoidance Scheduling Tool (FAST) Effectiveness Graph

Controller schedules were analyzed, in part, using the Fatigue Avoidance Scheduling Tool (FAST).¹⁷ FAST is a software decision aid designed to assess and forecast performance changes induced by sleep restriction and time of day. No planning software, including FAST, can predict fatigue or fatigue-induced errors in all cases or for all individuals. The tool can only forecast the effects of sleep and circadian rhythms on performance and cannot account for other factors that alter performance such as training, experience, stress, illness, or any of a variety of variables besides fatigue that are known to affect performance. Fatigue can be the result of factors other than restricted sleep or circadian disruption. For example, fatigue can result from sleep disorders, excessive workload, medications, chronic fatigue syndrome, exercise, temperature, or infection. These factors are not currently considered in FAST predictions. Furthermore, FAST does not take into account fatigue countermeasures employed by NAV CANADA such as naps, breaks, and physical activity.

normally rested person. Because shortened total sleep time causes fatigue, the risk that controllers will suffer from fatigue resulting from this eight-hour off-duty period is higher than the risk for normally rested persons. In this instance, FAST predicted a significant performance reduction during the midnight shift following the eight-hour off-duty period (see Appendix C).
