## Fire Performance of Houses. Phase I. Study of Unprotected Floor Assemblies in Basement Fire Scenarios Summary Report

**RR-252**

2008-12-15

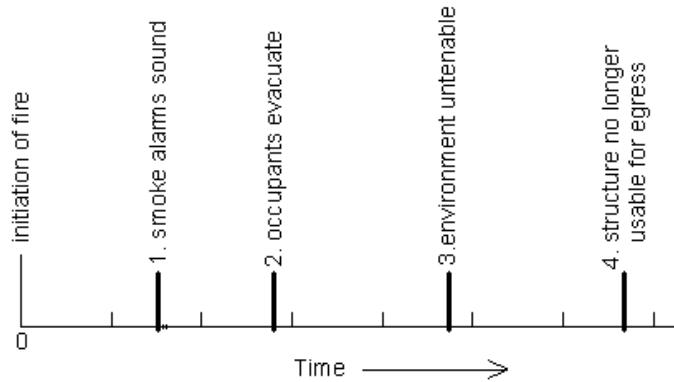
**Figure 1.** Possible chronological sequence of events affecting the life safety of occupants in a fire situation

Figure 1 shows a possible chronological sequence of relevant critical events that might occur in a fire scenario. It is acknowledged that the chronology of the occurrence of events may differ, and in some cases can shift in ordering.

Phase 1 (2004 to 2007) of the experimental study focused on basement fires and their impacts on the structural integrity of unprotected floor assemblies above a basement and the tenability conditions in a full-scale test facility. It is acknowledged that a basement is not the most frequent site of household fires but it is the fire location that is most likely to create the greatest challenge to the structural integrity of the 1<sup>st</sup> storey structure, which typically provides the main egress routes. The study of fires originating in basements also provides a good model for the migration of combustion products throughout the house and its egress paths. The data collected during this phase of the project provided important indicators for identifying and evaluating the sequence of critical events shown in Figure 1.

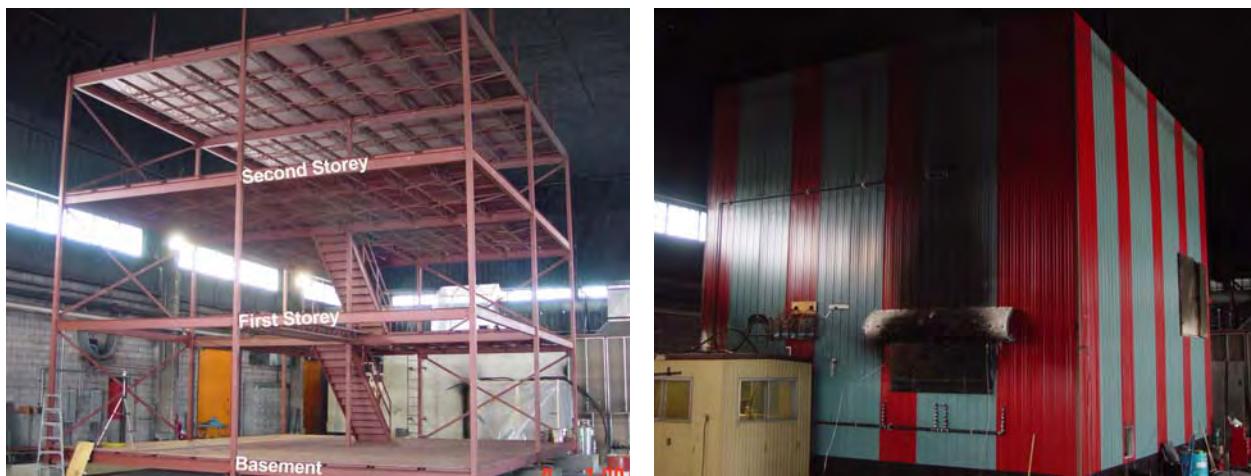
**Figure 2.** The test facility

The Fire Performance of Houses test facility was designed to represent a typical two-storey detached single-family house with a basement. A detailed description of the facility including the layout of the instrumentation can be found in separate reports [4-10]. Figure 2 is an elevation view showing the levels of the test facility: basement, first storey and second storey. Each of the three levels has a floor area of  $95\text{ m}^2$  and a ceiling height of 2.4 m. There was no heating, ventilating and air-conditioning or plumbing system installed in the test house, i.e., no associated mechanical openings.

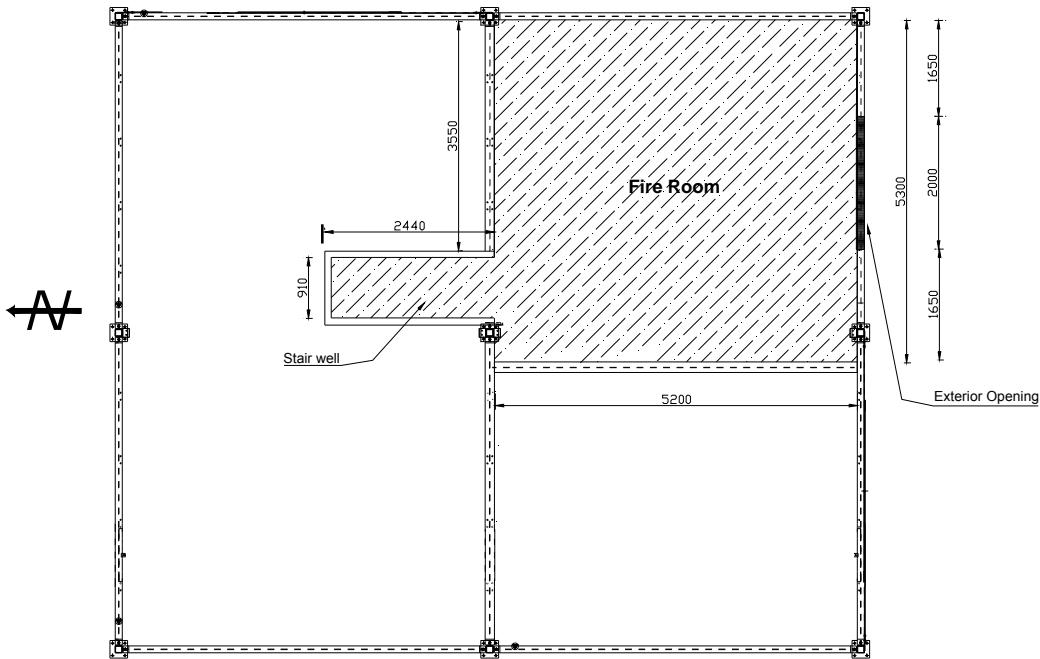
**Figure 3.** Basement plan view (all dimensions in mm)

The layout of the basement is shown in Figure 3. The basement was partitioned to create a fire room representing a  $27.6\text{ m}^2$  basement living area. This was the average size of basement compartments based on survey results [11]. A rectangular exterior opening measuring 2.0 m wide by 0.5 m high and located 1.8 m above the floor was provided in the south wall of the fire room. The size of the opening is equivalent to the area of two typical basement windows (1.0 x 0.5 m). A removable noncombustible panel was used to cover the opening at the beginning of each experiment.

A 0.91 m wide by 2.05 m high doorway opening located on north wall of the fire room led into an empty stairwell enclosure (without a staircase). At the top of this stairwell, a 0.81 m wide by 2.05 m high doorway led into the first storey, as shown in Figure 4. This doorway leading to the first storey either had a door in the closed position (closed basement doorway) or had no door (open basement doorway) depending on the scenario being studied. There is no requirement for a basement door in the NBCC.

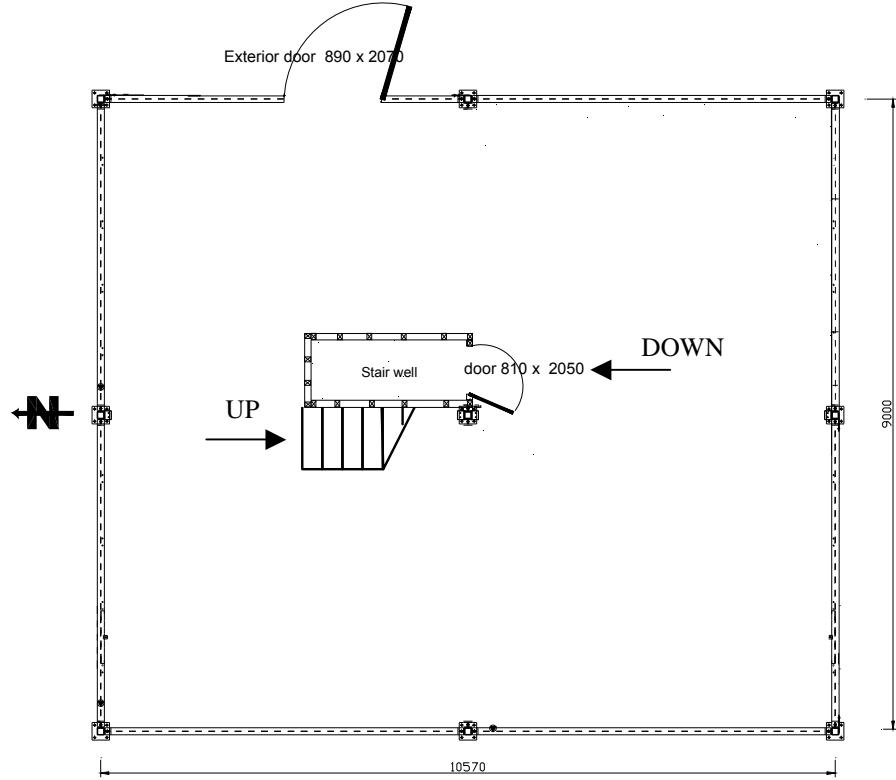
**Figure 4.** First storey plan view (all dimensions in mm)

The first storey had an open-plan layout with no partitions, as shown in Figure 4. A test floor assembly was constructed on the first storey directly above the fire room for each experiment (more details are provided in Section 3.3). The remainder of the floor on the first storey was constructed out of non-combustible materials. A 0.89 m wide by 2.07 m high doorway led to the exterior. The staircase to the second storey was not enclosed. There were no window openings on the first storey.

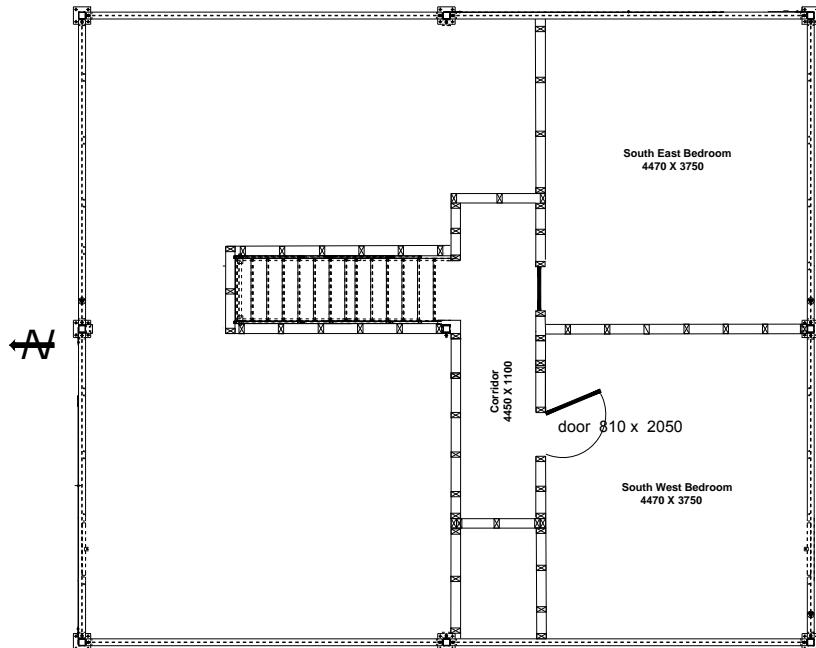
**Figure 5.** Second storey plan view (all dimensions in mm)

The layout of the 2<sup>nd</sup> storey is shown in Figure 5. It was partitioned to contain bedrooms, which were connected by a corridor. The experiments involved two target bedrooms of the same size. The door of the southeast bedroom remained closed whereas the door on the southwest bedroom was kept open. Each bedroom doorway was 0.81 m wide by 2.05 m high. There were no window openings on the second storey.

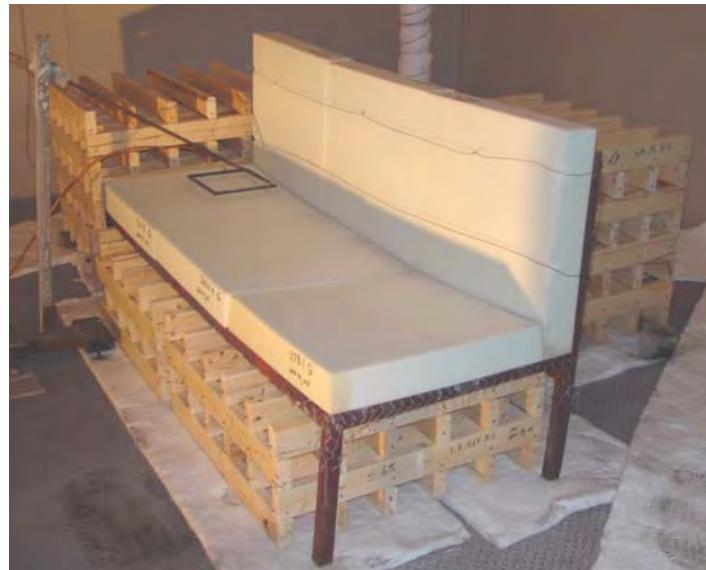
**Figure 6.** Fuel package

This fuel package consisted of a mock-up sofa constructed with 9 kg of exposed polyurethane foam (PUF), the dominant combustible constituent of upholstered furniture, and 190 kg of wood cribs beside and underneath the mock-up sofa. A photograph of the fuel package is shown in Figure 6. The mock-up sofa was constructed with 6 blocks of flexible polyurethane foam (with a density of  $32.8 \text{ kg/m}^3$ ) placed on a metal frame. Each block was 610 mm long by 610 mm wide and 100 mm or 150 mm thick. The 150-mm thick foam blocks were used for the backrest and the 100 mm thick foam blocks for the seat cushion. The PUF foam was used without any upholstery fabric that is used in typical upholstered furniture. The wood cribs were made with spruce lumber pieces, each piece measuring 38 mm x 89 mm x 800 mm. For the small cribs located under the mock-up sofa, four layers with six pieces per layer were used. The other two cribs used eight layers.

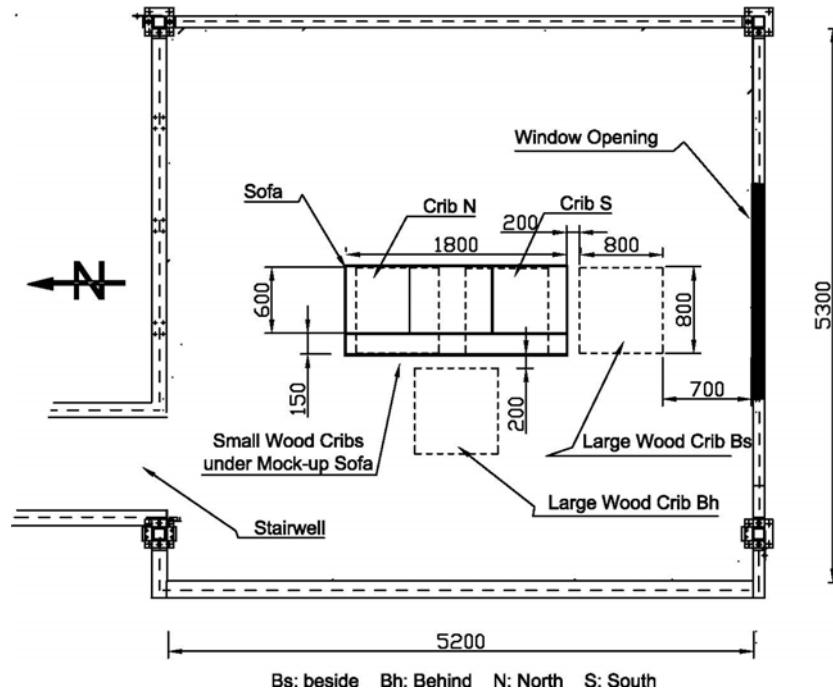
**Figure 7.** Layout of the fuel package (all dimensions in mm)

The placement of the fuel package in the basement fire compartment is illustrated in Figure 7. The mock-up sofa was located at the center of the floor area. The mock-up sofa was ignited in accordance with the ASTM 1537 test protocol [16] and the wood cribs provided the remaining fire load to sustain the fire for the desired period of time.

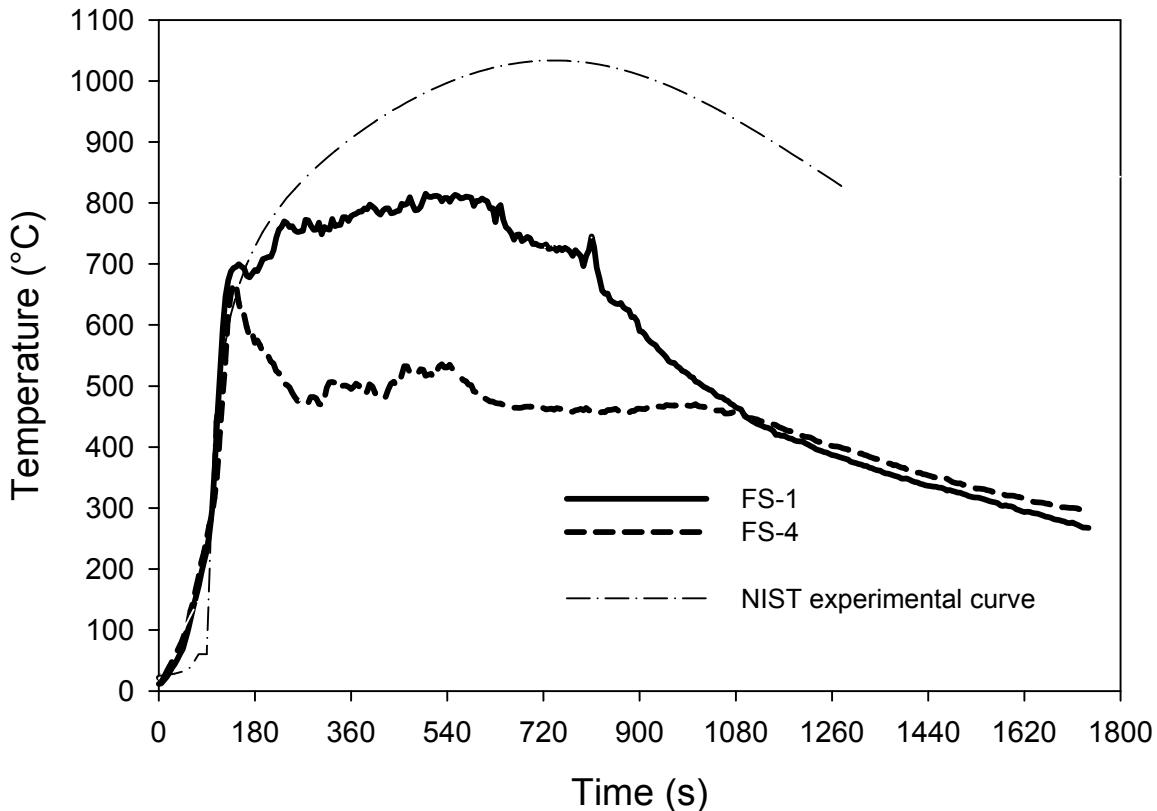
**Figure 8.** Average temperature profiles at 2.4 m height for FS-1 and FS-4

Figure 8 shows the average temperature profiles in the fire room at a height of 2.4 m for FS-1 and FS-4. The polyurethane foam used for the mock-up sofa dominated the initial fire growth (first 180 s). There was good repeatability of the ignition source and the initial fire development. Following this initial stage, the effects of ventilation became more pronounced and the fire became wood-crib-dominated.

The rate of fire growth for FS-1 and FS-4 in the early development stage agrees well with the test results from full-scale tests conducted by NIST [17] and the University of Canterbury [18] using residential living room settings. (The results from NIST tests are shown in Figure 8 for comparison). The NIST tests were conducted with higher fuel load densities and ventilation rates and hence the higher peak temperatures.)

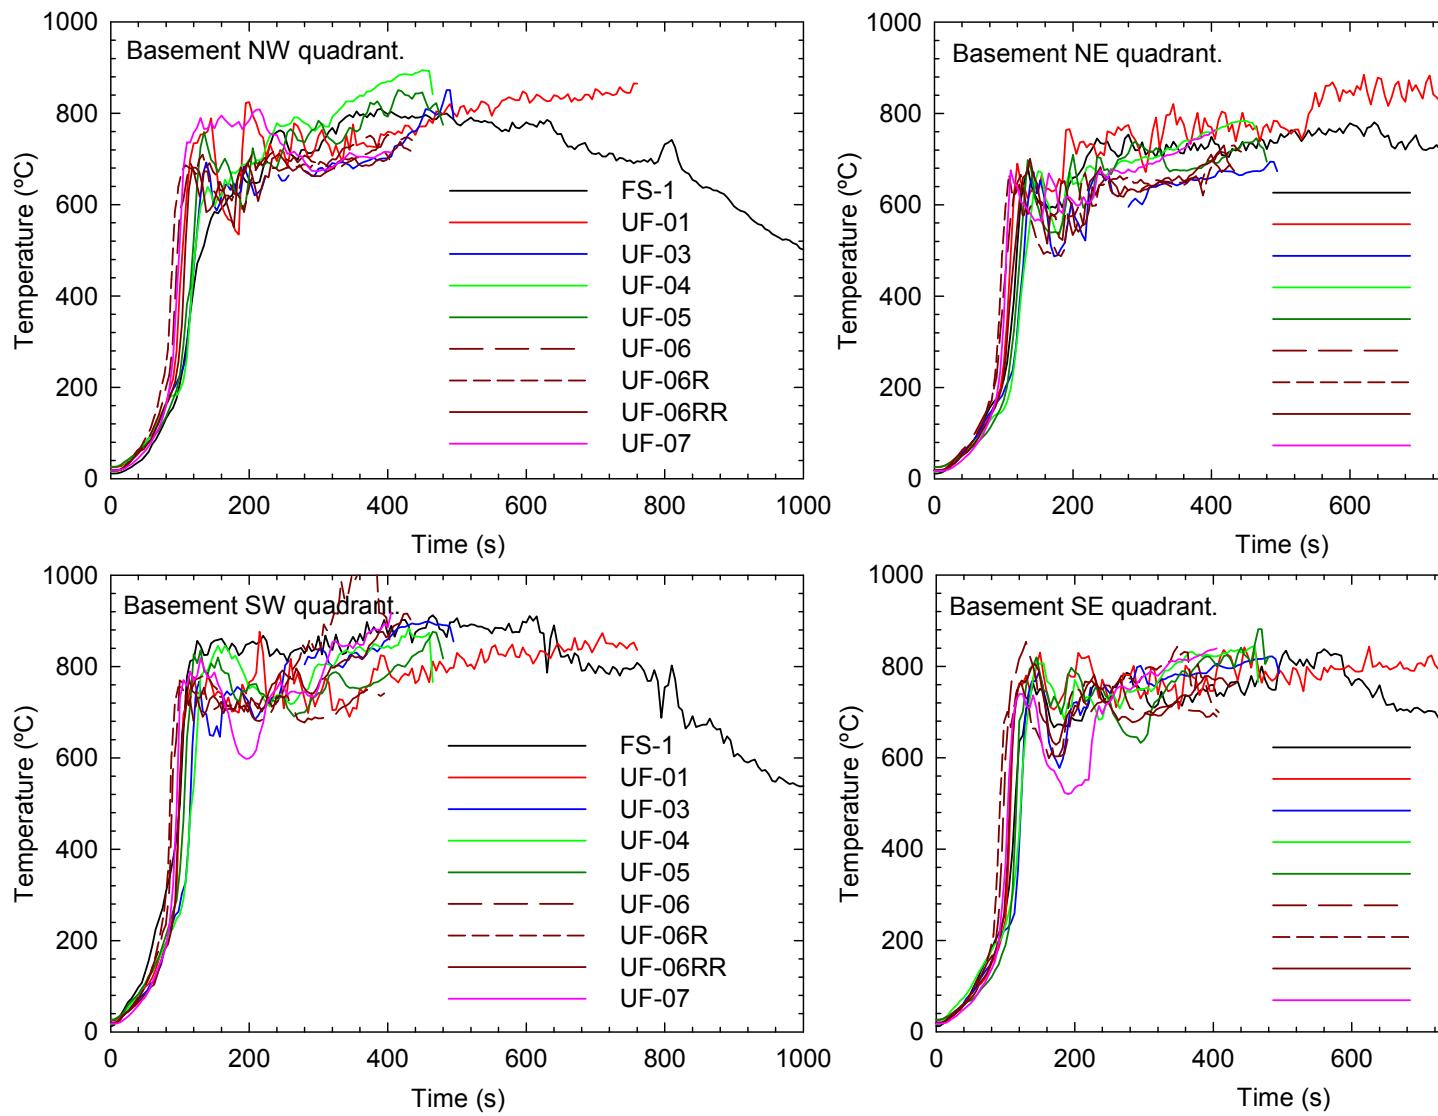
**Figure 9.** Temperature profiles in the basement fire compartment at 2.4 m height for experiments with open

Figure 9 and Figure 10 show the temperature profiles measured at the centre of the four quadrants of the basement fire room at a height of 2.4 m above the floor for all of the tests. Data on temperature stratification at different heights in the fire room can be found in a series of reports [5-10]. The polyurethane foam used for the mock-up sofa dominated the initial fire growth. The fast development of the fire from ignition to attainment of the first temperature peak was consistent for all of the tests. Following this initial stage, the effects of ventilation became more pronounced and the fire became wood-crib-dominated and also involved the unprotected floor assemblies.

There was good repeatability of the fire development and severity. The temperatures at the 2.4 m height exceeded 600°C at approximately 120 s in all of the tests, indicating that the basement fire compartment reached flashover conditions. Figure 9 indicates that under the full ventilation conditions (open basement doorway) the fire scenario provided a very reproducible fire exposure to the unprotected floor assemblies in all experiments. As shown in Figure 10, under the limited ventilation conditions (closed basement doorway), the fire scenario also provided a relatively severe and consistent fire exposure to the unprotected floor assemblies (the closed hollow-core interior door at the top of the basement stairwell was breached by the fire later in the experiments). There was a quick transition from a well-ventilated flaming fire to an under-ventilated fire in all experiments. The results from the fire scenario tests (FS-1 and FS-4) with a non-combustible ceiling in the fire room are also included in Figure 9 and Figure 10 for reference.
